Profile/Photo Observation Report

Street:	FOXCROFT STREET	Flow Control:	Not Controlled
City:	Hobart, IN	Year Renewed:	
Location:	Light Highway	Tape/Media #:	
Purpose:	Routine Assessment	Dia/Height:	12"
Use:	Sanitary	Material:	VCP
Drain Area:	NA	Lining:	
Category:	NA		
Comment:	R_M at 25 ft debris .		
Location Details:		Direction of Survey:	Upstream
US MH:	M-507-006	DS MH:	M-507-019A
		Total Length Surveyed (ft):	27.0

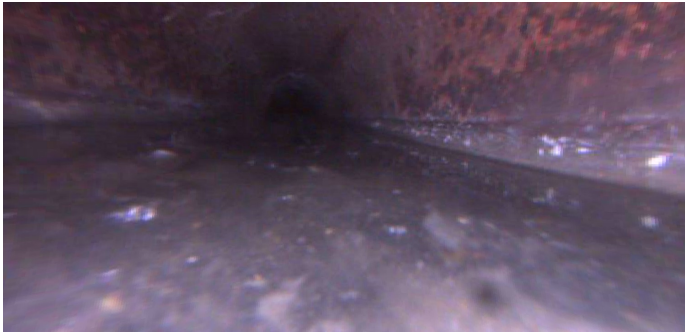
Code:	MWL
Description:	Water Level

Distance (ft):	.0
Structural Grade:	0
O&M Grade:	0
Clock Start/From:	
Clock To:	
1st Value:	
2nd Value:	
Value Percent:	5.000
Continuous Index:	
Within 8" of Joint:	NO
Remarks:

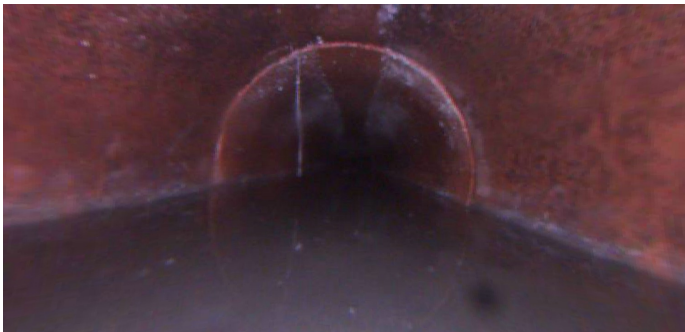
Code:	RFJ
Description:	Roots Fine Joint

Distance (ft):	10.1
Structural Grade:	0
O&M Grade:	1
Clock Start/From:	11
Clock To:	
1st Value:	
2nd Value:	
Value Percent:	
Continuous Index:	
Within 8" of Joint:	YES
Remarks:

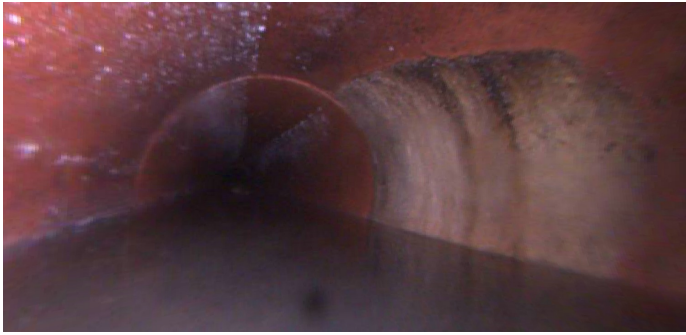
Code: **FL**
Description: **Fracture Longitudinal**

Distance (ft): **16.1**
Structural Grade: **3**
O&M Grade: **0**
Clock Start/From: **1**
Clock To:
1st Value:
2nd Value:
Value Percent:
Continuous Index:
Within 8" of Joint: **YES**
Remarks:

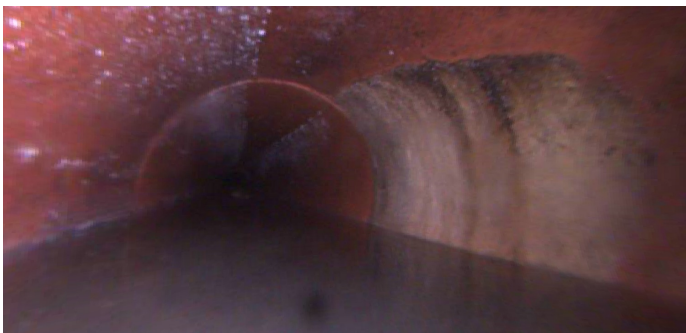
Code: **IS**
Description: **Infil Stain**

Distance (ft): **16.1**
Structural Grade: **0**
O&M Grade: **0**
Clock Start/From: **1**
Clock To: **4**
1st Value:
2nd Value:
Value Percent:
Continuous Index:
Within 8" of Joint: **YES**
Remarks:

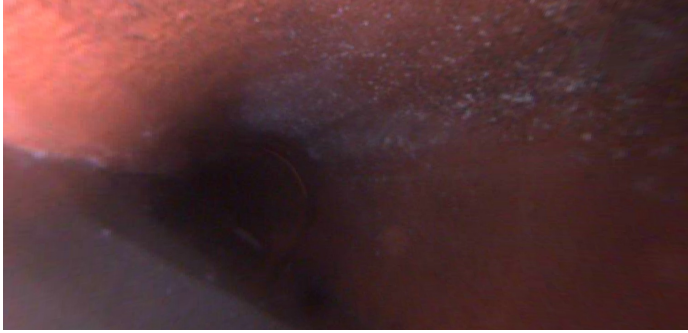
Code:	MSA
Description:	Abandoned Survey
Distance (ft):	27.0
Structural Grade:	0
O&M Grade:	0
Clock Start/From:	
Clock To:	
1st Value:	
2nd Value:	
Value Percent:	
Continuous Index:	
Within 8" of Joint:	NO
Remarks:	camera stopped
