Profile/Photo Observation Report

Street:	FOXCROFT STREET	Flow Control:	Not Controlled
City:	Hobart, IN	Year Renewed:	
Location:	Light Highway	Tape/Media #:	
Purpose:	Routine Assessment	Dia/Height:	12"
Use:	Sanitary	Material:	VCP
Drain Area:	NA	Lining:	
Category:	NA		
Comment:	R_M at 16 ft debris

Location Details:		Direction of Survey:	Downstream
US MH:	M-507-006	DS MH:	M-507-019A
		Total Length Surveyed (ft):	28.0

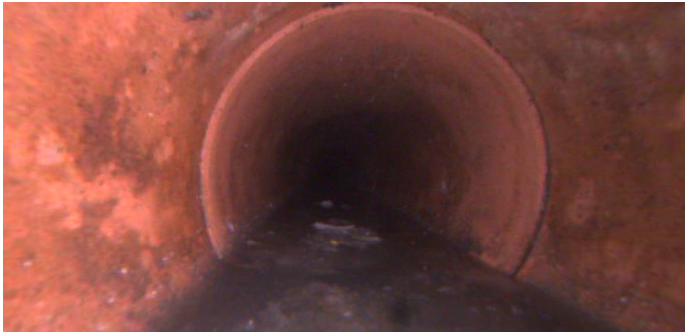
Code:	MWL
Description:	Water Level

Distance (ft):	.0
Structural Grade:	0
O&M Grade:	0
Clock Start/From:	
Clock To:	
1st Value:	
2nd Value:	
Value Percent:	10.000
Continuous Index:	
Within 8" of Joint:	NO
Remarks:

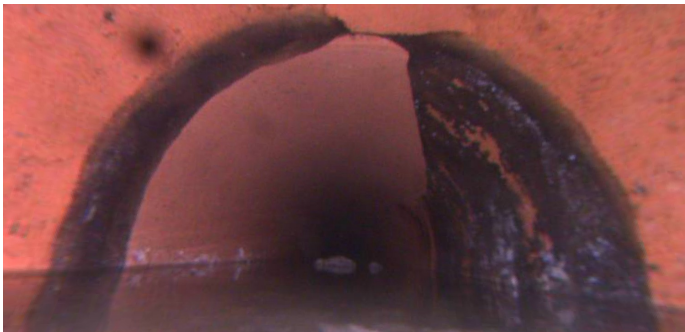
Code:	IW
Description:	Infil Weeper

Distance (ft):	25.2
Structural Grade:	0
O&M Grade:	2
Clock Start/From:	8
Clock To:	4
1st Value:	
2nd Value:	
Value Percent:	
Continuous Index:	
Within 8" of Joint:	YES
Remarks:

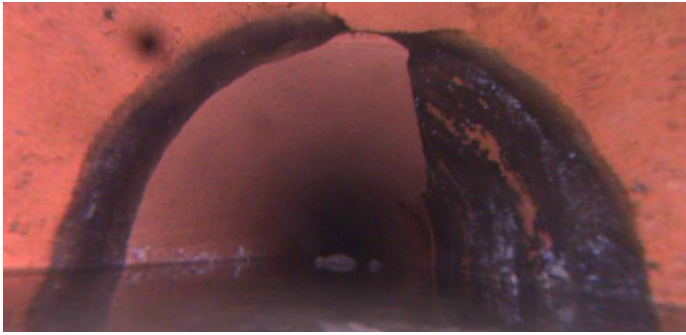
Code: **FS**
Description: **Fracture Spiral**

Distance (ft): **25.2**
Structural Grade: **3**
O&M Grade: **0**
Clock Start/From: **1**
Clock To: **3**
1st Value:
2nd Value:
Value Percent:
Continuous Index:
Within 8" of Joint: **YES**
Remarks:

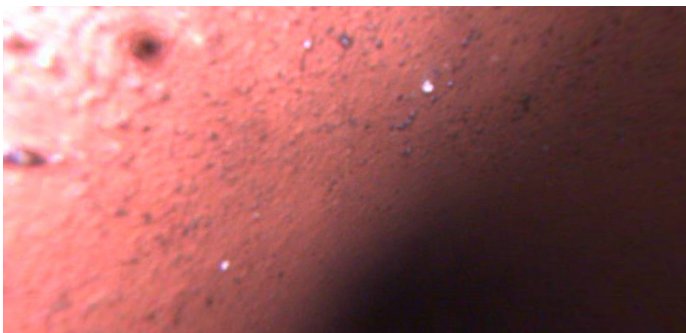
Code: **MSA**
Description: **Abandoned Survey**

Distance (ft): **28.0**
Structural Grade: **0**
O&M Grade: **0**
Clock Start/From:
Clock To:
1st Value:
2nd Value:
Value Percent:
Continuous Index:
Within 8" of Joint: **NO**
Remarks: **DEBRIS UNDER WATER**
