Profile/Photo Observation Report

Street:	S DELAWARE ST	Flow Control:	Not Controlled
City:	Hobart, IN	Year Renewed:	
Location:	Light Highway	Tape/Media #:	
Purpose:	Routine Assessment	Dia/Height:	12"
Use:	Sanitary	Material:	VCP
Drain Area:	NA	Lining:	
Category:	NA		
Comment:	False O_C at 26 ft R_M solo on it's side . Flow direction wrong		
Location Details:		Direction of Survey:	Upstream
US MH:	M-507-004	DS MH:	M-507-006
		Total Length Surveyed (ft):	27.5

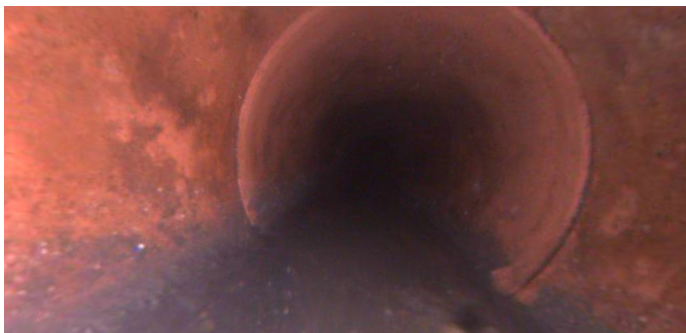
Code: **AMH**
Description: **Manhole**

Distance (ft): **.0**
Structural Grade: **0**
O&M Grade: **0**
Clock Start/From:
Clock To:
1st Value:
2nd Value:
Value Percent:
Continuous Index:
Within 8" of Joint: **NO**
Remarks: **M-507-006**

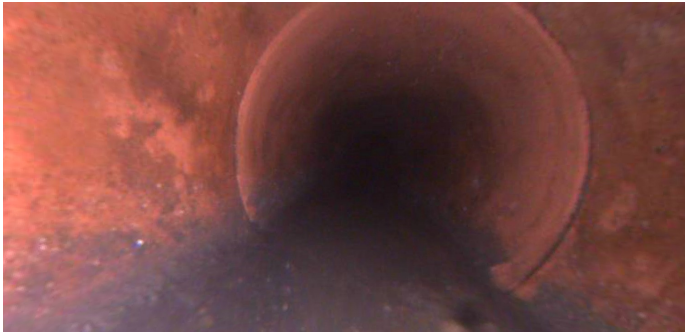
Code:	MWL
Description:	Water Level

Distance (ft):	.0
Structural Grade:	0
O&M Grade:	0
Clock Start/From:	
Clock To:	
1st Value:	
2nd Value:	
Value Percent:	10.000
Continuous Index:	
Within 8" of Joint:	NO
Remarks:

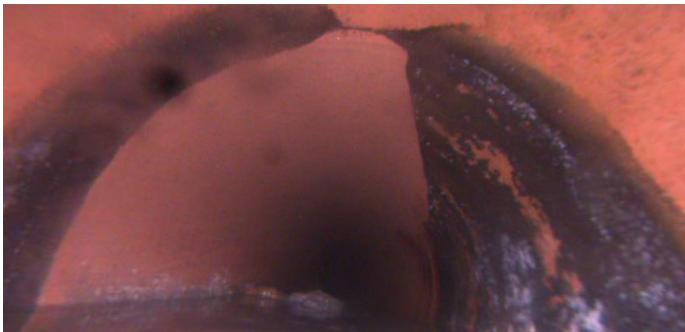
Code:	IW
Description:	Infil Weeper

Distance (ft):	25.5
Structural Grade:	0
O&M Grade:	2
Clock Start/From:	8
Clock To:	4
1st Value:	
2nd Value:	
Value Percent:	
Continuous Index:	
Within 8" of Joint:	YES
Remarks:

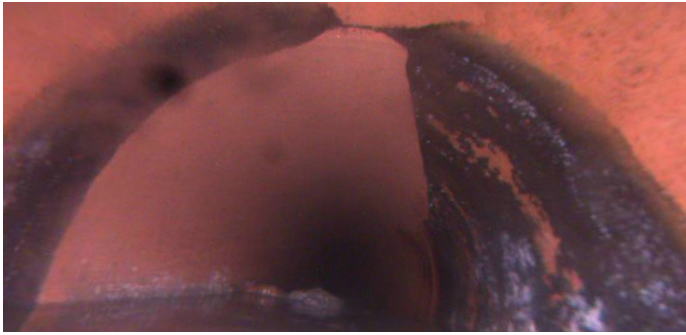
Code: **FS**
Description: **Fracture Spiral**

Distance (ft): **25.5**
Structural Grade: **3**
O&M Grade: **0**
Clock Start/From: **1**
Clock To: **4**
1st Value:
2nd Value:
Value Percent:
Continuous Index:
Within 8" of Joint: **YES**
Remarks:

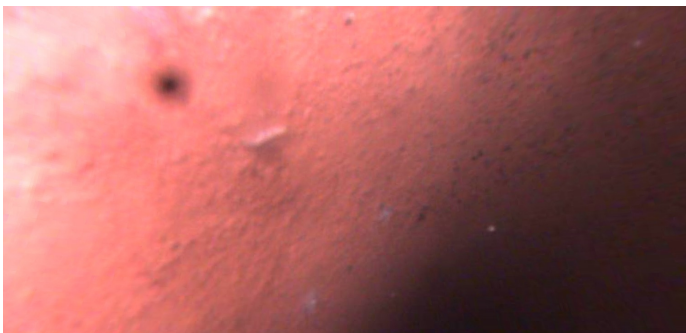
Code: **MSA**
Description: **Abandoned Survey**

Distance (ft): **27.5**
Structural Grade: **0**
O&M Grade: **0**
Clock Start/From:
Clock To:
1st Value:
2nd Value:
Value Percent:
Continuous Index:
Within 8" of Joint: **NO**
Remarks: **DEBRIS UNDER WATER**
