Profile/Photo Observation Report

Date:	10/09/2018	Weather:		Coding:	PACP 6.0
Pipe Length (ft):	244.7	Owner:	NA	Pre Clean:	Not Known
P.O.#:		Surveyor:	Selasie Honu	PSR:	P-507-006-004
Customer:		Clean Date:	01/01/1900	Shape:	C

Street:	S DELAWARE ST	Flow Control:	Not Controlled
City:	Hobart, IN	Year Renewed:	
Location:	Light Highway	Tape/Media #:	
Purpose:	Routine Assessment	Dia/Height:	12"
Use:	Sanitary	Material:	VCP
Drain Area:	NA	Lining:	
Category:	NA		
Comment:

Location Details:		Direction of Survey:	Upstream
US MH:	M-507-004	DS MH:	M-507-006
		Total Length Surveyed (ft):	29.6

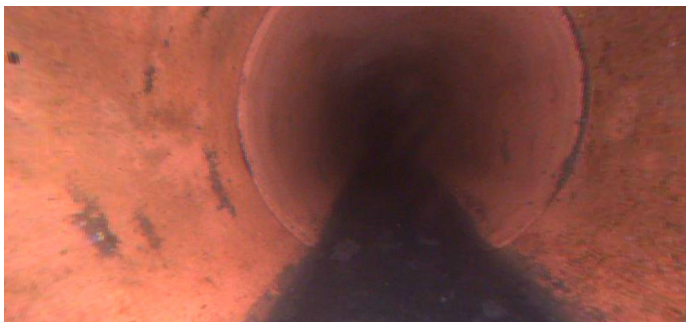
Code: **AMH**
Description: **Manhole**

Distance (ft): **.0**
Structural Grade: **0**
O&M Grade: **0**
Clock Start/From:
Clock To:
1st Value:
2nd Value:
Value Percent:
Continuous Index:
Within 8" of Joint: **NO**
Remarks: **M-507-006**

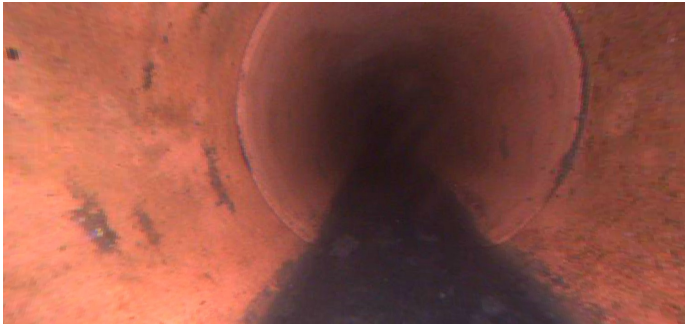
Code:	MWL
Description:	Water Level

Distance (ft):	.0
Structural Grade:	0
O&M Grade:	0
Clock Start/From:	
Clock To:	
1st Value:	
2nd Value:	
Value Percent:	5.000
Continuous Index:	
Within 8" of Joint:	NO
Remarks:

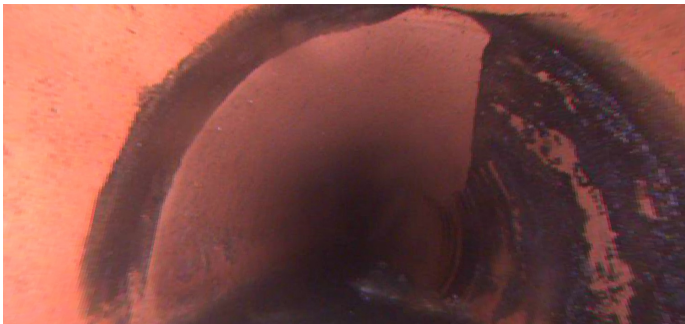
Code:	IS
Description:	Infil Stain

Distance (ft):	26.6
Structural Grade:	0
O&M Grade:	0
Clock Start/From:	8
Clock To:	4
1st Value:	
2nd Value:	
Value Percent:	
Continuous Index:	
Within 8" of Joint:	YES
Remarks:

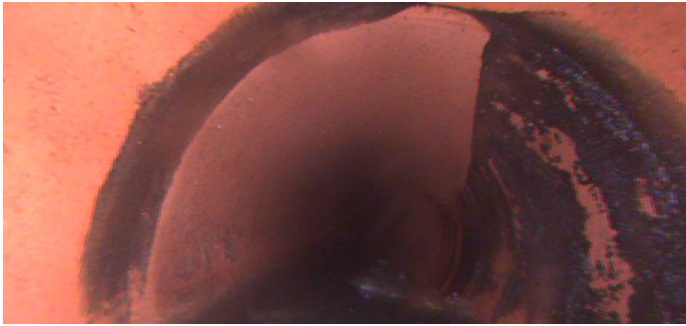
Code: **CL**
Description: **Crack Longitudinal**

Distance (ft): **26.6**
Structural Grade: **2**
O&M Grade: **0**
Clock Start/From: **1**
Clock To:
1st Value:
2nd Value:
Value Percent:
Continuous Index:
Within 8" of Joint: **YES**
Remarks:

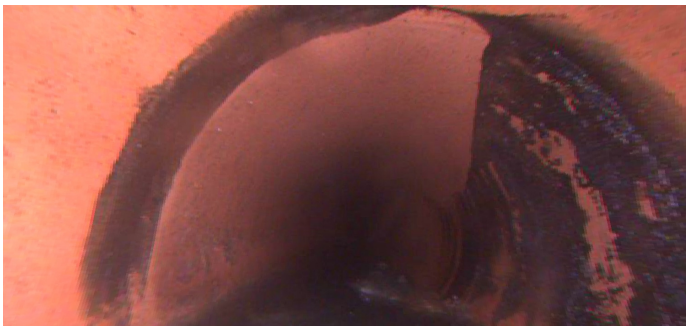
Code: **DAE**
Description: **Deposits Attached Encrustation**

Distance (ft): **26.6**
Structural Grade: **0**
O&M Grade: **3**
Clock Start/From: **8**
Clock To: **4**
1st Value:
2nd Value:
Value Percent: **20.000**
Continuous Index:
Within 8" of Joint: **YES**
Remarks:

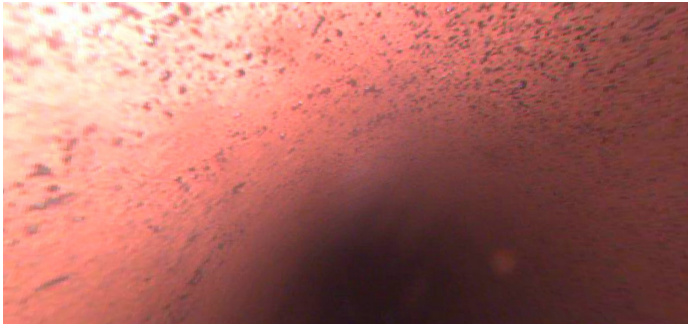
Code:	MSA
Description:	Abandoned Survey
Distance (ft):	29.6
Structural Grade:	0
O&M Grade:	0
Clock Start/From:	
Clock To:	
1st Value:	
2nd Value:	
Value Percent:	
Continuous Index:	
Within 8" of Joint:	NO
Remarks:	camera stopped
