Profile/Photo Observation Report

Street:	Delaware St.	Flow Control:	Not Controlled
City:	Hobart, IN	Year Renewed:	
Location:	Light Highway	Tape/Media #:	
Purpose:	Routine Assessment	Dia/Height:	12"
Use:	Sanitary	Material:	VCP
Drain Area:	NA	Lining:	
Category:	NA		
Comment:

Location Details:		Direction of Survey:	Upstream
US MH:	M-507-004	DS MH:	M-507-006
		Total Length Surveyed (ft):	29.6

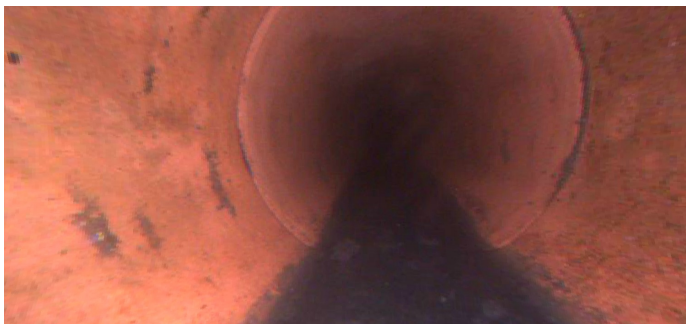
Code: **AMH**
Description: **Manhole**

Distance (ft): **.0**
Structural Grade: **0**
O&M Grade: **0**
Clock Start/From:
Clock To:
1st Value:
2nd Value:
Value Percent:
Continuous Index:
Within 8" of Joint: **NO**
Remarks: **M-507-006**

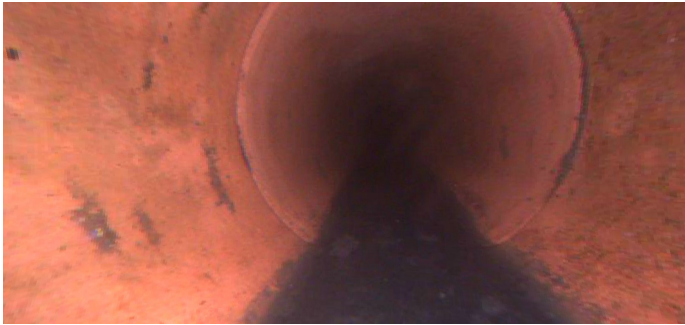
Code:	MWL
Description:	Water Level

Distance (ft):	.0
Structural Grade:	0
O&M Grade:	0
Clock Start/From:	
Clock To:	
1st Value:	
2nd Value:	
Value Percent:	5.000
Continuous Index:	
Within 8" of Joint:	NO
Remarks:

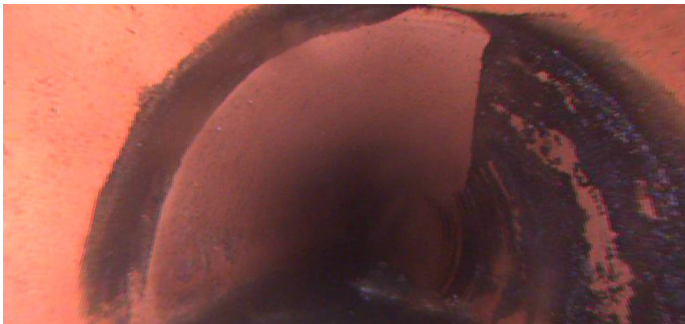
Code:	IS
Description:	Infil Stain

Distance (ft):	26.6
Structural Grade:	0
O&M Grade:	0
Clock Start/From:	8
Clock To:	4
1st Value:	
2nd Value:	
Value Percent:	
Continuous Index:	
Within 8" of Joint:	YES
Remarks:

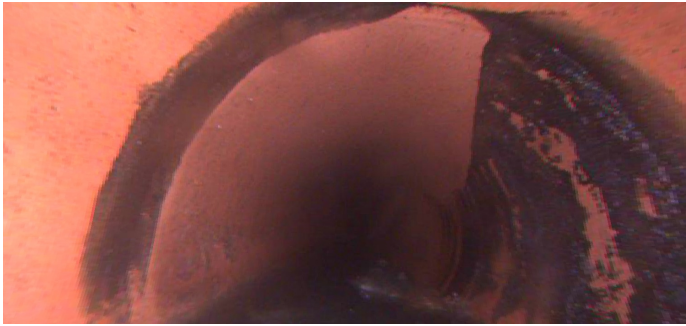
Code: **CL**
Description: **Crack Longitudinal**

Distance (ft): **26.6**
Structural Grade: **2**
O&M Grade: **0**
Clock Start/From: **1**
Clock To:
1st Value:
2nd Value:
Value Percent:
Continuous Index:
Within 8" of Joint: **YES**
Remarks:

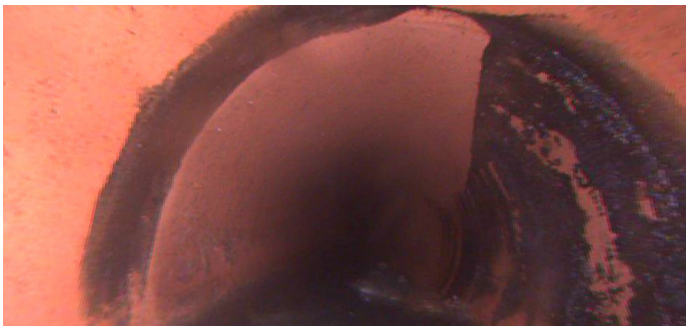
Code: **DAE**
Description: **Deposits Attached Encrustation**

Distance (ft): **26.6**
Structural Grade: **0**
O&M Grade: **3**
Clock Start/From: **8**
Clock To: **4**
1st Value:
2nd Value:
Value Percent: **20.000**
Continuous Index:
Within 8" of Joint: **YES**
Remarks:

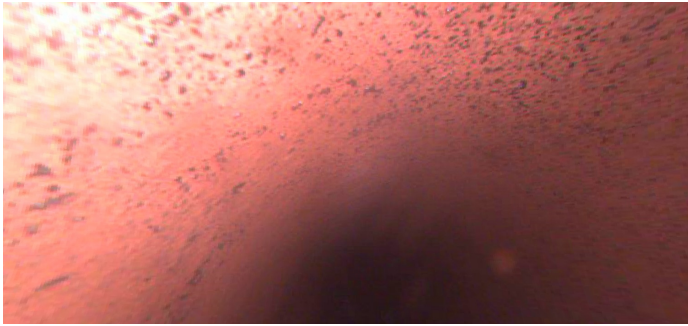
Code:	MSA
Description:	Abandoned Survey
Distance (ft):	29.6
Structural Grade:	0
O&M Grade:	0
Clock Start/From:	
Clock To:	
1st Value:	
2nd Value:	
Value Percent:	
Continuous Index:	
Within 8" of Joint:	NO
Remarks:	camera stopped
