# Profile/Photo Observation Report

| Street: | <b>FOXCROFT STREET</b> | Flow Control: | <b>Not Controlled</b> |
| City: | <b>Hobart, IN</b> | Year Renewed: | |
| US MH: | <b>M-507-011</b> | DS MH: | <b>M-507-019A</b> |

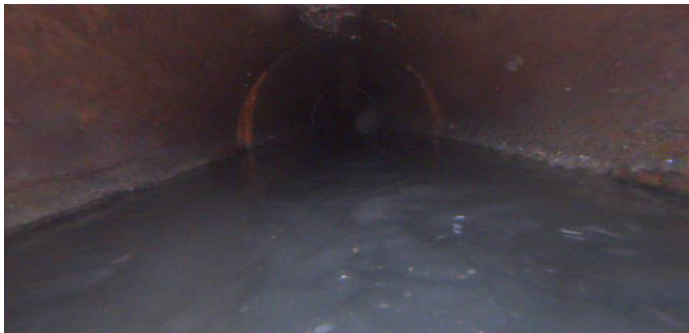
Code: **AMH**  
 Description: **Manhole**  
 Distance (ft): **.0**  
 Structural Grade: **0**  
 O&M Grade: **0**  
 Clock Start/From:  
 Clock To:  
 1st Value:  
 2nd Value:  
 Value Percent:  
 Continuous Index:  
 Within 8" of Joint: **NO**  
 Remarks: **M-507-011**

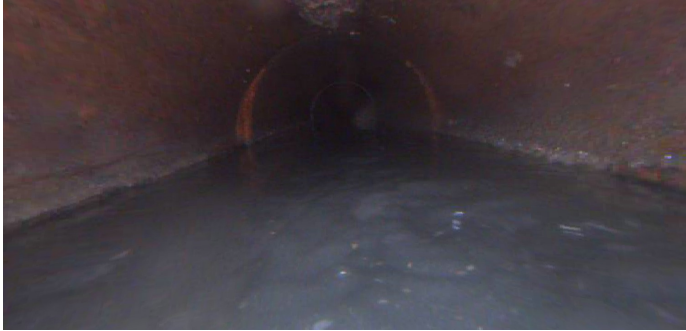
Code: **MWL**  
Description: **Water Level**

Distance (ft): **.0**  
Structural Grade: **0**  
O&M Grade: **0**  
Clock Start/From:  
Clock To:  
1st Value:  
2nd Value:  
Value Percent: **5.000**  
Continuous Index:  
Within 8" of Joint: **NO**  
Remarks:

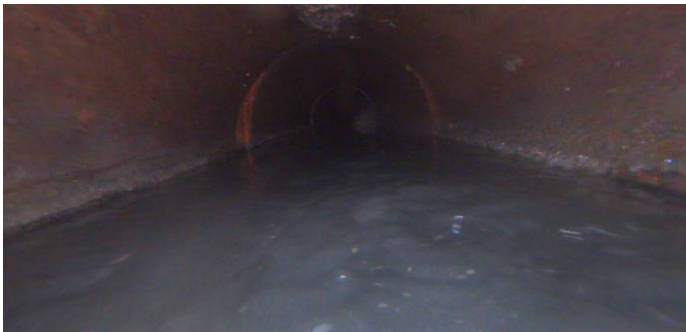
Code: **IS**  
Description: **Infil Stain**

Distance (ft): **.0**  
Structural Grade: **0**  
O&M Grade: **0**  
Clock Start/From: **8**  
Clock To: **12**  
1st Value:  
2nd Value:  
Value Percent:  
Continuous Index:  
Within 8" of Joint: **YES**  
Remarks:

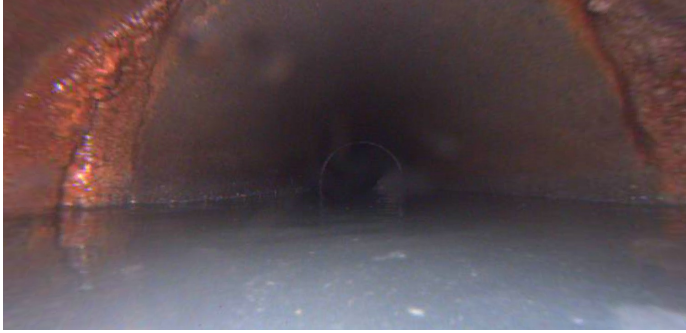
Code: **DAE**  
Description: **Deposits Attached Encrustation**

Distance (ft): **2.2**  
Structural Grade: **0**  
O&M Grade: **2**  
Clock Start/From: **8**  
Clock To: **4**  
1st Value:  
2nd Value:  
Value Percent: **5.000**  
Continuous Index:  
Within 8" of Joint: **YES**  
Remarks:

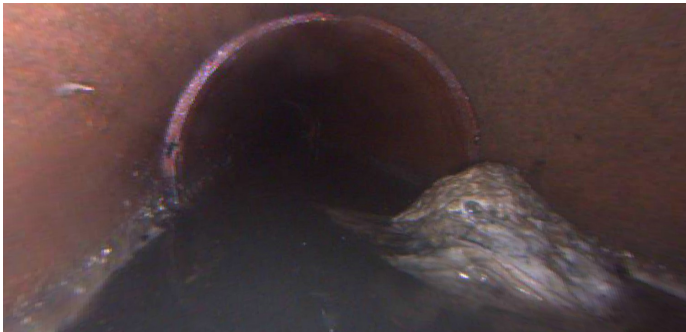
Code: **DSZ**  
Description: **Deposits Settled Other**

Distance (ft): **4.6**  
Structural Grade: **0**  
O&M Grade: **2**  
Clock Start/From: **4**  
Clock To:  
1st Value:  
2nd Value:  
Value Percent: **10.000**  
Continuous Index:  
Within 8" of Joint: **YES**  
Remarks: **mixed material**

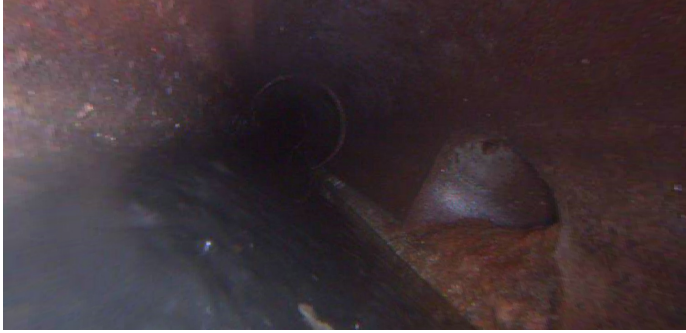
Code: **TFD**  
Description: **Tap Factory Defective**

Distance (ft): **9.4**  
Structural Grade: **0**  
O&M Grade: **2**  
Clock Start/From: **3**  
Clock To:  
1st Value: **4.000**  
2nd Value:  
Value Percent:  
Continuous Index:  
Within 8" of Joint:  
Remarks: **DAE**

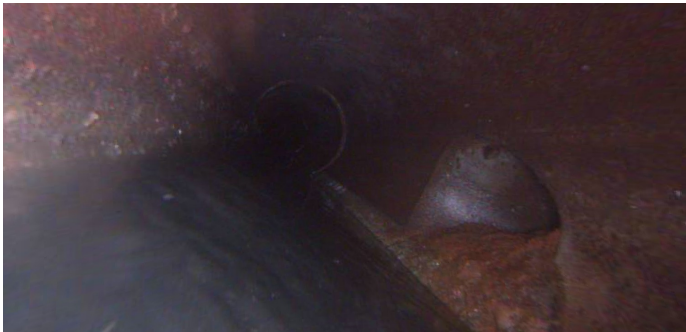
Code: **DAE**  
Description: **Deposits Attached Encrustation**

Distance (ft): **9.4**  
Structural Grade: **0**  
O&M Grade: **2**  
Clock Start/From: **3**  
Clock To: **4**  
1st Value:  
2nd Value:  
Value Percent: **5.000**  
Continuous Index:  
Within 8" of Joint: **NO**  
Remarks:

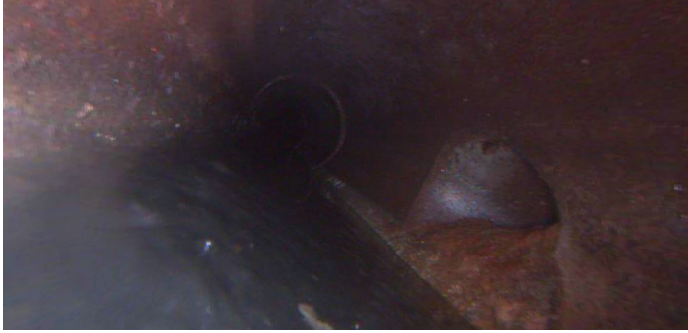
| Code: | <b>MSA</b> |
| Description: | <b>Abandoned Survey</b> |
| Remarks: | <b>camera stopped</b> |
