Profile/Photo Observation Report

Street:	FOXCROFT STREET	Flow Control:	Not Controlled
City:	Hobart, IN	Year Renewed:	
Location:	Yard	Tape/Media #:	
Purpose:	Routine Assessment	Dia/Height:	12"
Use:	Sanitary	Material:	VCP
Drain Area:	NA	Lining:	
Category:	NA		
Comment:	P_C at 16 ft debris

Location Details:		Direction of Survey:	Upstream
US MH:	M-507-011	DS MH:	M-507-019A
		Total Length Surveyed (ft):	17.5

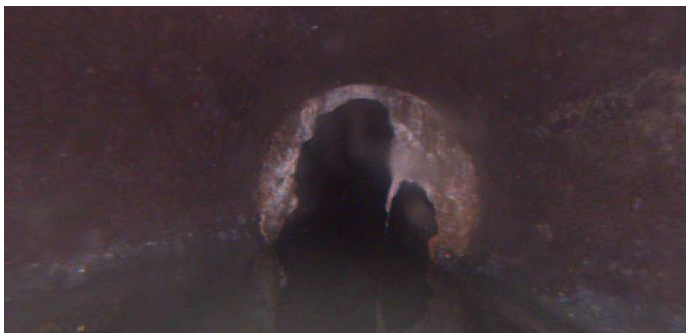
Code: **AMH**
Description: **Manhole**

Distance (ft): **.0**
Structural Grade: **0**
O&M Grade: **0**
Clock Start/From:
Clock To:
1st Value:
2nd Value:
Value Percent:
Continuous Index:
Within 8" of Joint: **NO**
Remarks: **M-507-019A**

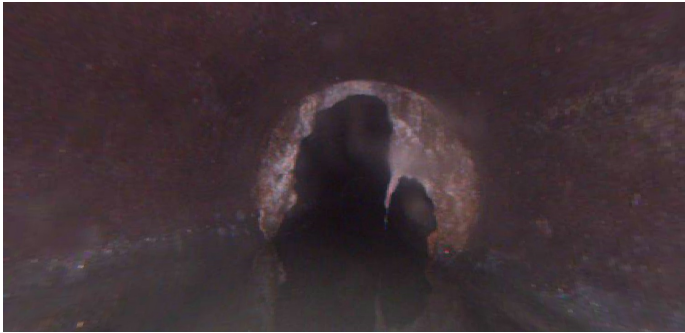
Code:	MWL
Description:	Water Level

Distance (ft):	.0
Structural Grade:	0
O&M Grade:	0
Clock Start/From:	
Clock To:	
1st Value:	
2nd Value:	
Value Percent:	5.000
Continuous Index:	
Within 8" of Joint:	NO
Remarks:

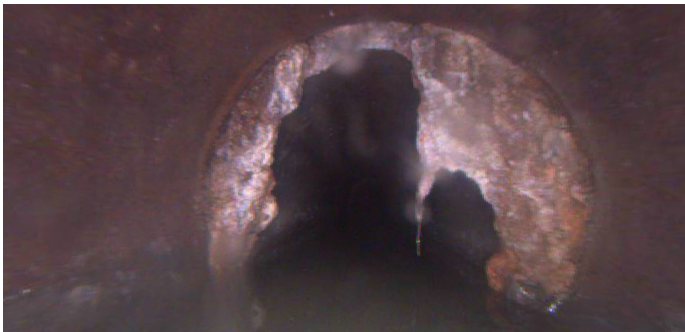
Code:	DAE
Description:	Deposits Attached Encrustation

Distance (ft):	1.4
Structural Grade:	0
O&M Grade:	4
Clock Start/From:	7
Clock To:	5
1st Value:	
2nd Value:	
Value Percent:	25.000
Continuous Index:	
Within 8" of Joint:	YES
Remarks:

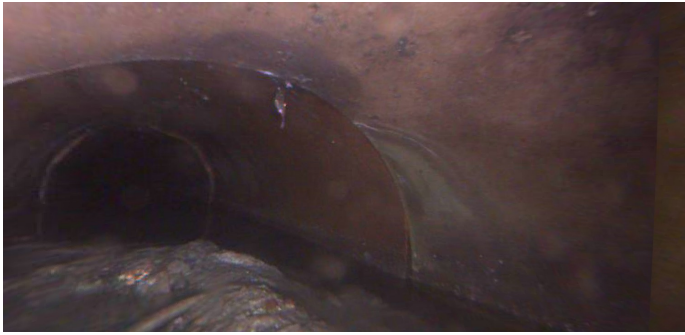
Code: **CS**
Description: **Crack Spiral**

Distance (ft): **15.3**
Structural Grade: **2**
O&M Grade: **0**
Clock Start/From: **2**
Clock To: **3**
1st Value:
2nd Value:
Value Percent:
Continuous Index:
Within 8" of Joint: **YES**
Remarks:

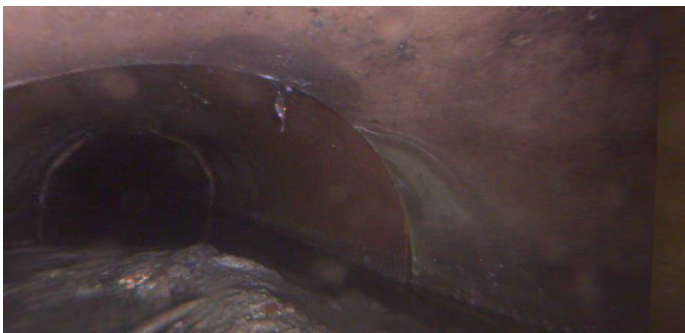
Code: **IW**
Description: **Infil Weeper**

Distance (ft): **15.3**
Structural Grade: **0**
O&M Grade: **2**
Clock Start/From: **2**
Clock To: **4**
1st Value:
2nd Value:
Value Percent:
Continuous Index:
Within 8" of Joint: **YES**
Remarks:

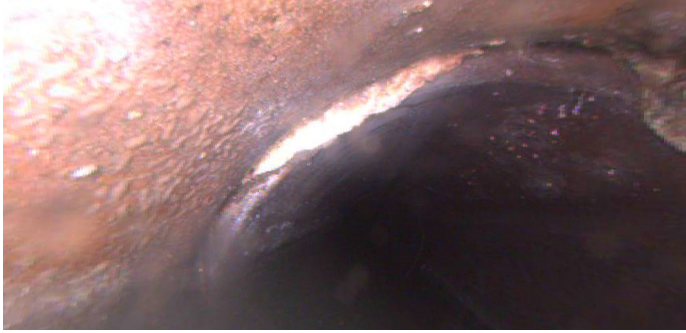
Code:	MSA
Description:	Abandoned Survey
Distance (ft):	17.5
Structural Grade:	0
O&M Grade:	0
Clock Start/From:	
Clock To:	
1st Value:	
2nd Value:	
Value Percent:	
Continuous Index:	
Within 8" of Joint:	NO
Remarks:	camera stopped
