## Profile/Photo Observation Report

Date:	<b>04/08/2018</b>	Weather:		Coding:	<b>PACP 6.0</b>
Pipe Length (ft):		Owner:	<b>City of Hobart</b>	Pre Clean:	<b>Not Known</b>
P.O.#:	<b>206</b>	Surveyor:	<b>B. Helbling</b>	PSR:	<b>P-507-011-004</b>
Customer:	<b>City of Hobart</b>	Clean Date:		Shape:	<b>C</b>

Street:	<b>South Colorado Street</b>	Flow Control:	<b>Not Controlled</b>
City:	<b>Hobart, IN</b>	Year Renewed:	
Location:	<b>Yard</b>	Tape/Media #:	<b>DEP206</b>
Purpose:	<b>Routine Assessment</b>	Dia/Height:	<b>12"</b>
Use:	<b>Sanitary</b>	Material:	<b>VCP</b>
Drain Area:		Lining:	
Category:	<b>NA</b>		
Comment:	<b>YES501824 Submittal 2</b>		
Location Details:		Direction of Survey:	<b>Downstream</b>
US MH:	<b>M-507-004</b>	DS MH:	<b>M-507-011</b>
		Total Length Surveyed (ft):	<b>7.4</b>

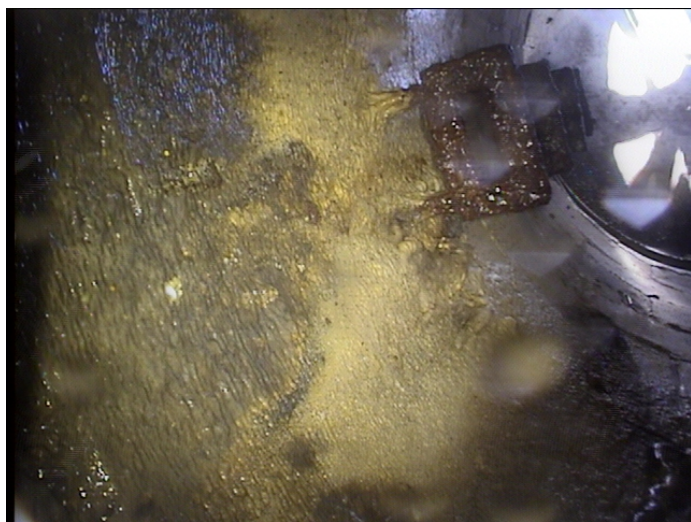
Code: **AMH**  
Description: **Manhole**

Distance (ft): **.0**  
Structural Grade: **0**  
O&M Grade: **0**  
Clock Start/From:  
Clock To:  
1st Value:  
2nd Value:  
Value Percent:  
Continuous Index:  
Within 8" of Joint: **NO**  
Remarks: **M-507-004**

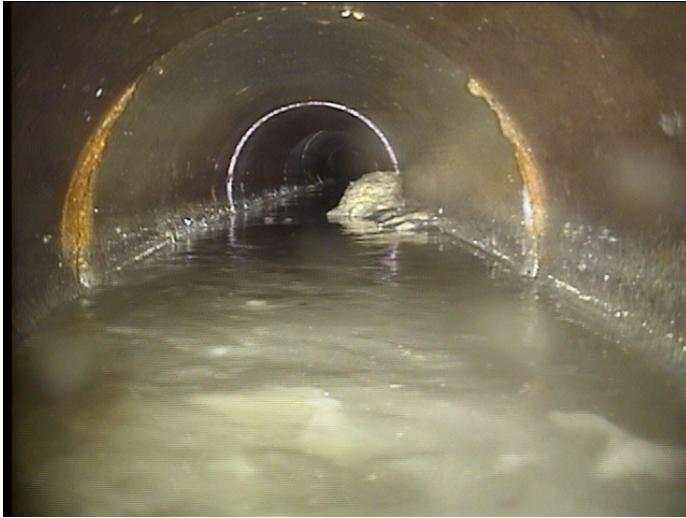
Code: **MWL**  
Description: **Water Level**

Distance (ft): **.0**  
Structural Grade: **0**  
O&M Grade: **0**  
Clock Start/From:  
Clock To:  
1st Value:  
2nd Value:  
Value Percent: **15.000**  
Continuous Index:  
Within 8" of Joint: **NO**  
Remarks:

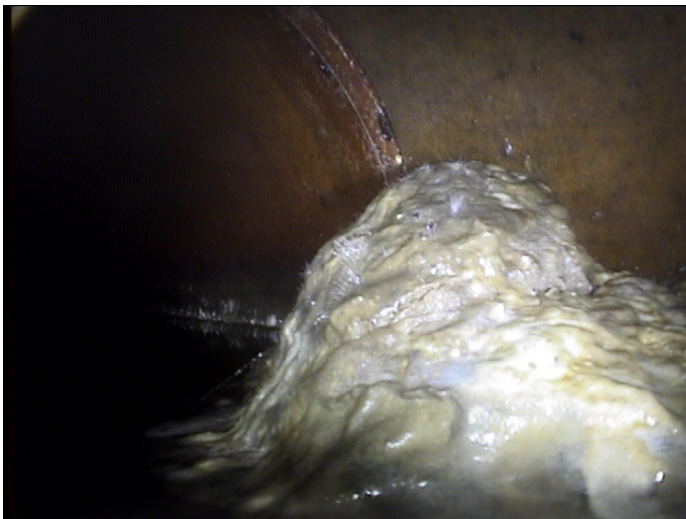
Code: **OBZ**  
Description: **Obstacle Other**

Distance (ft): **5.8**  
Structural Grade: **0**  
O&M Grade: **2**  
Clock Start/From: **2**  
Clock To: **4**  
1st Value:  
2nd Value:  
Value Percent: **10.000**  
Continuous Index:  
Within 8" of Joint: **NO**  
Remarks: **rock**

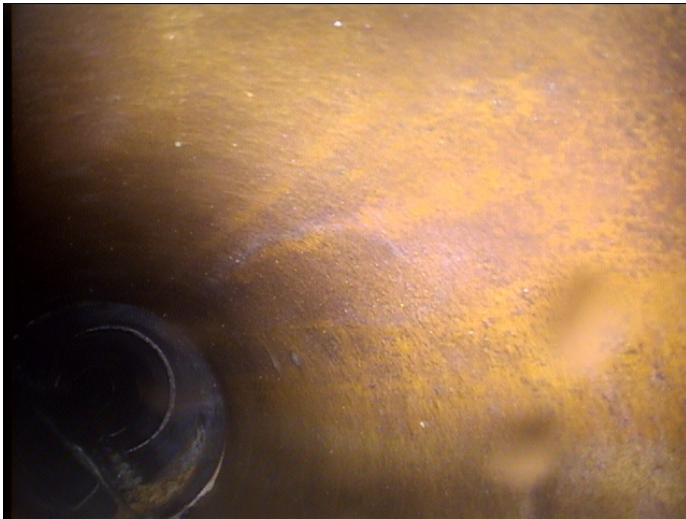
Code:	<b>MSA</b>
Description:	<b>Abandoned Survey</b>
Distance (ft):	<b>7.4</b>
Structural Grade:	<b>0</b>
O&M Grade:	<b>0</b>
Clock Start/From:	
Clock To:	
1st Value:	
2nd Value:	
Value Percent:	
Continuous Index:	
Within 8" of Joint:	<b>NO</b>
Remarks:	<b>Cannot pass rock</b>
