RedZone  
ROBOTICS

Street:	South Delaware Street		Flow Control:	Not Controlled	
City:	Hobart, IN		Year Renewed:		
Location:	Easement/Right of Way		Tape/Media #:		
Purpose:	Sewer System Evaluation Survey (SS		Dia/Height:	12"	
Use:	Sanitary Sewage Pipe		Material:	VCP	
Drain Area:			Lining:	None	
Category:	NA				
Comment:					
Location Details:			Direction of Survey:	Upstream	
US MH:	M-507-011	DS MH:	M-507-004	Total Length Surveyed (ft):	218.1

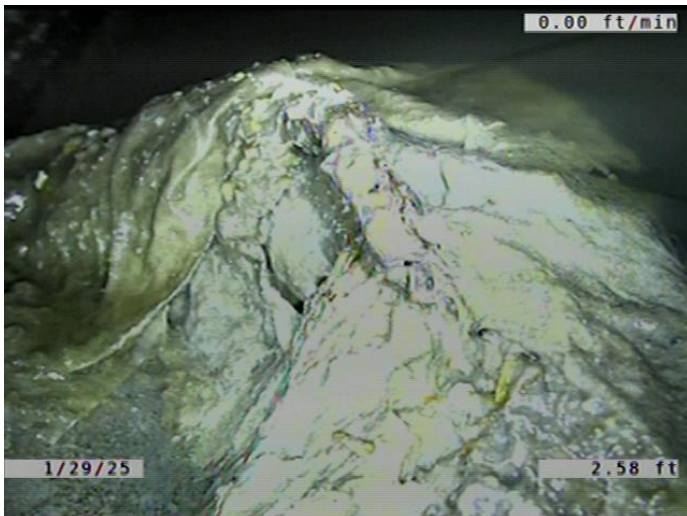
Code: **DAR**  
 Description: **Deposits Attached Ragging**

Distance (ft): **2.6**  
 Structural Grade: **0**  
 O&M Grade: **2**  
 Clock Start/From: **6**  
 Clock To: **8**  
 1st Value:  
 2nd Value:  
 Value Percent: **5.000**  
 Continuous Index:  
 Within 8" of Joint: **YES**  
 Remarks:

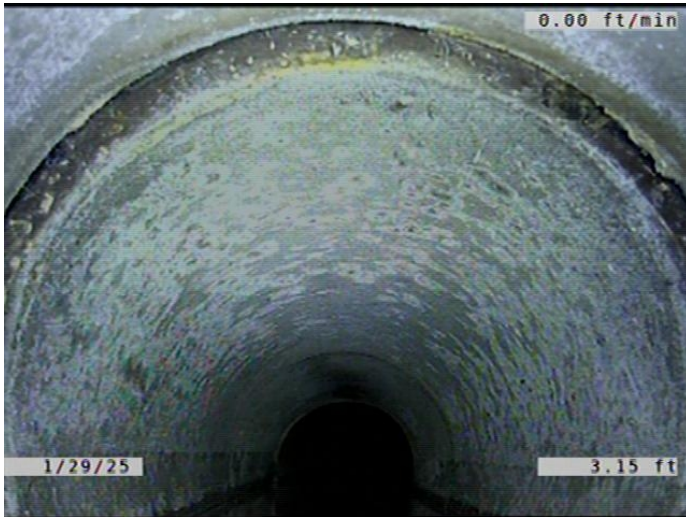
Code: **JOMD**  
Description: **Joint Offset Medium Defective**

Distance (ft): **3.2**  
Structural Grade: **3**  
O&M Grade: **0**  
Clock Start/From:  
Clock To:  
1st Value:  
2nd Value:  
Value Percent:  
Continuous Index:  
Within 8" of Joint: **NO**  
Remarks:

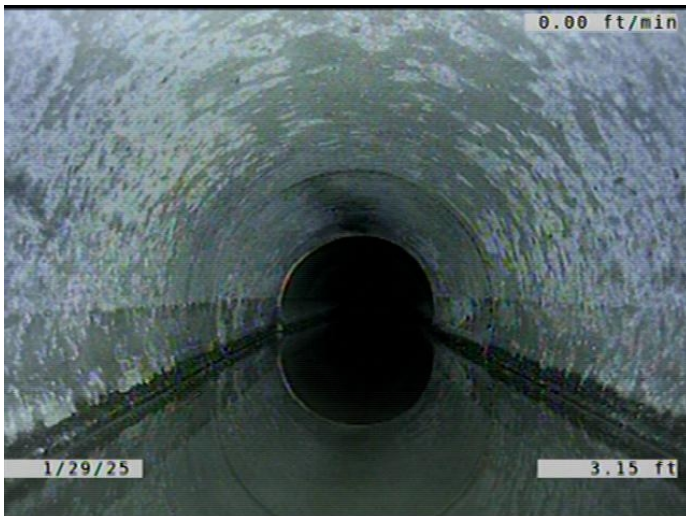
Code: **MWLS**  
Description: **Miscellaneous Water Level Sag**

Distance (ft): **3.2**  
Structural Grade: **2**  
O&M Grade: **0**  
Clock Start/From:  
Clock To:  
1st Value:  
2nd Value:  
Value Percent: **30.000**  
Continuous Index: **S02**  
Within 8" of Joint: **NO**  
Remarks:

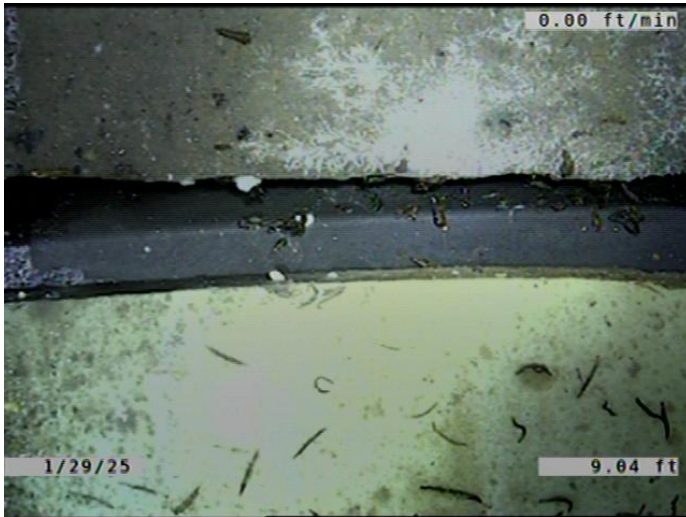
Code: **JOMD**  
Description: **Joint Offset Medium Defective**

Distance (ft): **9.0**  
Structural Grade: **3**  
O&M Grade: **0**  
Clock Start/From:  
Clock To:  
1st Value:  
2nd Value:  
Value Percent:  
Continuous Index:  
Within 8" of Joint: **NO**  
Remarks:

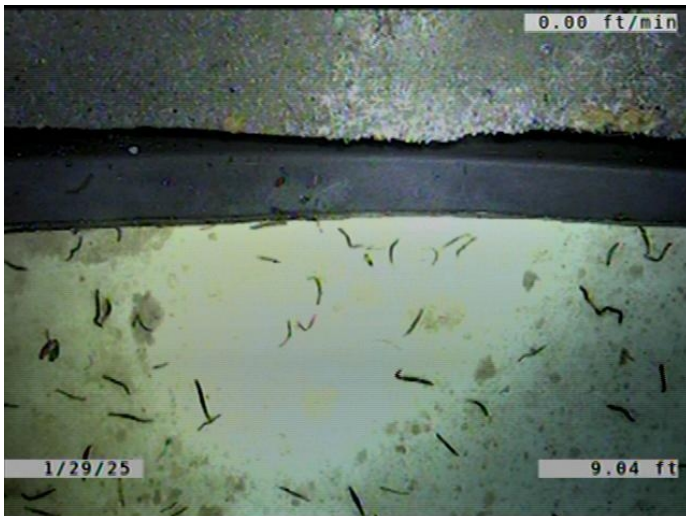
Code: **RPR**  
Description: **Point Repair Replacement**

Distance (ft): **9.0**  
Structural Grade: **0**  
O&M Grade: **0**  
Clock Start/From:  
Clock To:  
1st Value:  
2nd Value:  
Value Percent:  
Continuous Index: **S01**  
Within 8" of Joint: **YES**  
Remarks: **REPLACED WITH PVC.**

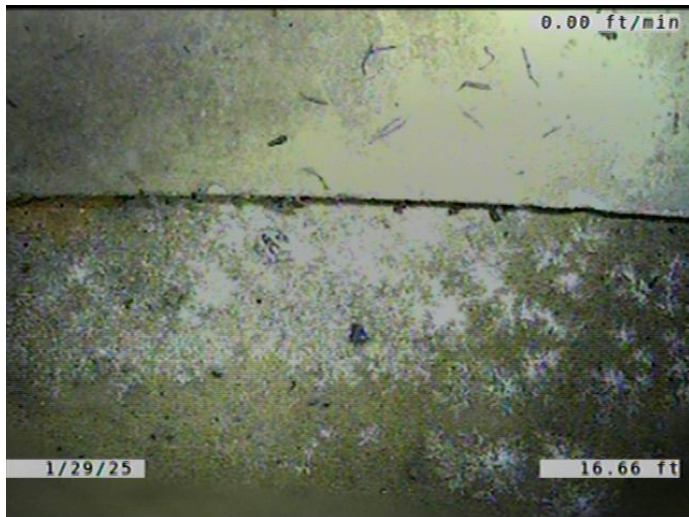
Code: **RPR**  
 Description: **Point Repair Replacement**

Distance (ft): **16.7**  
 Structural Grade: **0**  
 O&M Grade: **0**  
 Clock Start/From:  
 Clock To:  
 1st Value:  
 2nd Value:  
 Value Percent:  
 Continuous Index: **F01**  
 Within 8" of Joint: **YES**  
 Remarks: **REPLACED WITH PVC.**

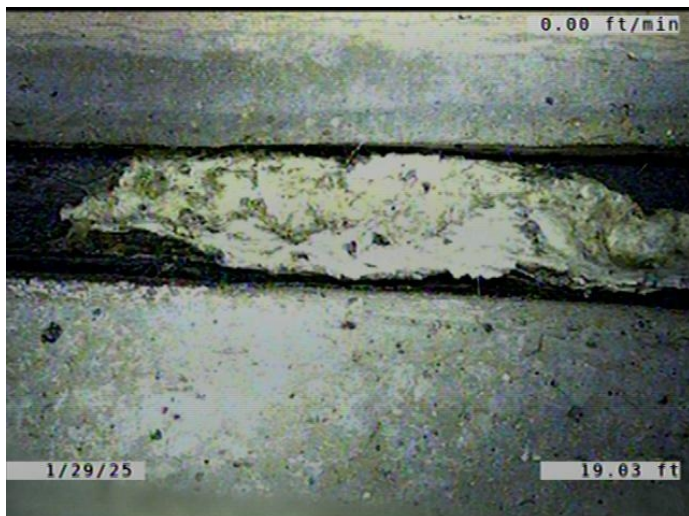
Code: **DAE**  
 Description: **Deposits Attached Encrustation**

Distance (ft): **19.0**  
 Structural Grade: **0**  
 O&M Grade: **2**  
 Clock Start/From: **9**  
 Clock To: **12**  
 1st Value:  
 2nd Value:  
 Value Percent: **5.000**  
 Continuous Index:  
 Within 8" of Joint: **YES**  
 Remarks:

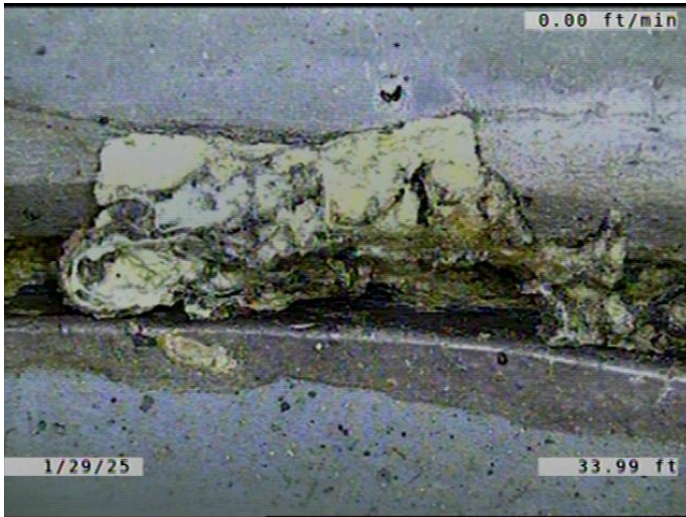
Code: **DAE**  
Description: **Deposits Attached Encrustation**

Distance (ft): **34.0**  
Structural Grade: **0**  
O&M Grade: **2**  
Clock Start/From: **8**  
Clock To: **4**  
1st Value:  
2nd Value:  
Value Percent: **5.000**  
Continuous Index:  
Within 8" of Joint: **YES**  
Remarks:

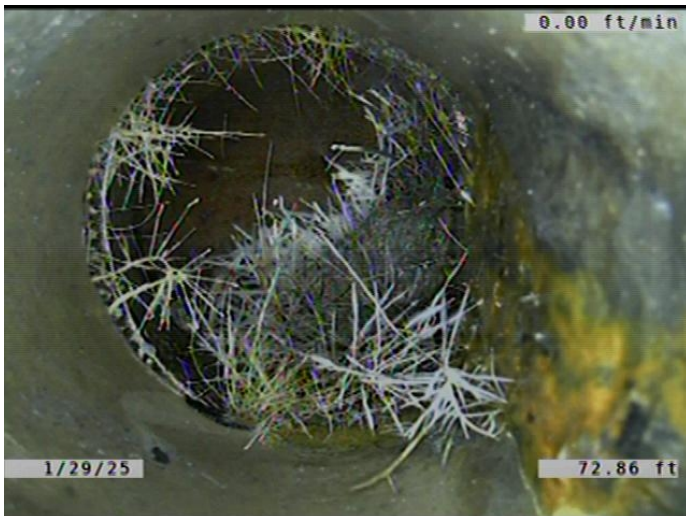
Code: **TFD**  
Description: **Tap Factory Defective**

Distance (ft): **72.9**  
Structural Grade: **0**  
O&M Grade: **3**  
Clock Start/From: **3**  
Clock To:  
1st Value: **6.000**  
2nd Value:  
Value Percent:  
Continuous Index:  
Within 8" of Joint: **YES**  
Remarks: **CAPPED. ROOTS GROWING AROUND THE CAP. ENCRUSTATION COMING A**

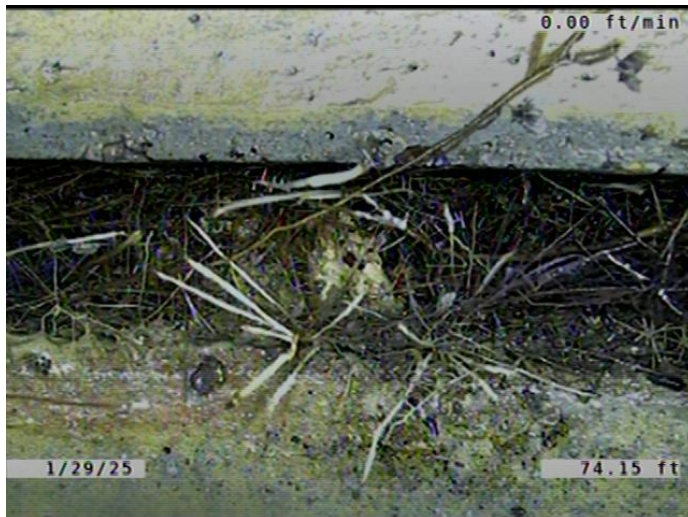
Code: **RMJ**  
Description: **Roots Medium Joint**

Distance (ft): **74.2**  
Structural Grade: **0**  
O&M Grade: **3**  
Clock Start/From: **8**  
Clock To: **4**  
1st Value:  
2nd Value:  
Value Percent: **5.000**  
Continuous Index: **S03**  
Within 8" of Joint: **YES**  
Remarks:

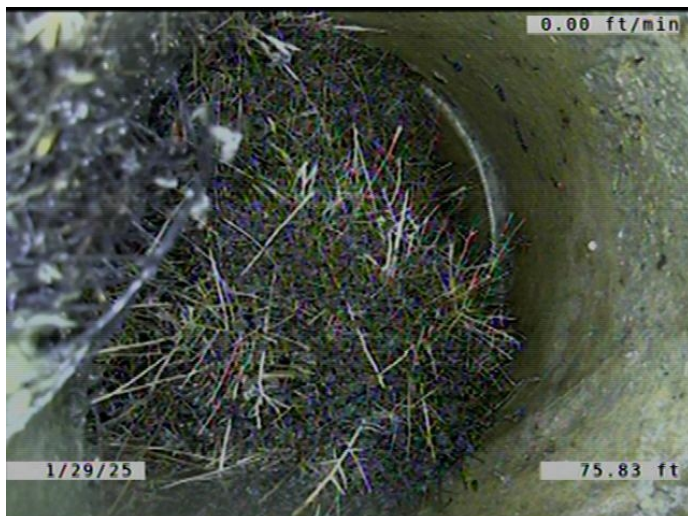
Code: **TFD**  
Description: **Tap Factory Defective**

Distance (ft): **75.8**  
Structural Grade: **0**  
O&M Grade: **3**  
Clock Start/From: **9**  
Clock To:  
1st Value: **6.000**  
2nd Value:  
Value Percent:  
Continuous Index:  
Within 8" of Joint: **YES**  
Remarks: **95% PLUGGED WITH ROOTS.**

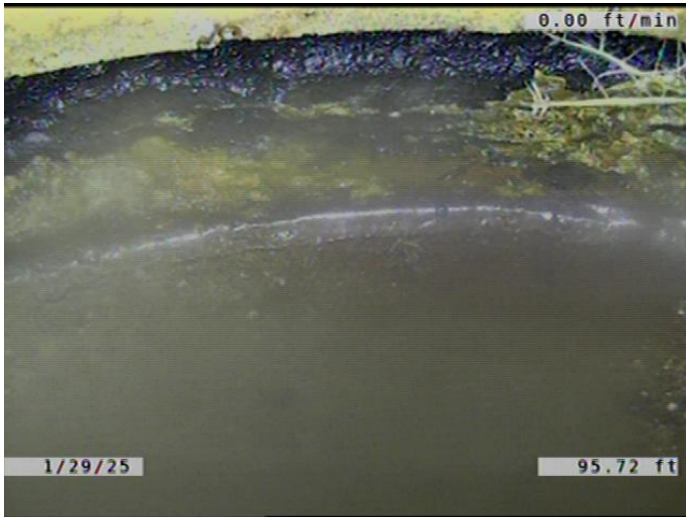
Code: **DAE**  
 Description: **Deposits Attached Encrustation**

Distance (ft): **95.7**  
 Structural Grade: **0**  
 O&M Grade: **2**  
 Clock Start/From: **9**  
 Clock To: **3**  
 1st Value:  
 2nd Value:  
 Value Percent: **5.000**  
 Continuous Index:  
 Within 8" of Joint: **YES**  
 Remarks:

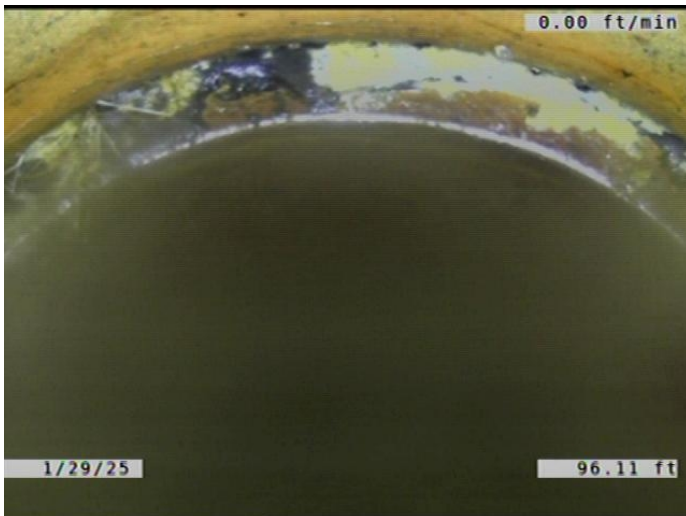
Code: **JOMD**  
 Description: **Joint Offset Medium Defective**

Distance (ft): **96.1**  
 Structural Grade: **3**  
 O&M Grade: **0**  
 Clock Start/From:  
 Clock To:  
 1st Value:  
 2nd Value:  
 Value Percent:  
 Continuous Index:  
 Within 8" of Joint: **NO**  
 Remarks:

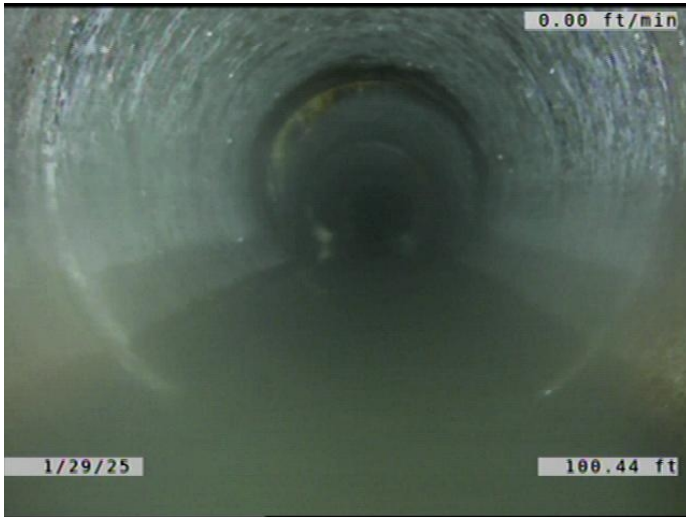
Code: **MWLS**  
Description: **Miscellaneous Water Level Sag**

Distance (ft): **100.4**  
Structural Grade: **2**  
O&M Grade: **0**  
Clock Start/From:  
Clock To:  
1st Value:  
2nd Value:  
Value Percent: **30.000**  
Continuous Index: **F02**  
Within 8" of Joint: **NO**  
Remarks:

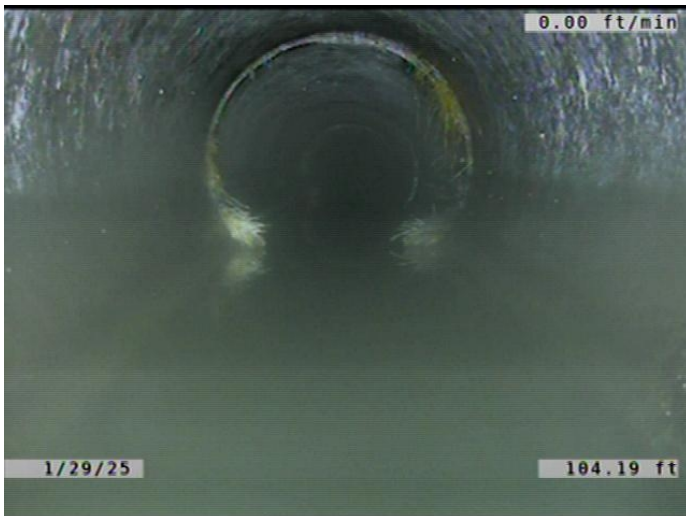
Code: **MWLS**  
Description: **Miscellaneous Water Level Sag**

Distance (ft): **104.2**  
Structural Grade: **2**  
O&M Grade: **0**  
Clock Start/From:  
Clock To:  
1st Value:  
2nd Value:  
Value Percent: **15.000**  
Continuous Index: **S04**  
Within 8" of Joint: **NO**  
Remarks:

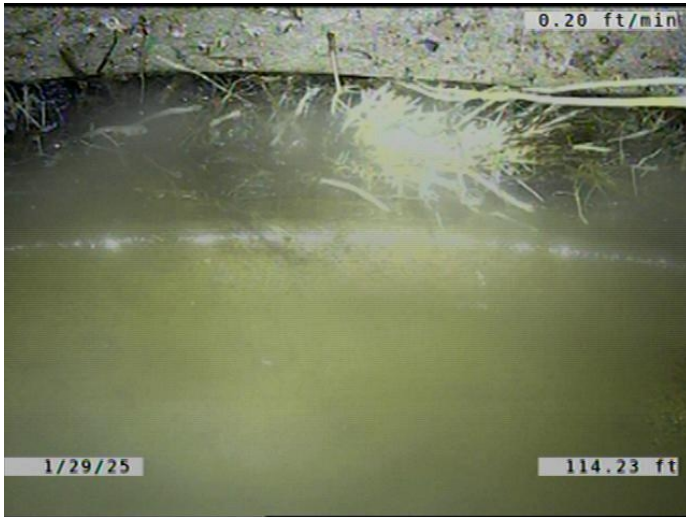
Code: **IDJ**  
 Description: **Infiltration Dripper Joint**

Distance (ft): **114.2**  
 Structural Grade: **0**  
 O&M Grade: **3**  
 Clock Start/From: **12**  
 Clock To: **1**  
 1st Value:  
 2nd Value:  
 Value Percent:  
 Continuous Index:  
 Within 8" of Joint: **YES**  
 Remarks:

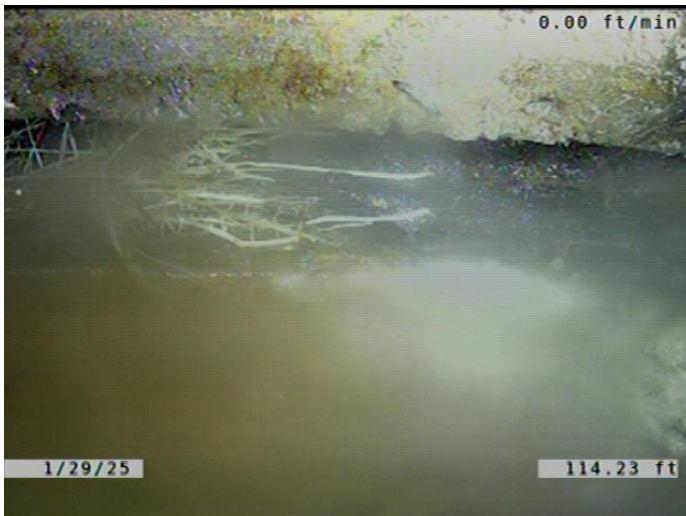
Code: **DAE**  
 Description: **Deposits Attached Encrustation**

Distance (ft): **114.2**  
 Structural Grade: **0**  
 O&M Grade: **2**  
 Clock Start/From: **9**  
 Clock To: **4**  
 1st Value:  
 2nd Value:  
 Value Percent: **5.000**  
 Continuous Index:  
 Within 8" of Joint: **YES**  
 Remarks:

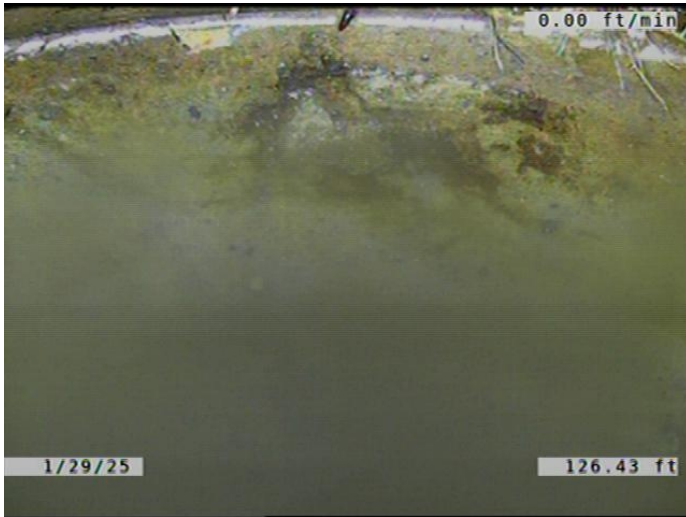
Code: **DAE**  
 Description: **Deposits Attached Encrustation**

Distance (ft): **126.4**  
 Structural Grade: **0**  
 O&M Grade: **2**  
 Clock Start/From: **8**  
 Clock To: **4**  
 1st Value:  
 2nd Value:  
 Value Percent: **5.000**  
 Continuous Index:  
 Within 8" of Joint: **YES**  
 Remarks:

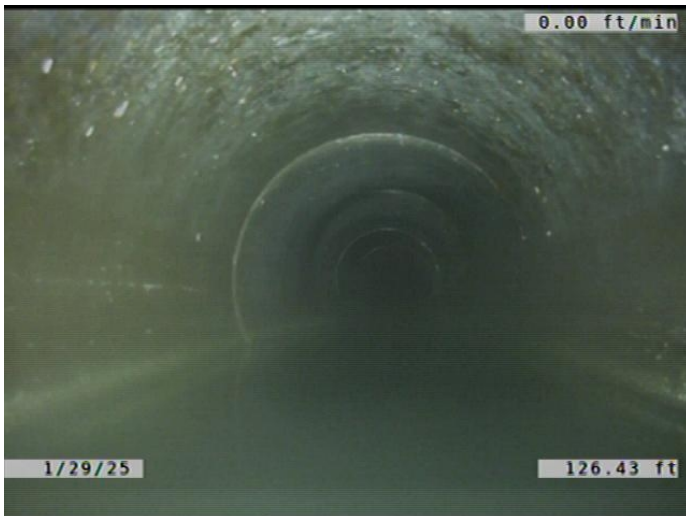
Code: **LR**  
 Description: **Line Right**

Distance (ft): **126.4**  
 Structural Grade: **0**  
 O&M Grade: **1**  
 Clock Start/From:  
 Clock To:  
 1st Value:  
 2nd Value:  
 Value Percent: **10.000**  
 Continuous Index:  
 Within 8" of Joint: **NO**  
 Remarks:

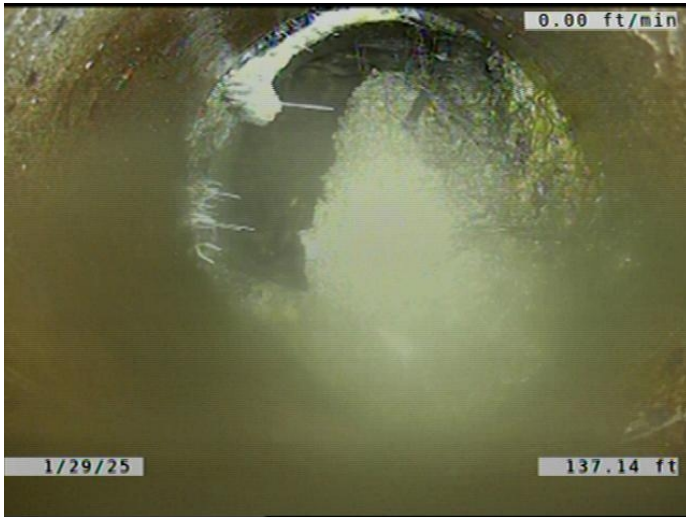
Code: **TFD**  
Description: **Tap Factory Defective**

Distance (ft): **137.1**  
Structural Grade: **0**  
O&M Grade: **3**  
Clock Start/From: **2**  
Clock To:  
1st Value: **6.000**  
2nd Value:  
Value Percent:  
Continuous Index:  
Within 8" of Joint: **YES**  
Remarks: **100% PLUGGED WITH ROOTS.**

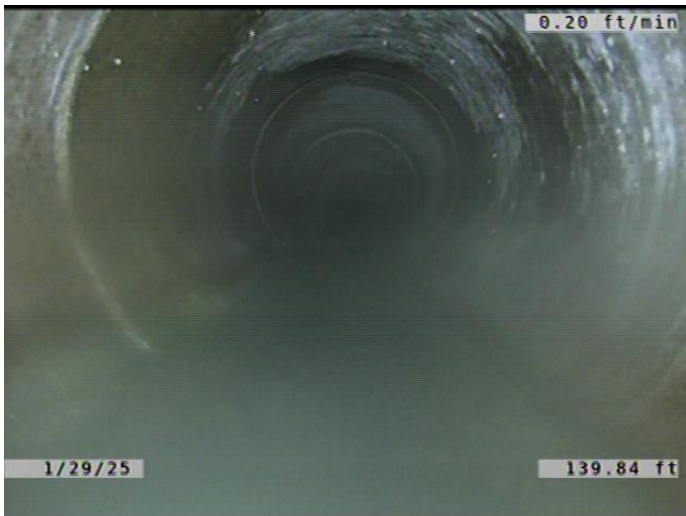
Code: **MWLS**  
Description: **Miscellaneous Water Level Sag**

Distance (ft): **139.8**  
Structural Grade: **2**  
O&M Grade: **0**  
Clock Start/From:  
Clock To:  
1st Value:  
2nd Value:  
Value Percent: **15.000**  
Continuous Index: **F04**  
Within 8" of Joint: **NO**  
Remarks:

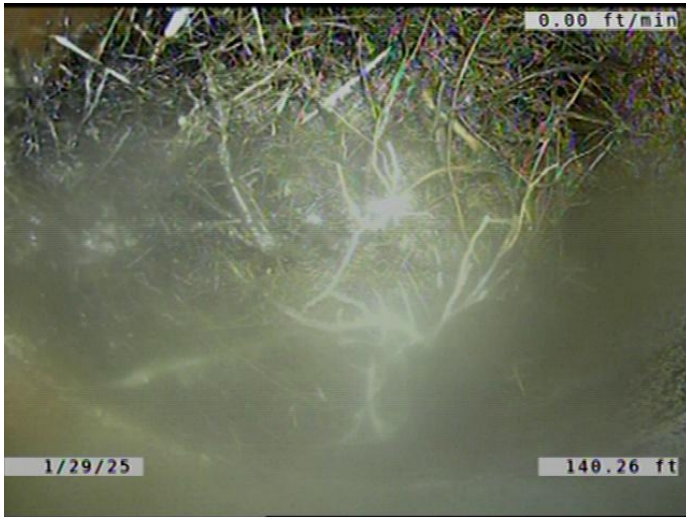
Code: **TFD**  
Description: **Tap Factory Defective**

Distance (ft): **140.3**  
Structural Grade: **0**  
O&M Grade: **3**  
Clock Start/From: **9**  
Clock To:  
1st Value: **6.000**  
2nd Value:  
Value Percent:  
Continuous Index:  
Within 8" of Joint: **YES**  
Remarks: **100% PLUGGED WITH ROOTS.**

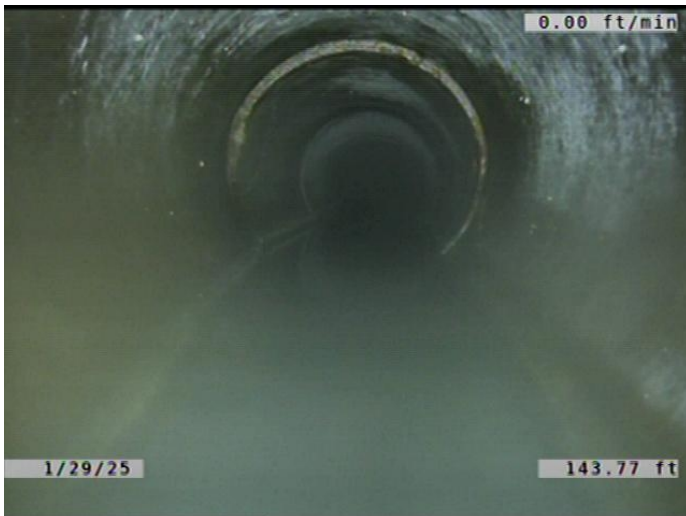
Code: **MWLS**  
Description: **Miscellaneous Water Level Sag**

Distance (ft): **143.8**  
Structural Grade: **2**  
O&M Grade: **0**  
Clock Start/From:  
Clock To:  
1st Value:  
2nd Value:  
Value Percent: **20.000**  
Continuous Index: **S05**  
Within 8" of Joint: **NO**  
Remarks:

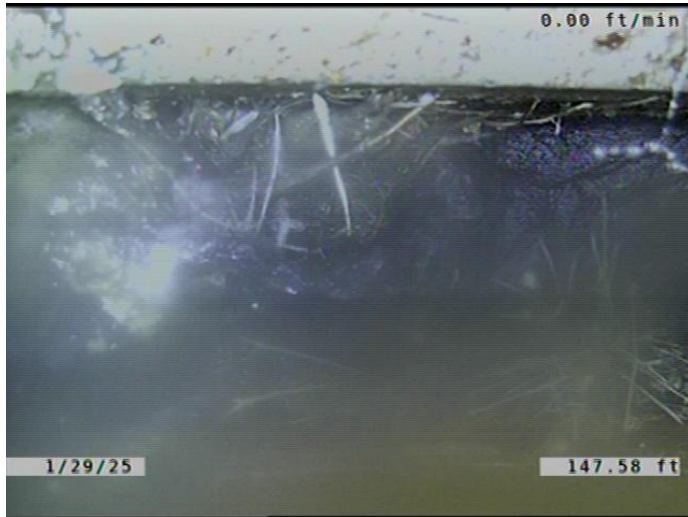
Code: **DAE**  
Description: **Deposits Attached Encrustation**

Distance (ft): **147.6**  
Structural Grade: **0**  
O&M Grade: **2**  
Clock Start/From: **8**  
Clock To: **4**  
1st Value:  
2nd Value:  
Value Percent: **5.000**  
Continuous Index:  
Within 8" of Joint: **YES**  
Remarks:

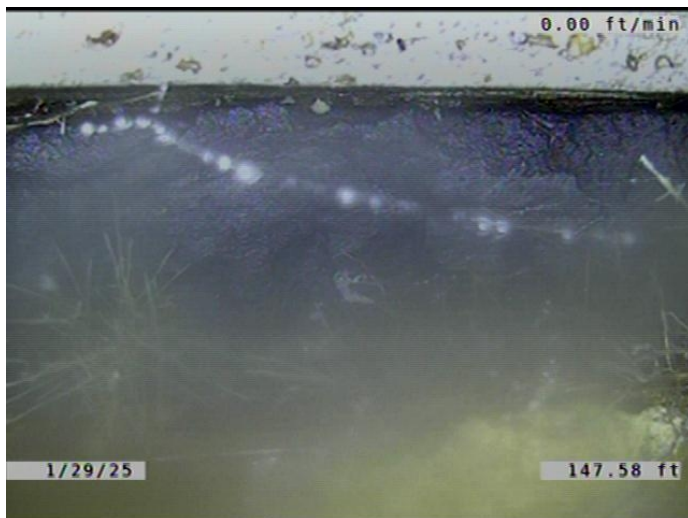
Code: **JAM**  
Description: **Joint Angular Medium**

Distance (ft): **147.6**  
Structural Grade: **3**  
O&M Grade: **0**  
Clock Start/From:  
Clock To:  
1st Value:  
2nd Value:  
Value Percent:  
Continuous Index:  
Within 8" of Joint: **NO**  
Remarks:

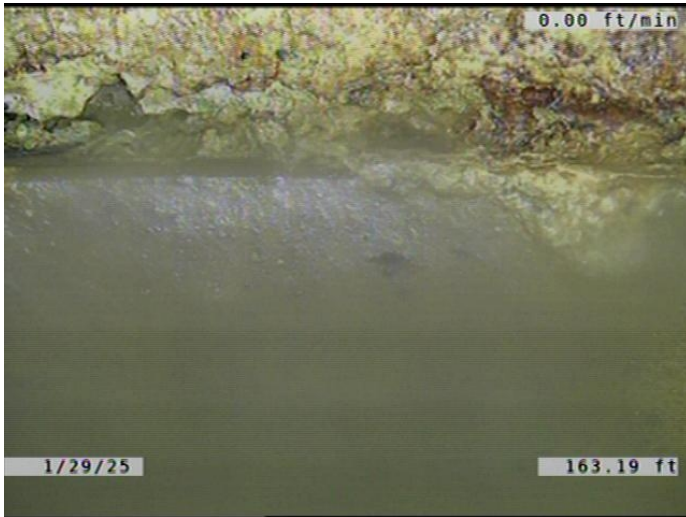
Code: **DAE**  
Description: **Deposits Attached Encrustation**

Distance (ft): **163.2**  
Structural Grade: **0**  
O&M Grade: **2**  
Clock Start/From: **8**  
Clock To: **4**  
1st Value:  
2nd Value:  
Value Percent: **5.000**  
Continuous Index: **S06**  
Within 8" of Joint: **YES**  
Remarks:

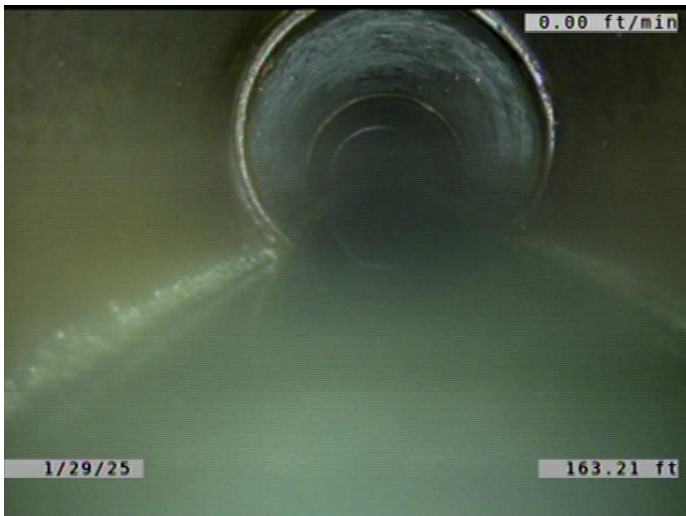
Code: **RMJ**  
Description: **Roots Medium Joint**

Distance (ft): **163.2**  
Structural Grade: **0**  
O&M Grade: **3**  
Clock Start/From: **8**  
Clock To: **4**  
1st Value:  
2nd Value:  
Value Percent: **5.000**  
Continuous Index: **F03**  
Within 8" of Joint: **YES**  
Remarks:

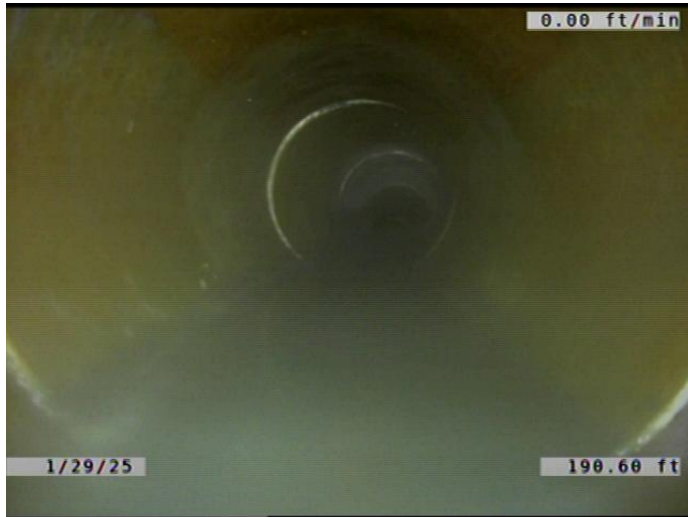
Code: **MWLS**  
Description: **Miscellaneous Water Level Sag**

Distance (ft): **190.6**  
Structural Grade: **2**  
O&M Grade: **0**  
Clock Start/From:  
Clock To:  
1st Value:  
2nd Value:  
Value Percent: **20.000**  
Continuous Index: **F05**  
Within 8" of Joint: **NO**  
Remarks:

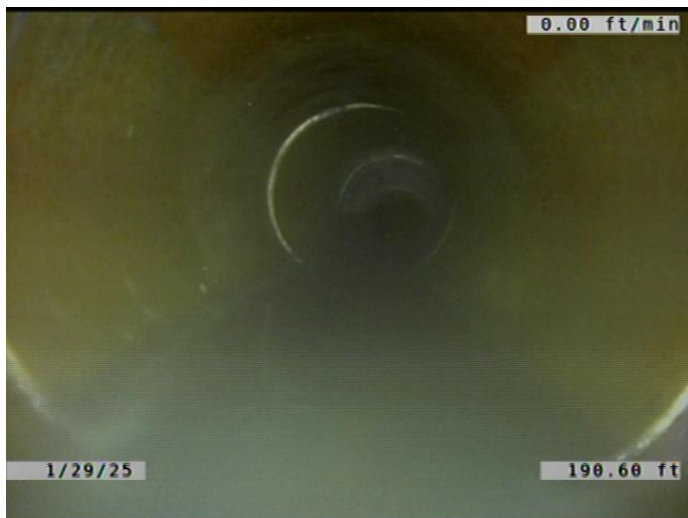
Code: **LR**  
Description: **Line Right**

Distance (ft): **190.6**  
Structural Grade: **0**  
O&M Grade: **1**  
Clock Start/From:  
Clock To:  
1st Value:  
2nd Value:  
Value Percent: **5.000**  
Continuous Index:  
Within 8" of Joint: **NO**  
Remarks:

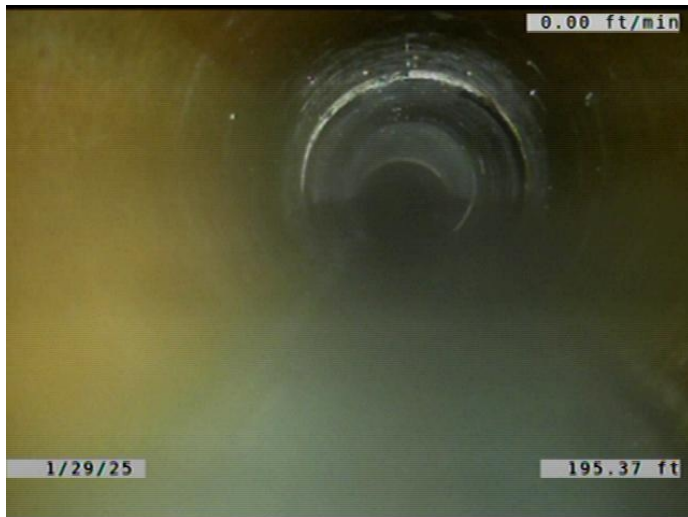
Code: **LR**  
Description: **Line Right**

Distance (ft): **195.4**  
Structural Grade: **0**  
O&M Grade: **1**  
Clock Start/From:  
Clock To:  
1st Value:  
2nd Value:  
Value Percent: **5.000**  
Continuous Index:  
Within 8" of Joint: **NO**  
Remarks:

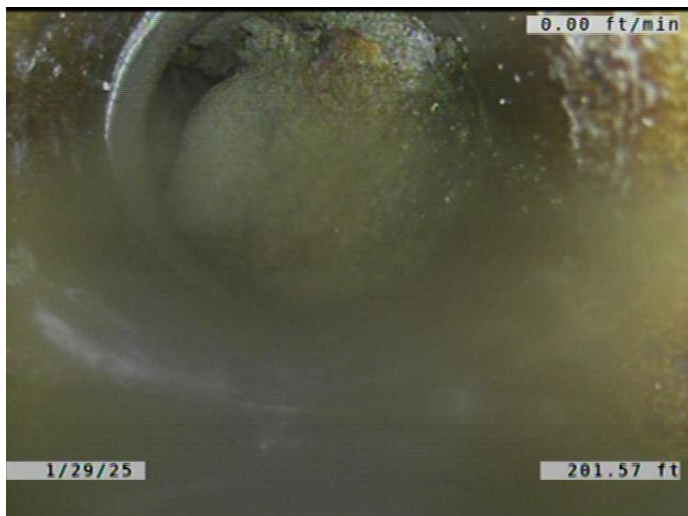
Code: **TFD**  
Description: **Tap Factory Defective**

Distance (ft): **201.6**  
Structural Grade: **0**  
O&M Grade: **3**  
Clock Start/From: **3**  
Clock To:  
1st Value: **6.000**  
2nd Value:  
Value Percent:  
Continuous Index:  
Within 8" of Joint: **YES**  
Remarks: **90% PLUGGED WITH DIRT AND ENCRUSTATION.**

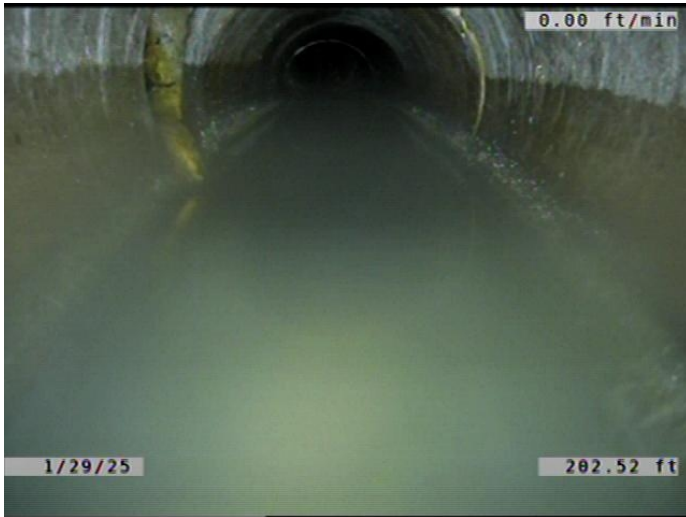
Code: **MWLS**  
Description: **Miscellaneous Water Level Sag**

Distance (ft): **202.5**  
Structural Grade: **2**  
O&M Grade: **0**  
Clock Start/From:  
Clock To:  
1st Value:  
2nd Value:  
Value Percent: **25.000**  
Continuous Index: **S07**  
Within 8" of Joint: **NO**  
Remarks:

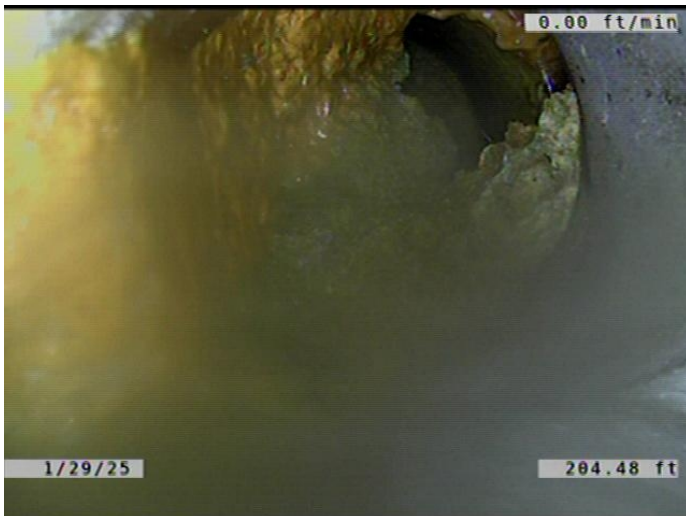
Code: **TFD**  
Description: **Tap Factory Defective**

Distance (ft): **204.5**  
Structural Grade: **0**  
O&M Grade: **3**  
Clock Start/From: **9**  
Clock To:  
1st Value: **6.000**  
2nd Value:  
Value Percent:  
Continuous Index:  
Within 8" of Joint: **YES**  
Remarks: **95% PLUGGED WITH DIRT AND ENCRUSTATION. ENCRUSTATION C**

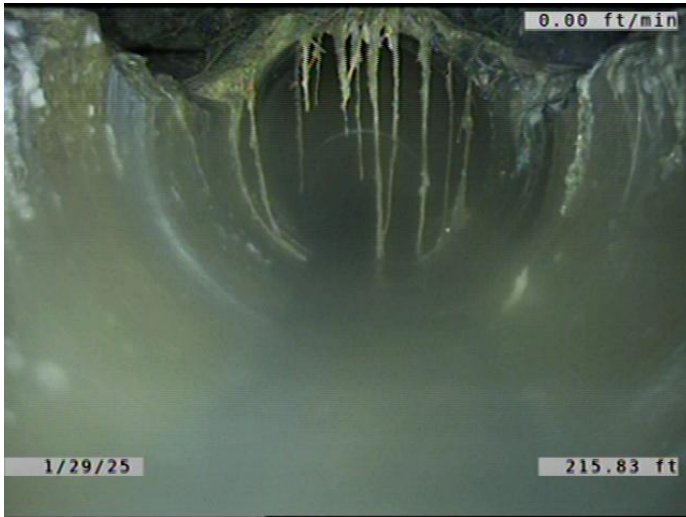
Code: **MWLS**  
Description: **Miscellaneous Water Level Sag**

Distance (ft): **215.8**  
Structural Grade: **2**  
O&M Grade: **0**  
Clock Start/From:  
Clock To:  
1st Value:  
2nd Value:  
Value Percent: **25.000**  
Continuous Index: **F07**  
Within 8" of Joint: **NO**  
Remarks:

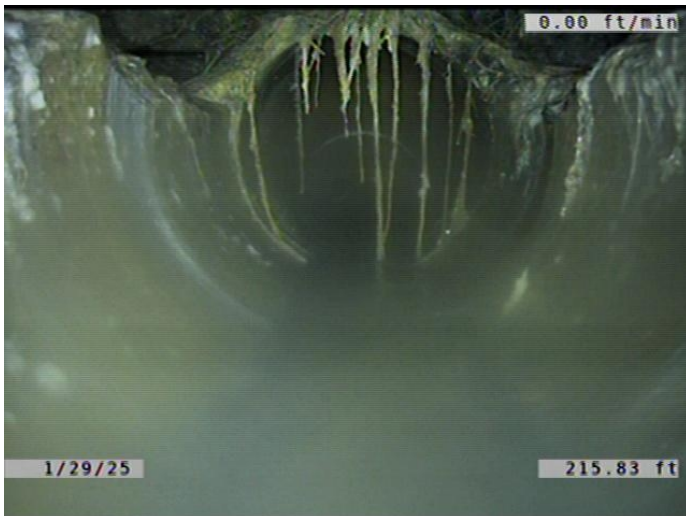
Code: **DAE**  
Description: **Deposits Attached Encrustation**

Distance (ft): **215.8**  
Structural Grade: **0**  
O&M Grade: **2**  
Clock Start/From: **8**  
Clock To: **4**  
1st Value:  
2nd Value:  
Value Percent: **5.000**  
Continuous Index: **F06**  
Within 8" of Joint: **YES**  
Remarks:
