## Profile/Photo Observation Report

Street:	<b>FOXCROFT STREET</b>	Flow Control:	<b>Not Controlled</b>
City:	<b>Hobart, IN</b>	Year Renewed:	
Location:	<b>Woods</b>	Tape/Media #:	
Purpose:	<b>Routine Assessment</b>	Dia/Height:	<b>12"</b>
Use:	<b>Sanitary</b>	Material:	<b>VCP</b>
Drain Area:	<b>NA</b>	Lining:	
Category:	<b>NA</b>		
Comment:	<b>P_C at 108 ft debris</b>

Location Details:		Direction of Survey:	<b>Downstream</b>
US MH:	<b>M-507-019</b>	DS MH:	<b>M-507-019A</b>
		Total Length Surveyed (ft):	<b>109.9</b>

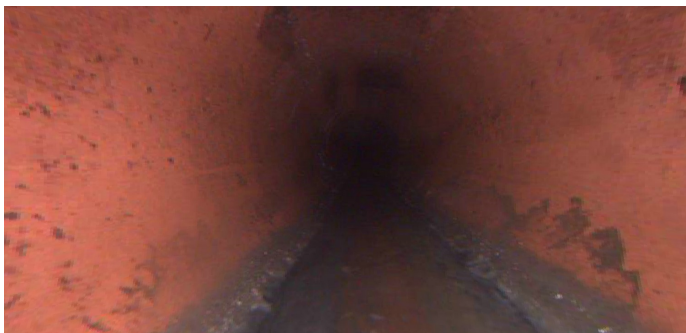
Code: **AMH**  
Description: **Manhole**

Distance (ft):	.0
Structural Grade:	0
O&M Grade:	0
Clock Start/From:	
Clock To:	
1st Value:	
2nd Value:	
Value Percent:	
Continuous Index:	
Within 8" of Joint:	NO
Remarks:	M-507-019

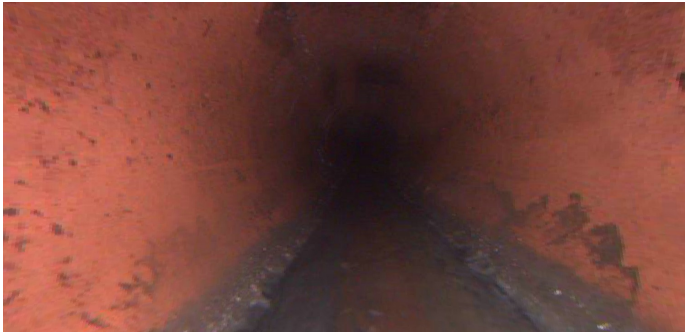
Code:	<b>MWL</b>
Description:	<b>Water Level</b>

Distance (ft):	<b>.0</b>
Structural Grade:	<b>0</b>
O&M Grade:	<b>0</b>
Clock Start/From:	
Clock To:	
1st Value:	
2nd Value:	
Value Percent:	<b>5.000</b>
Continuous Index:	
Within 8" of Joint:	<b>NO</b>
Remarks:

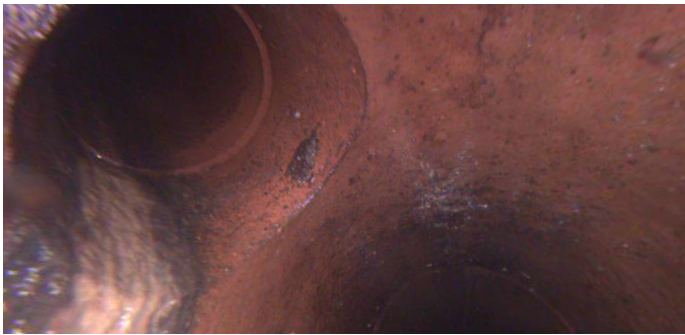
Code:	<b>TFA</b>
Description:	<b>Tap Factory Active</b>

Distance (ft):	<b>83.1</b>
Structural Grade:	<b>0</b>
O&M Grade:	<b>0</b>
Clock Start/From:	<b>10</b>
Clock To:	
1st Value:	<b>4.000</b>
2nd Value:	
Value Percent:	
Continuous Index:	
Within 8" of Joint:	
Remarks:

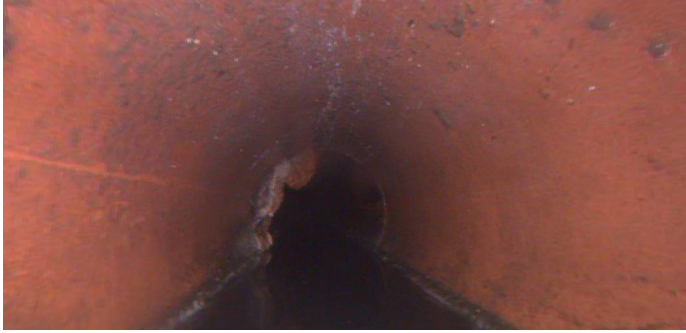
Code: **DAE**  
Description: **Deposits Attached Encrustation**

Distance (ft): **94.6**  
Structural Grade: **0**  
O&M Grade: **3**  
Clock Start/From: **7**  
Clock To: **12**  
1st Value:  
2nd Value:  
Value Percent: **15.000**  
Continuous Index:  
Within 8" of Joint: **YES**  
Remarks:

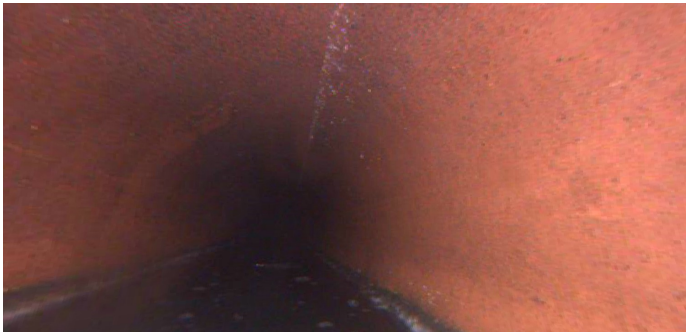
Code: **MSA**  
Description: **Abandoned Survey**

Distance (ft): **109.9**  
Structural Grade: **0**  
O&M Grade: **0**  
Clock Start/From:  
Clock To:  
1st Value:  
2nd Value:  
Value Percent:  
Continuous Index:  
Within 8" of Joint: **NO**  
Remarks: **camera stopped**
