Profile/Photo Observation Report

Date:	01/29/2025	Weather:		Coding:	PACP 7.0
Pipe Length (ft):	256.0	Owner:	City of Hobart	Pre Clean:	Heavy Cleaning
P.O.#:	YES502259	Surveyor:	S. Bucklin	PSR:	P-507-019-004
Customer:	City of Hobart	Clean Date:	08/06/2024	Shape:	C

Street:	Colorado Ct	Flow Control:	Not Controlled
City:	Hobart, IN	Year Renewed:	
Location:	Easement/Right of Way	Tape/Media #:	
Purpose:	Sewer System Evaluation Survey (SS	Dia/Height:	12"
Use:	Sanitary Sewage Pipe	Material:	VCP
Drain Area:		Lining:	None

US MH: **M-507-019** DS MH: **M-507-004** Total Length Surveyed (ft): **240.5**

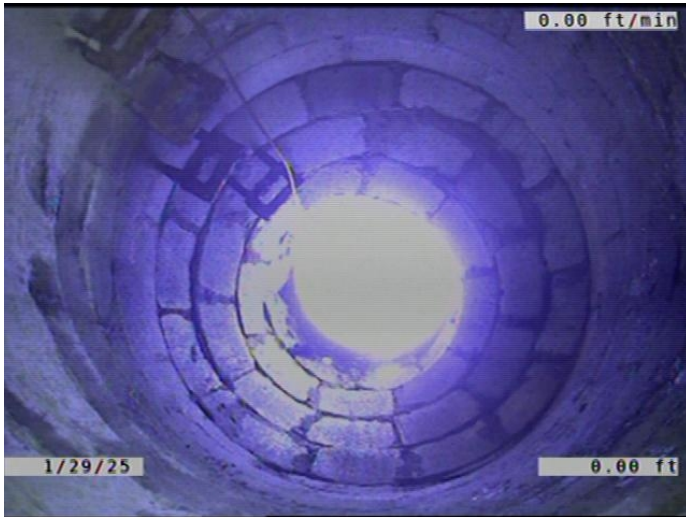
Code: **AMH**
Description: **Manhole**

Distance (ft): **.0**
Structural Grade: **0**
O&M Grade: **0**
Clock Start/From:
Clock To:
1st Value:
2nd Value:
Value Percent:
Continuous Index:
Within 8" of Joint: **NO**
Remarks: **M-507-004**

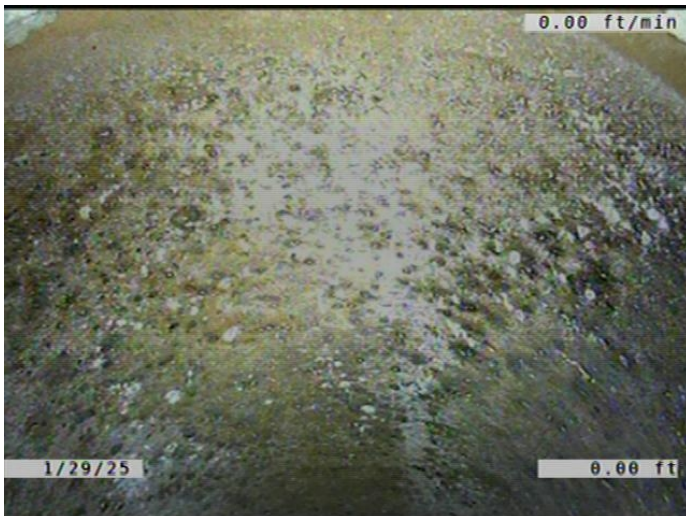
Code: **MWL**
Description: **Miscellaneous Water Level**

Distance (ft): **.0**
Structural Grade: **0**
O&M Grade: **0**
Clock Start/From:
Clock To:
1st Value:
2nd Value:
Value Percent: **15.000**
Continuous Index:
Within 8" of Joint: **NO**
Remarks:

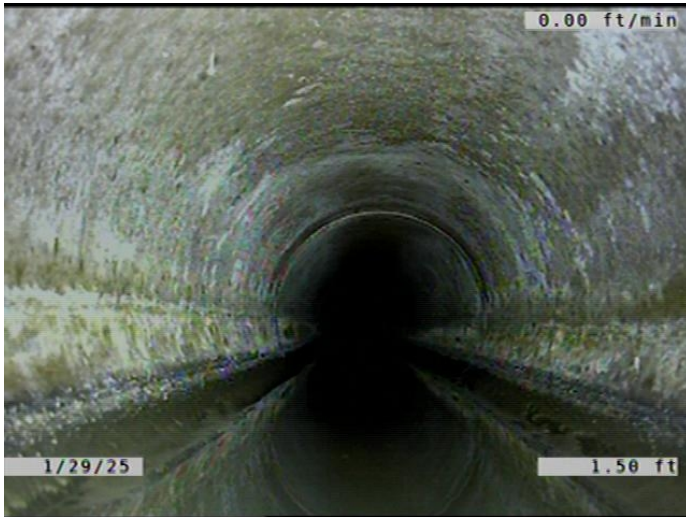
Code: **MGO**
Description: **Miscellaneous General Observation**

Distance (ft): **1.5**
Structural Grade: **0**
O&M Grade: **0**
Clock Start/From:
Clock To:
1st Value:
2nd Value:
Value Percent:
Continuous Index:
Within 8" of Joint: **NO**
Remarks: **DROP INTO THE MANHOLE. HAD TO START IN THE PIPE.**

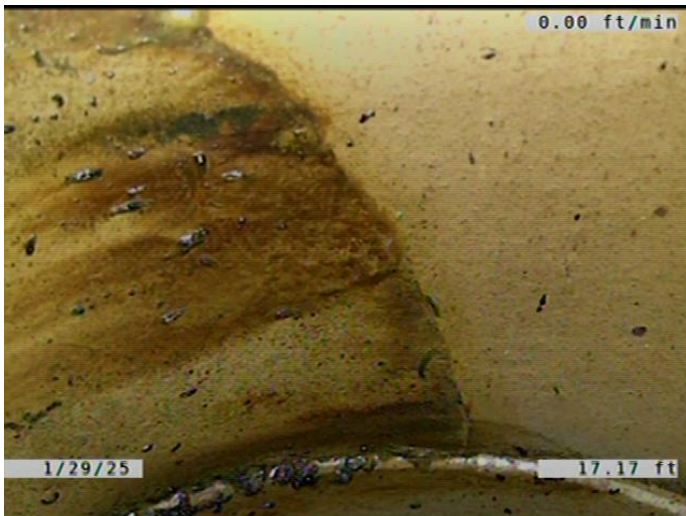
Code: **CS**
Description: **Crack Spiral**

Distance (ft): **17.2**
Structural Grade: **2**
O&M Grade: **0**
Clock Start/From: **10**
Clock To: **11**
1st Value:
2nd Value:
Value Percent:
Continuous Index:
Within 8" of Joint: **YES**
Remarks:

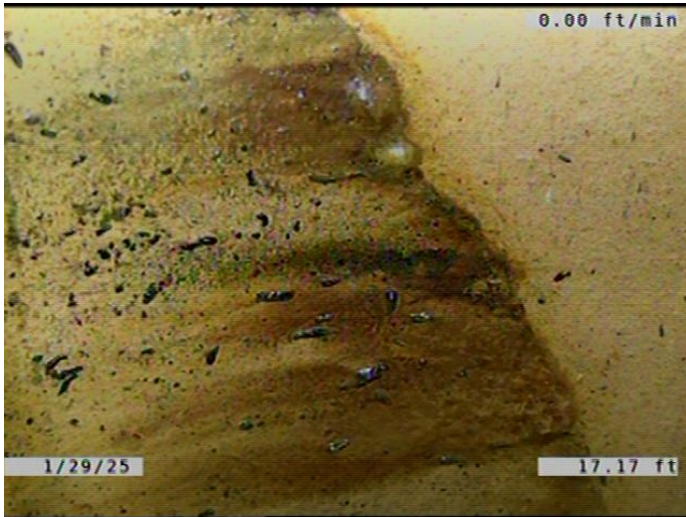
Code: **ISB**
 Description: **Infiltration Stain Barrel**

Distance (ft): **17.2**
 Structural Grade: **0**
 O&M Grade: **1**
 Clock Start/From: **8**
 Clock To: **11**
 1st Value:
 2nd Value:
 Value Percent:
 Continuous Index:
 Within 8" of Joint: **YES**
 Remarks:

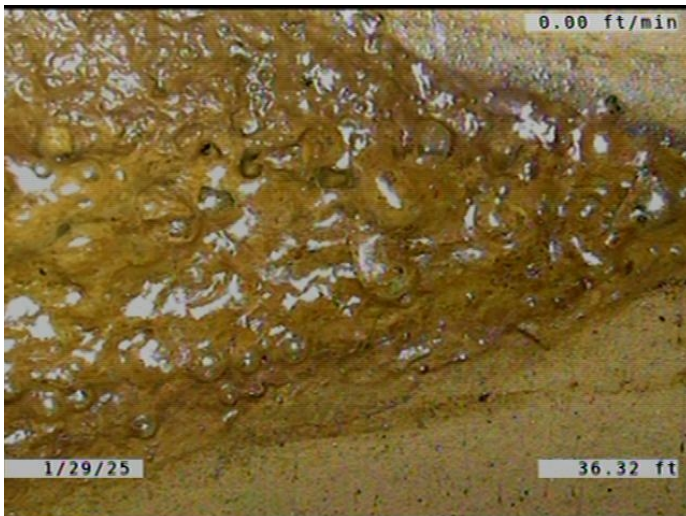
Code: **DAE**
 Description: **Deposits Attached Encrustation**

Distance (ft): **36.3**
 Structural Grade: **0**
 O&M Grade: **2**
 Clock Start/From: **7**
 Clock To: **12**
 1st Value:
 2nd Value:
 Value Percent: **5.000**
 Continuous Index:
 Within 8" of Joint: **YES**
 Remarks:

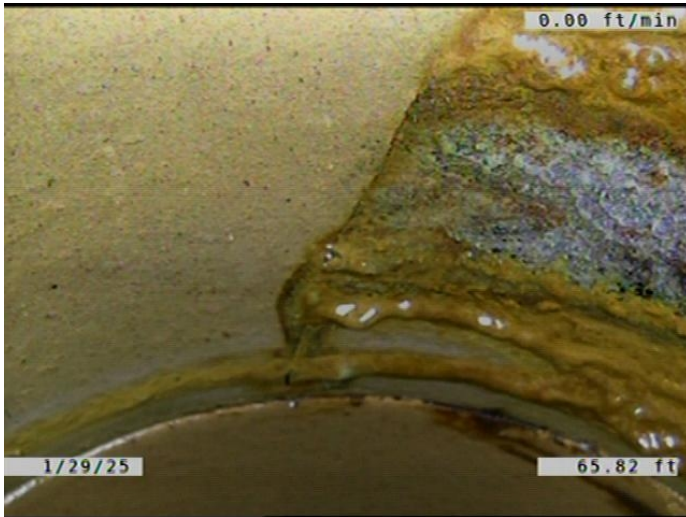
Code: **CS**
Description: **Crack Spiral**

Distance (ft): **65.8**
Structural Grade: **2**
O&M Grade: **0**
Clock Start/From: **12**
Clock To: **1**
1st Value:
2nd Value:
Value Percent:
Continuous Index:
Within 8" of Joint: **YES**
Remarks:

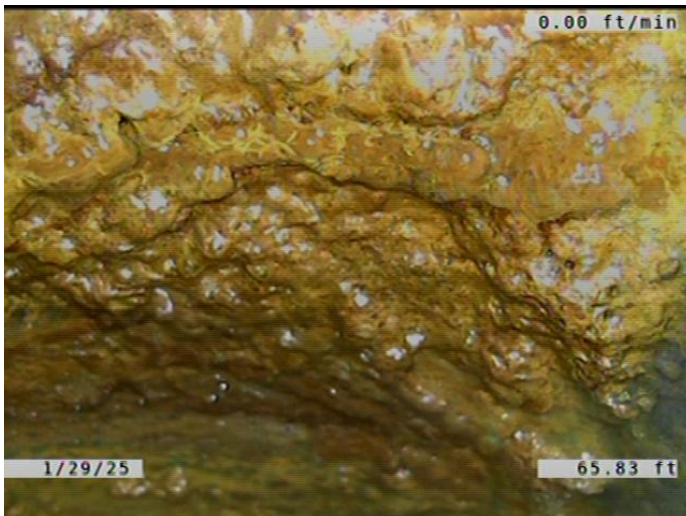
Code: **DAE**
Description: **Deposits Attached Encrustation**

Distance (ft): **65.8**
Structural Grade: **0**
O&M Grade: **2**
Clock Start/From: **7**
Clock To: **5**
1st Value:
2nd Value:
Value Percent: **5.000**
Continuous Index:
Within 8" of Joint: **YES**
Remarks:

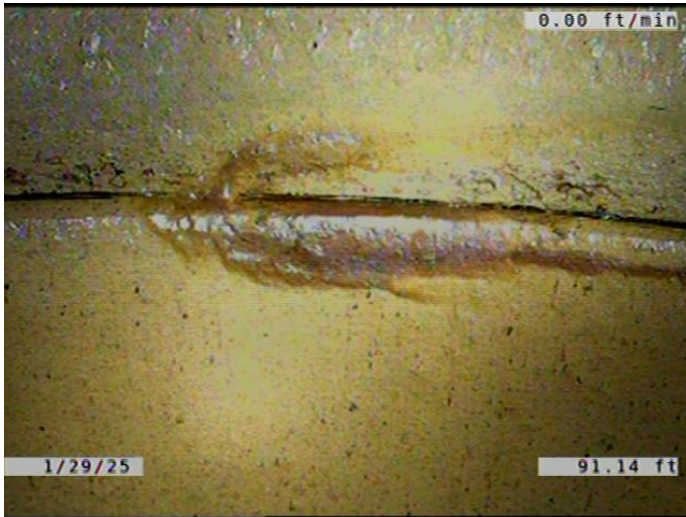
Code: **DAE**
 Description: **Deposits Attached Encrustation**

Distance (ft): **91.1**
 Structural Grade: **0**
 O&M Grade: **2**
 Clock Start/From: **1**
 Clock To: **3**
 1st Value:
 2nd Value:
 Value Percent: **5.000**
 Continuous Index:
 Within 8" of Joint: **YES**
 Remarks:

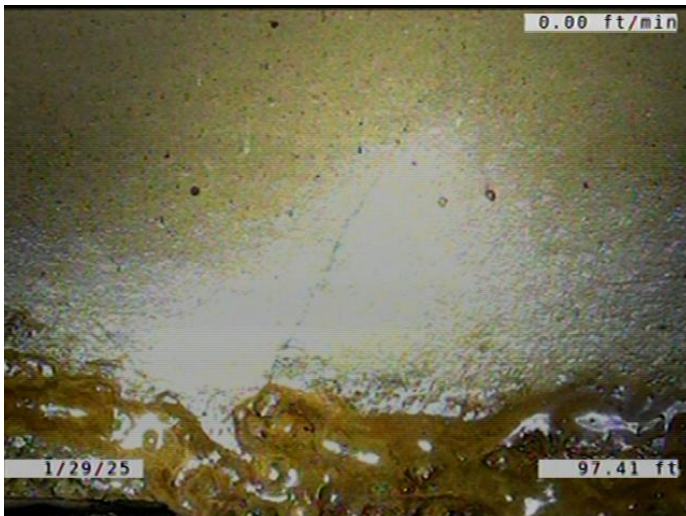
Code: **CL**
 Description: **Crack Longitudinal**

Distance (ft): **97.4**
 Structural Grade: **2**
 O&M Grade: **0**
 Clock Start/From: **12**
 Clock To:
 1st Value:
 2nd Value:
 Value Percent:
 Continuous Index:
 Within 8" of Joint: **YES**
 Remarks:

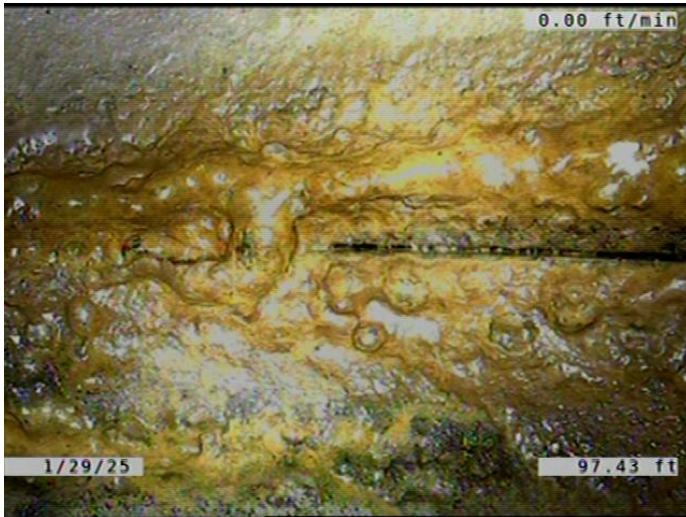
Code: **IWJ**
 Description: **Infiltration Weeper Joint**

Distance (ft): **97.4**
 Structural Grade: **0**
 O&M Grade: **2**
 Clock Start/From: **1**
 Clock To:
 1st Value:
 2nd Value:
 Value Percent:
 Continuous Index:
 Within 8" of Joint: **YES**
 Remarks:

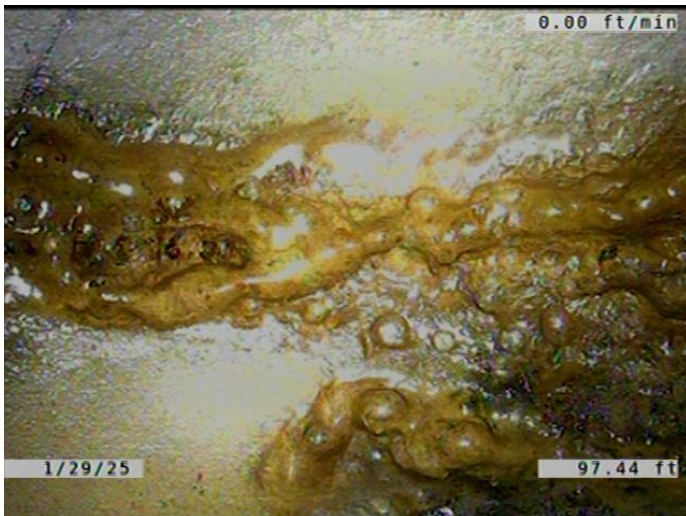
Code: **DAE**
 Description: **Deposits Attached Encrustation**

Distance (ft): **97.4**
 Structural Grade: **0**
 O&M Grade: **2**
 Clock Start/From: **7**
 Clock To: **5**
 1st Value:
 2nd Value:
 Value Percent: **5.000**
 Continuous Index:
 Within 8" of Joint: **YES**
 Remarks:

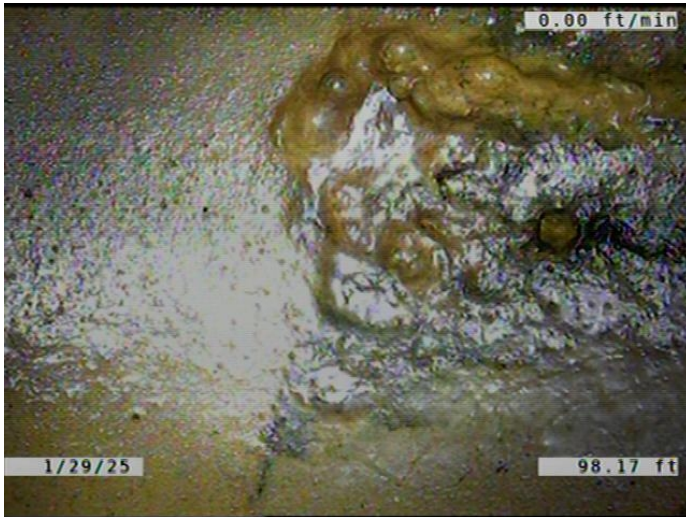
Code: **CL**
Description: **Crack Longitudinal**

Distance (ft): **98.2**
Structural Grade: **2**
O&M Grade: **0**
Clock Start/From: **1**
Clock To:
1st Value:
2nd Value:
Value Percent:
Continuous Index:
Within 8" of Joint: **YES**
Remarks:

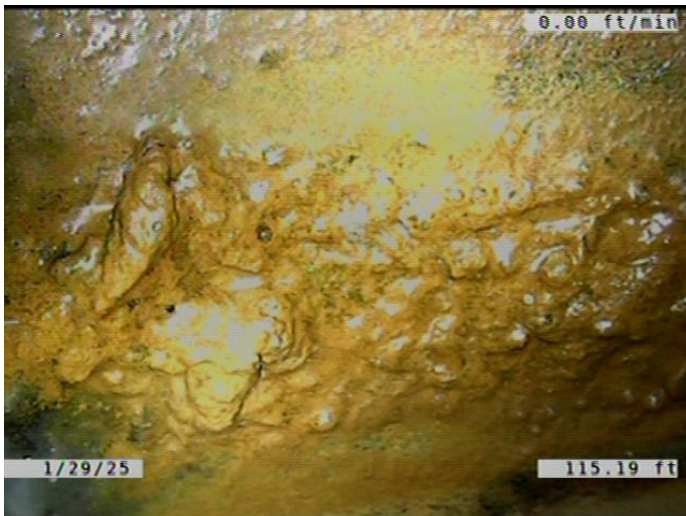
Code: **DAE**
Description: **Deposits Attached Encrustation**

Distance (ft): **115.2**
Structural Grade: **0**
O&M Grade: **2**
Clock Start/From: **7**
Clock To: **12**
1st Value:
2nd Value:
Value Percent: **5.000**
Continuous Index:
Within 8" of Joint: **YES**
Remarks:

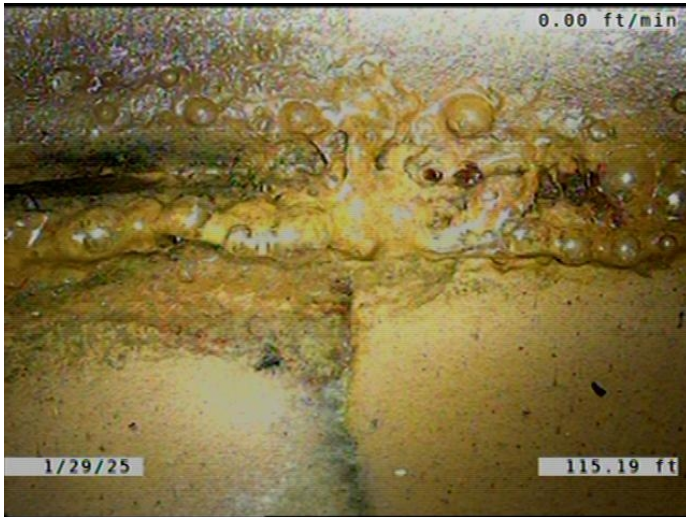
Code: **IWJ**
 Description: **Infiltration Weeper Joint**

Distance (ft): **115.2**
 Structural Grade: **0**
 O&M Grade: **2**
 Clock Start/From: **11**
 Clock To:
 1st Value:
 2nd Value:
 Value Percent:
 Continuous Index:
 Within 8" of Joint: **YES**
 Remarks:

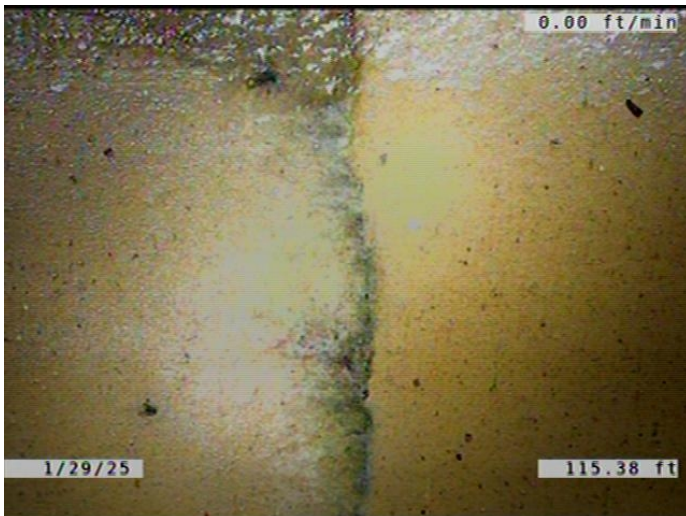
Code: **CL**
 Description: **Crack Longitudinal**

Distance (ft): **115.4**
 Structural Grade: **2**
 O&M Grade: **0**
 Clock Start/From: **11**
 Clock To:
 1st Value:
 2nd Value:
 Value Percent:
 Continuous Index:
 Within 8" of Joint: **YES**
 Remarks:

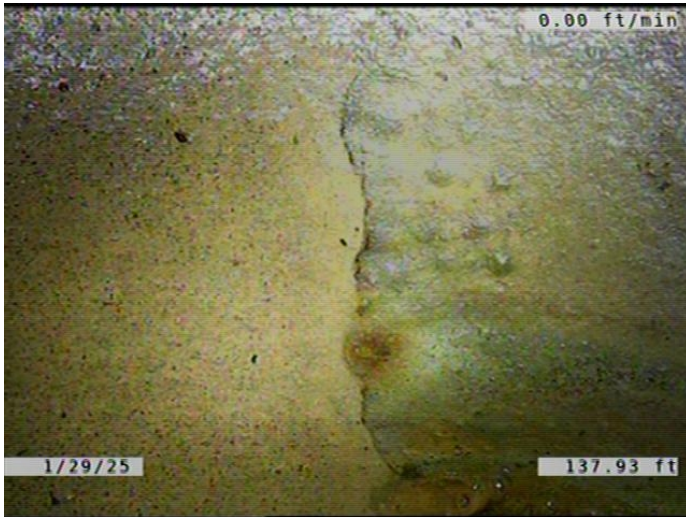
Code: **CS**
Description: **Crack Spiral**

Distance (ft): **137.9**
Structural Grade: **2**
O&M Grade: **0**
Clock Start/From: **12**
Clock To: **1**
1st Value:
2nd Value:
Value Percent:
Continuous Index:
Within 8" of Joint: **YES**
Remarks:

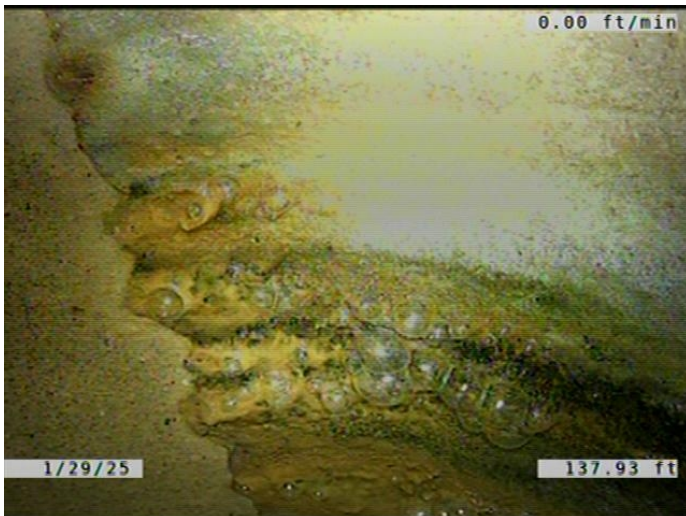
Code: **DAE**
Description: **Deposits Attached Encrustation**

Distance (ft): **137.9**
Structural Grade: **0**
O&M Grade: **2**
Clock Start/From: **12**
Clock To: **5**
1st Value:
2nd Value:
Value Percent: **5.000**
Continuous Index:
Within 8" of Joint: **YES**
Remarks:

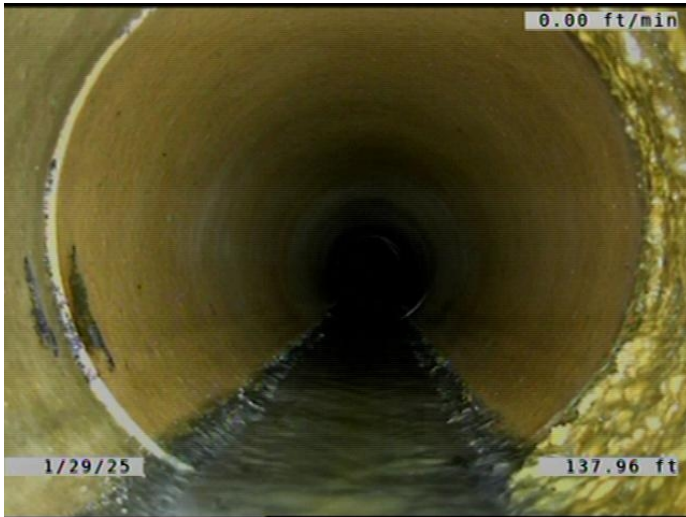
Code: **MWL**
Description: **Miscellaneous Water Level**

Distance (ft): **138.0**
Structural Grade: **0**
O&M Grade: **0**
Clock Start/From:
Clock To:
1st Value:
2nd Value:
Value Percent: **5.000**
Continuous Index:
Within 8" of Joint: **NO**
Remarks:

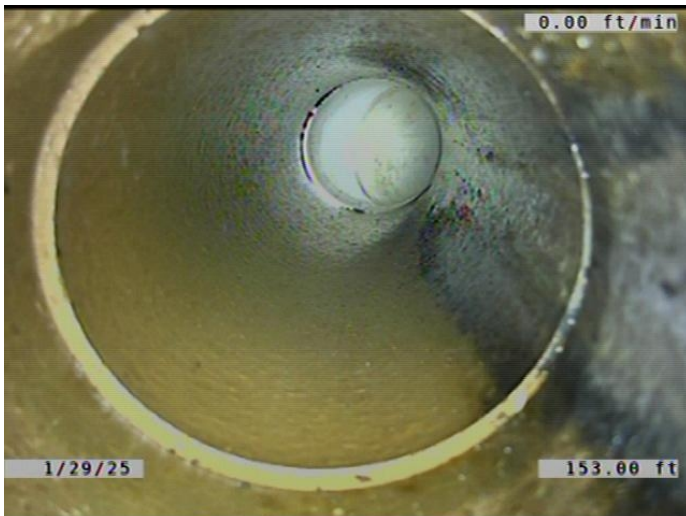
Code: **TF**
Description: **Tap Factory**

Distance (ft): **153.0**
Structural Grade: **0**
O&M Grade: **0**
Clock Start/From: **2**
Clock To:
1st Value: **6.000**
2nd Value:
Value Percent:
Continuous Index:
Within 8" of Joint: **YES**
Remarks: **SERVICE IS PVC.**

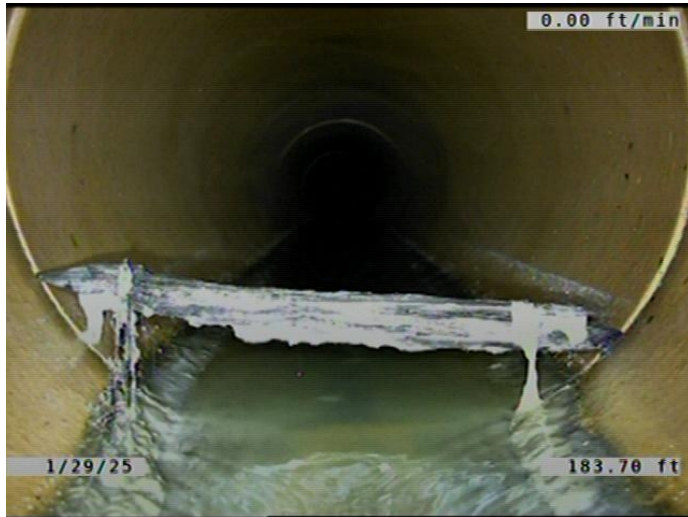
Code: **OBJ**
 Description: **Obstruction Wedged In The Joint**

Distance (ft): **183.7**
 Structural Grade: **0**
 O&M Grade: **2**
 Clock Start/From: **4**
 Clock To: **8**
 1st Value:
 2nd Value:
 Value Percent: **5.000**
 Continuous Index:
 Within 8" of Joint: **YES**
 Remarks:

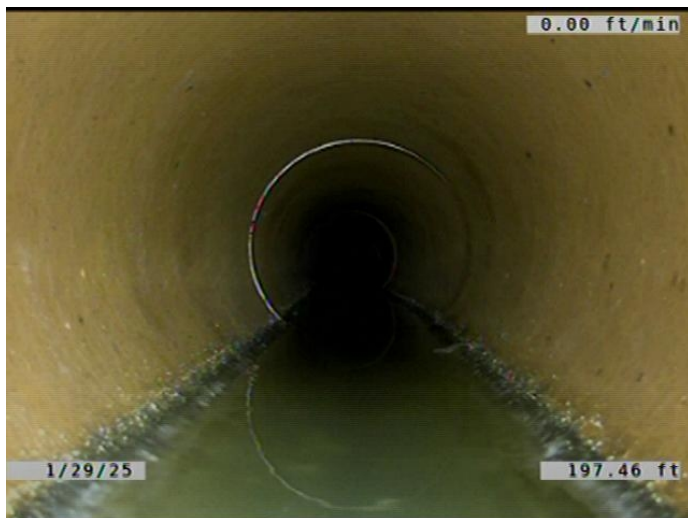
Code: **MWLS**
 Description: **Miscellaneous Water Level Sag**

Distance (ft): **197.5**
 Structural Grade: **2**
 O&M Grade: **0**
 Clock Start/From:
 Clock To:
 1st Value:
 2nd Value:
 Value Percent: **15.000**
 Continuous Index: **S01**
 Within 8" of Joint: **NO**
 Remarks:

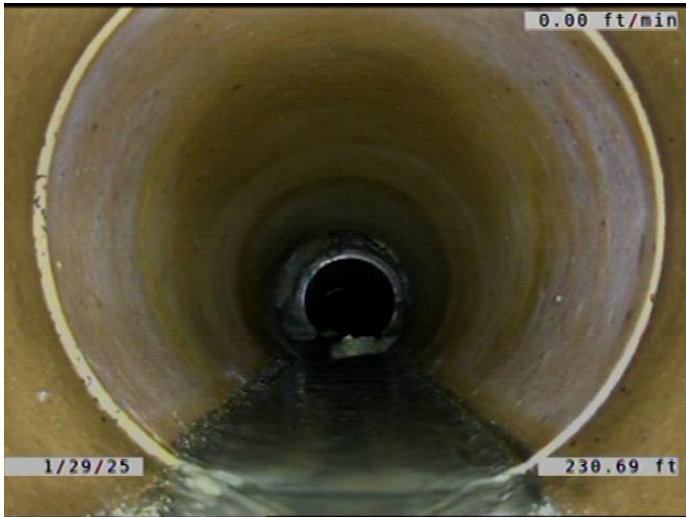
Code: **MWLS**
Description: **Miscellaneous Water Level Sag**

Distance (ft): **230.7**
Structural Grade: **2**
O&M Grade: **0**
Clock Start/From:
Clock To:
1st Value:
2nd Value:
Value Percent: **15.000**
Continuous Index: **F01**
Within 8" of Joint: **NO**
Remarks:

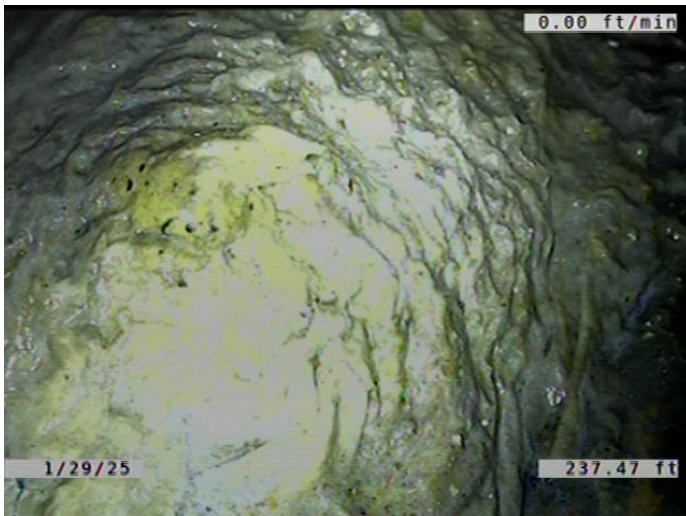
Code: **DAR**
Description: **Deposits Attached Ragging**

Distance (ft): **237.5**
Structural Grade: **0**
O&M Grade: **2**
Clock Start/From: **4**
Clock To: **6**
1st Value:
2nd Value:
Value Percent: **5.000**
Continuous Index:
Within 8" of Joint: **YES**
Remarks:

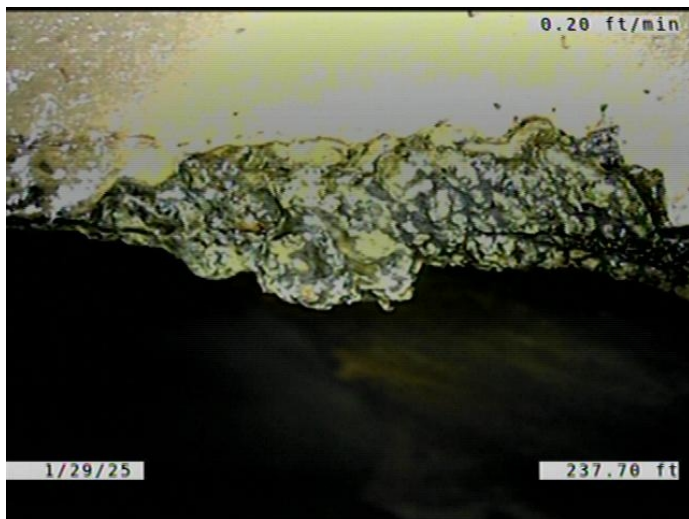
Code:	DAE
Description:	Deposits Attached Encrustation
Distance (ft):	237.7
Structural Grade:	0
O&M Grade:	2
Clock Start/From:	8
Clock To:	4
1st Value:	
2nd Value:	
Value Percent:	5.000
Continuous Index:	
Within 8" of Joint:	YES
Remarks:

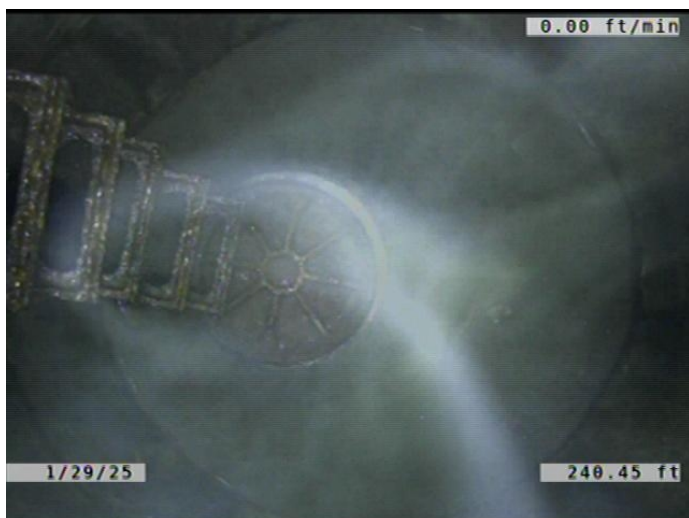
Code:	AMH
Description:	Manhole
Distance (ft):	240.4
Structural Grade:	0
O&M Grade:	0
Clock Start/From:	
Clock To:	
1st Value:	
2nd Value:	
Value Percent:	
Continuous Index:	
Within 8" of Joint:	NO
Remarks:	M-507-019
