Profile/Photo Observation Report

Date:	10/24/2021	Weather:		Coding:	PACP 6.0
Pipe Length (ft):		Owner:	Hobart, IN	Pre Clean:	Not Known
P.O.#:	1002_1	Surveyor:	M. Pielacha	PSR:	P-507-008-007
Customer:	Hobart, IN	Clean Date:		Shape:	C

Street:	Off Virginia Street	Flow Control:	Not Controlled
City:	Hobart, IN	Year Renewed:	
Location:	Sidewalk	Tape/Media #:	1002
Purpose:	Routine Assessment	Dia/Height:	12"
Use:	Sanitary	Material:	VCP
Drain Area:		Lining:	
Category:	NA		
Comment:			
Location Details:		Direction of Survey:	Downstream
US MH:	M-507-7	DS MH:	M-507-8
		Total Length Surveyed (ft):	.1

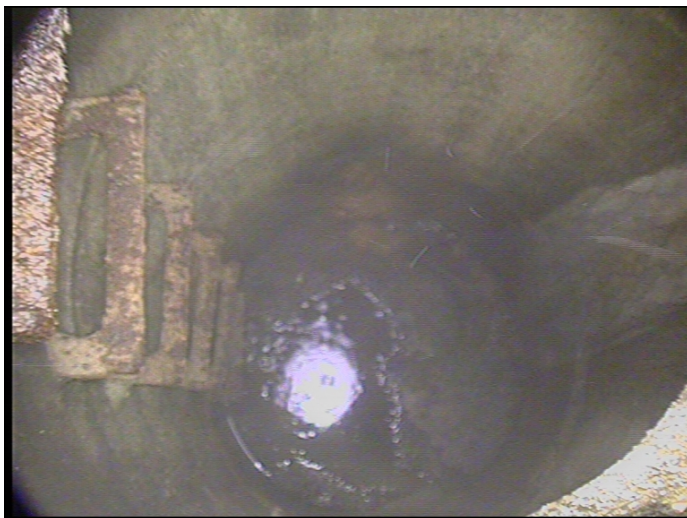
Code: **AMH**
 Description: **Manhole**

Distance (ft): **.0**
 Structural Grade: **0**
 O&M Grade: **0**
 Clock Start/From:
 Clock To:
 1st Value:
 2nd Value:
 Value Percent:
 Continuous Index:
 Within 8" of Joint: **NO**
 Remarks: **M-507-7**

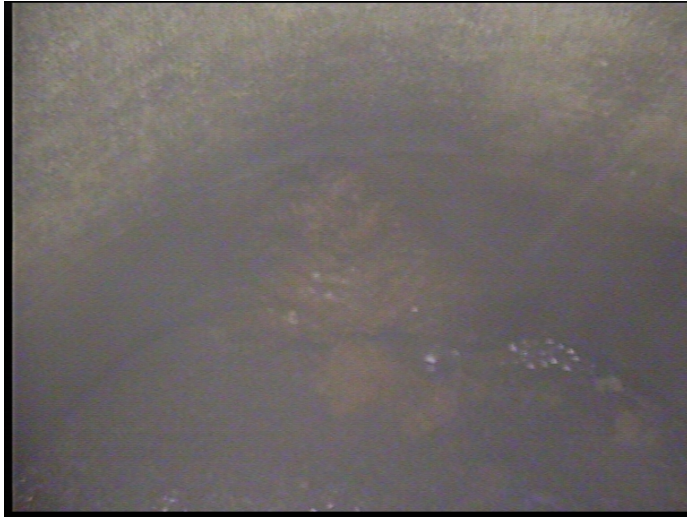
Code: **MWL**
Description: **Water Level**

Distance (ft): **.0**
Structural Grade: **0**
O&M Grade: **0**
Clock Start/From:
Clock To:
1st Value:
2nd Value:
Value Percent: **5.000**
Continuous Index:
Within 8" of Joint: **NO**
Remarks:

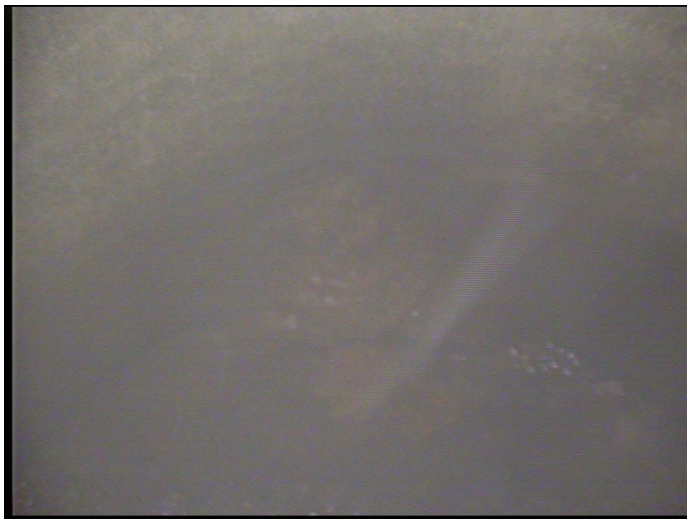
Code: **DAE**
Description: **Deposits Attached Encrustation**

Distance (ft): **.0**
Structural Grade: **0**
O&M Grade: **5**
Clock Start/From: **7**
Clock To: **5**
1st Value:
2nd Value:
Value Percent: **75.000**
Continuous Index:
Within 8" of Joint: **NO**
Remarks:

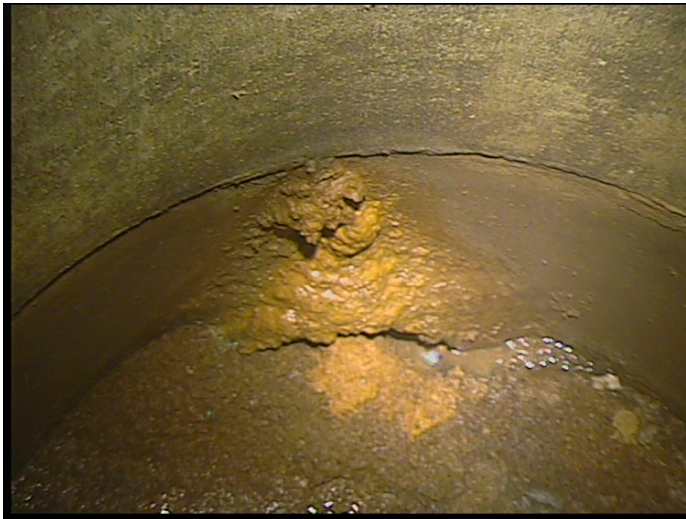
Code:	MSA
Description:	Abandoned Survey
Distance (ft):	.0
Structural Grade:	0
O&M Grade:	0
Clock Start/From:	
Clock To:	
1st Value:	
2nd Value:	
Value Percent:	
Continuous Index:	
Within 8" of Joint:	NO
Remarks:	Pipe almost completely encrusted
