Profile/Photo Observation Report

| Street: | FOXCROFT STREET | Flow Control: | Not Controlled |
| City: | Hobart, IN | Year Renewed: | |
| US MH: | M-507-009 | DS MH: | M-507-010 |

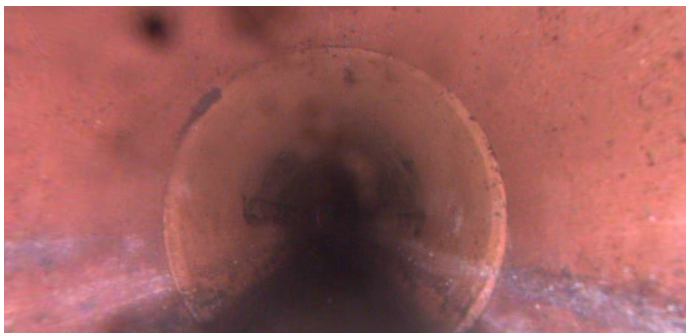
Code: **AMH**
Description: **Manhole**

Distance (ft): **.0**
Structural Grade: **0**
O&M Grade: **0**
Clock Start/From:
Clock To:
1st Value:
2nd Value:
Value Percent:
Continuous Index:
Within 8" of Joint: **NO**
Remarks: **M-507-010**

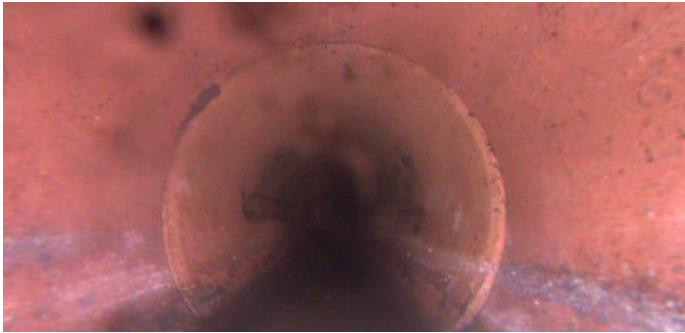
| Code: | MWL |
| Description: | Water Level |

| Distance (ft): | .0 |
| Value Percent: | 5.000 |

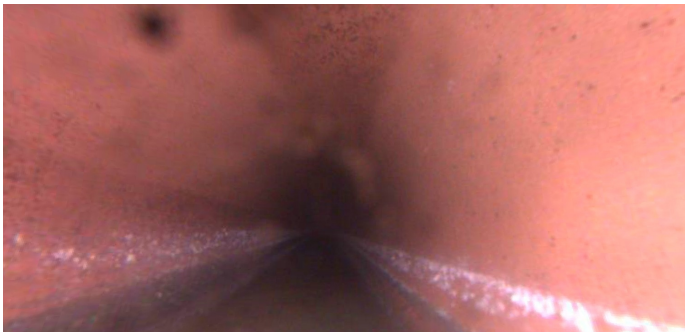
| Comment: | P_C at 31 ft nothing visible. Flow direction wrong | | |

| Code: | MSA |
| Description: | Abandoned Survey |

| Distance (ft): | 32.1 |
| Remarks: | Unknown |
