Profile/Photo Observation Report

Date:	03/27/2018	Weather:		Coding:	PACP 6.0
Pipe Length (ft):	55.7	Owner:	NA	Pre Clean:	No Pre-Cleaning
P.O.#:		Surveyor:	Jen Costello	PSR:	P-507-090-010
Customer:		Clean Date:	01/01/1900	Shape:	C

Street:	CSOKASY LN	Flow Control:	Not Controlled
City:	Hobart, IN	Year Renewed:	
Location:	Light Highway	Tape/Media #:	
Purpose:	Routine Assessment	Dia/Height:	8"
Use:	Sanitary	Material:	PVC
Drain Area:	NA	Lining:	
Category:	NA		
Comment:	R_M at 51 ft CU . Flow Direction wrong		
Location Details:		Direction of Survey:	Upstream
US MH:	M-507-010	DS MH:	M-507-090
		Total Length Surveyed (ft):	52.6

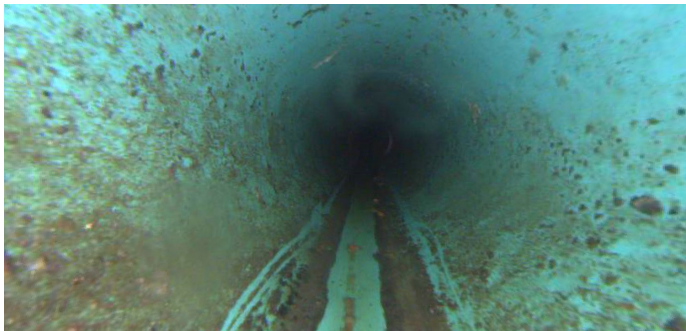
Code: **AMH**
Description: **Manhole**

Distance (ft): **.0**
Structural Grade: **0**
O&M Grade: **0**
Clock Start/From:
Clock To:
1st Value:
2nd Value:
Value Percent:
Continuous Index:
Within 8" of Joint: **NO**
Remarks: **M-507-090**

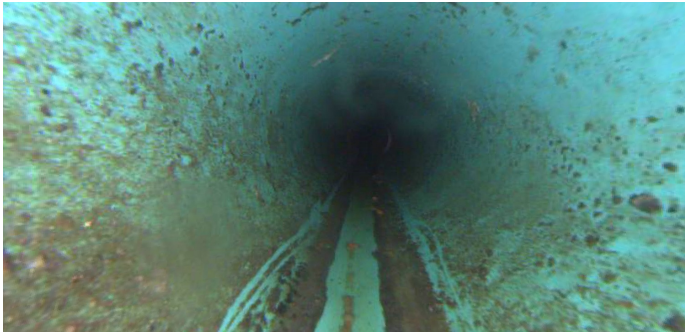
Code:	MWL
Description:	Water Level

Distance (ft):	.0
Structural Grade:	0
O&M Grade:	0
Clock Start/From:	
Clock To:	
1st Value:	
2nd Value:	
Value Percent:	5.000
Continuous Index:	
Within 8" of Joint:	NO
Remarks:

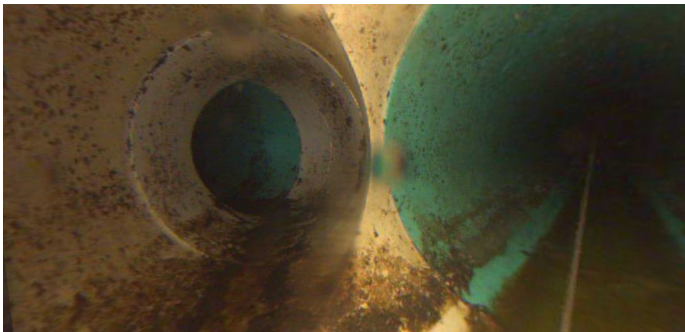
Code:	TF
Description:	Tap Factory

Distance (ft):	5.1
Structural Grade:	0
O&M Grade:	0
Clock Start/From:	3
Clock To:	
1st Value:	4.000
2nd Value:	
Value Percent:	
Continuous Index:	
Within 8" of Joint:	
Remarks:

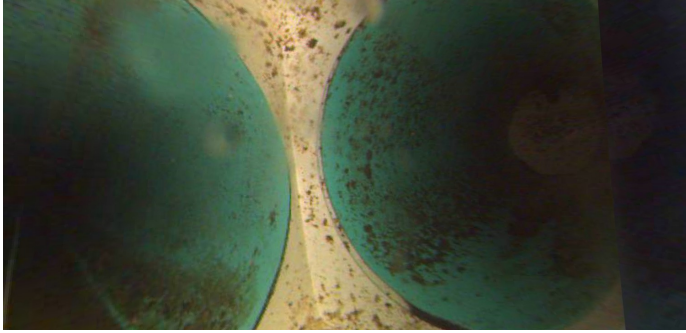
Code: **TFC**
Description: **Tap Factory Capped**

Distance (ft): **9.7**
Structural Grade: **0**
O&M Grade: **0**
Clock Start/From: **9**
Clock To:
1st Value: **4.000**
2nd Value:
Value Percent:
Continuous Index:
Within 8" of Joint:
Remarks:

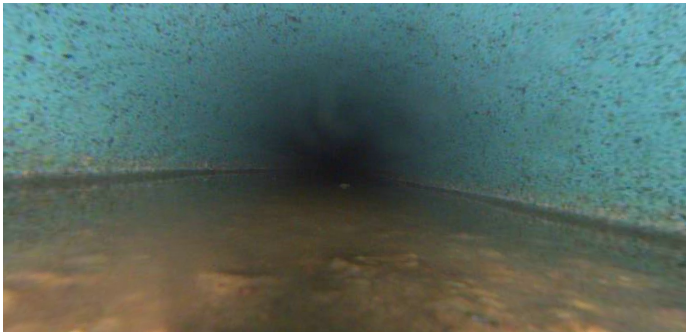
Code: **MWL**
Description: **Water Level**

Distance (ft): **41.9**
Structural Grade: **0**
O&M Grade: **0**
Clock Start/From:
Clock To:
1st Value:
2nd Value:
Value Percent: **40.000**
Continuous Index:
Within 8" of Joint: **NO**
Remarks:

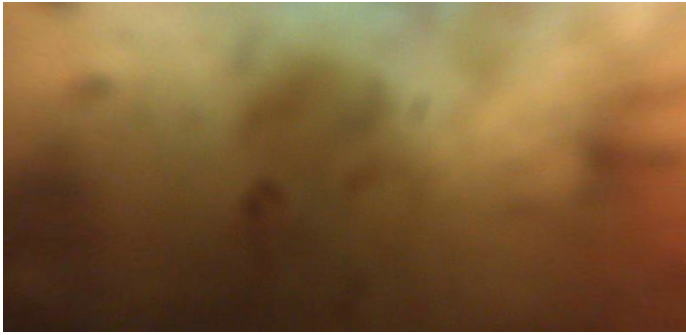
Code: **MWL**
Description: **Water Level**

Distance (ft): **45.6**
Structural Grade: **0**
O&M Grade: **0**
Clock Start/From:
Clock To:
1st Value:
2nd Value:
Value Percent: **60.000**
Continuous Index:
Within 8" of Joint: **NO**
Remarks:

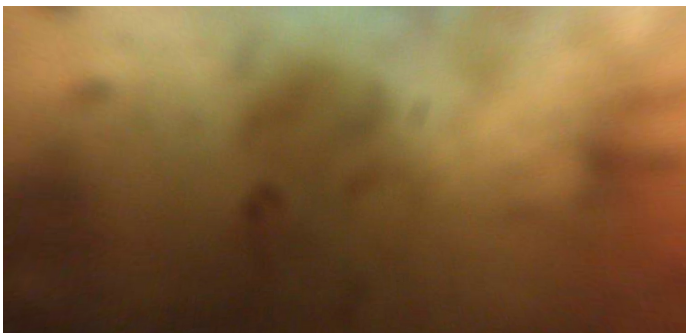
Code: **MCU**
Description: **Camera Underwater**

Distance (ft): **45.6**
Structural Grade: **0**
O&M Grade: **4**
Clock Start/From:
Clock To:
1st Value:
2nd Value:
Value Percent:
Continuous Index: **S01**
Within 8" of Joint: **NO**
Remarks:

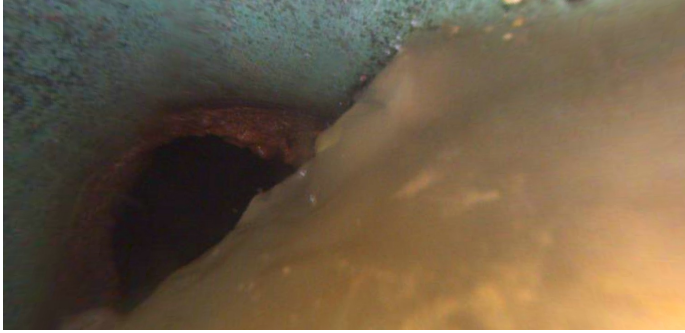
Code: **MSA**
Description: **Abandoned Survey**

Distance (ft): **52.6**
Structural Grade: **0**
O&M Grade: **0**
Clock Start/From:
Clock To:
1st Value:
2nd Value:
Value Percent:
Continuous Index:
Within 8" of Joint: **NO**
Remarks: **overturned**

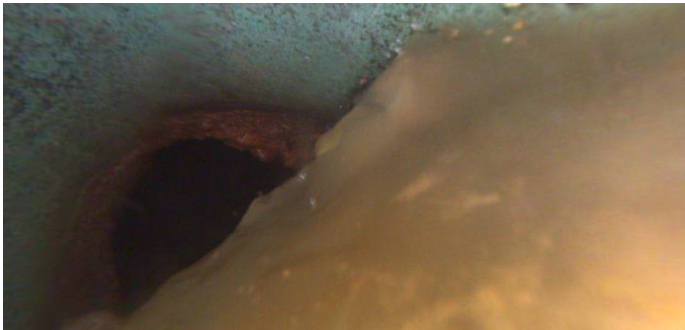
Code: **MCU**
Description: **Camera Underwater**

Distance (ft): **52.6**
Structural Grade: **0**
O&M Grade: **4**
Clock Start/From:
Clock To:
1st Value:
2nd Value:
Value Percent:
Continuous Index: **F01**
Within 8" of Joint: **NO**
Remarks:
