## Profile/Photo Observation Report

Date:	<b>03/27/2018</b>	Weather:		Coding:	<b>PACP 6.0</b>
Pipe Length (ft):	<b>55.7</b>	Owner:	<b>NA</b>	Pre Clean:	<b>No Pre-Cleaning</b>
P.O.#:		Surveyor:	<b>Jen Costello</b>	PSR:	<b>P-507-090-010</b>
Customer:		Clean Date:	<b>01/01/1900</b>	Shape:	<b>C</b>

Street:	<b>FOXCROFT STREET</b>	Flow Control:	<b>Not Controlled</b>
City:	<b>Hobart, IN</b>	Year Renewed:	
Location:	<b>Light Highway</b>	Tape/Media #:	
Purpose:	<b>Routine Assessment</b>	Dia/Height:	<b>8"</b>
Use:	<b>Sanitary</b>	Material:	<b>PVC</b>
Drain Area:	<b>NA</b>	Lining:	
Category:	<b>NA</b>		
Comment:	<b>R_M at 51 ft CU . Flow Direction wrong</b>		
Location Details:		Direction of Survey:	<b>Upstream</b>
US MH:	<b>M-507-010</b>	DS MH:	<b>M-507-090</b>
		Total Length Surveyed (ft):	<b>52.6</b>

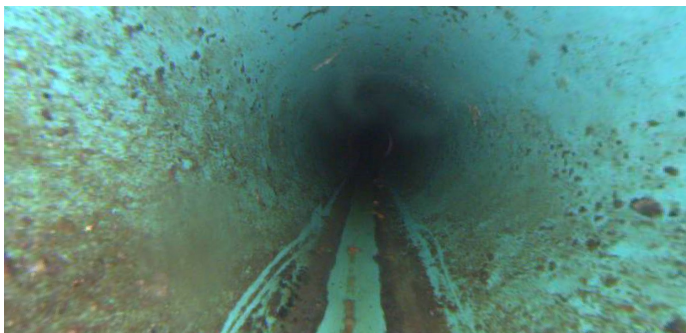
Code: **AMH**  
Description: **Manhole**

Distance (ft): **.0**  
Structural Grade: **0**  
O&M Grade: **0**  
Clock Start/From:  
Clock To:  
1st Value:  
2nd Value:  
Value Percent:  
Continuous Index:  
Within 8" of Joint: **NO**  
Remarks: **M-507-090**

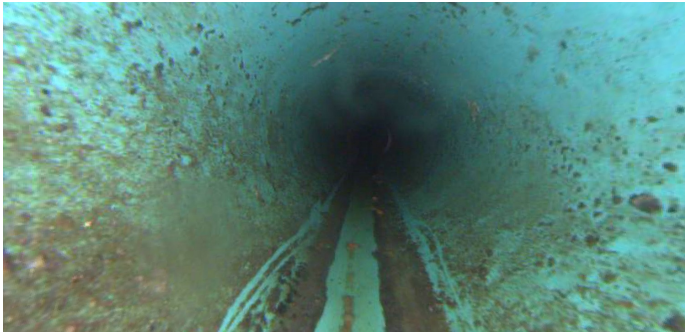
Code:	<b>MWL</b>
Description:	<b>Water Level</b>

Distance (ft):	<b>.0</b>
Structural Grade:	<b>0</b>
O&M Grade:	<b>0</b>
Clock Start/From:	
Clock To:	
1st Value:	
2nd Value:	
Value Percent:	<b>5.000</b>
Continuous Index:	
Within 8" of Joint:	<b>NO</b>
Remarks:

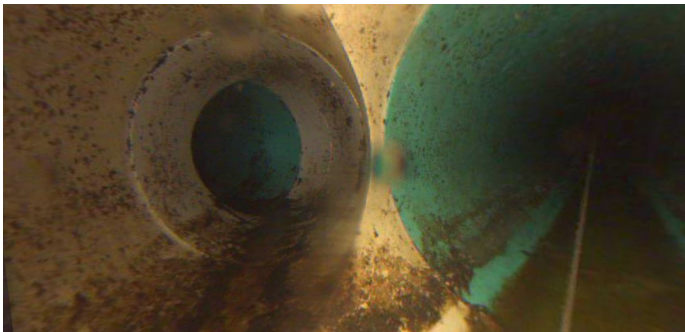
Code:	<b>TF</b>
Description:	<b>Tap Factory</b>

Distance (ft):	<b>5.1</b>
Structural Grade:	<b>0</b>
O&M Grade:	<b>0</b>
Clock Start/From:	<b>3</b>
Clock To:	
1st Value:	<b>4.000</b>
2nd Value:	
Value Percent:	
Continuous Index:	
Within 8" of Joint:	
Remarks:

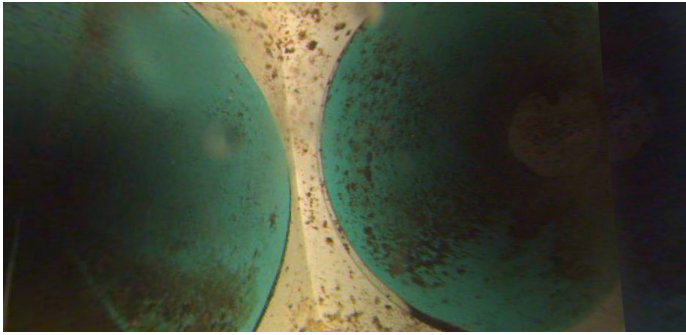
Code: **TFC**  
Description: **Tap Factory Capped**

Distance (ft): **9.7**  
Structural Grade: **0**  
O&M Grade: **0**  
Clock Start/From: **9**  
Clock To:  
1st Value: **4.000**  
2nd Value:  
Value Percent:  
Continuous Index:  
Within 8" of Joint:  
Remarks:

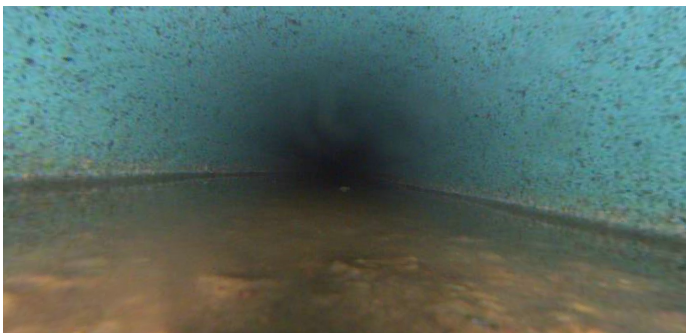
Code: **MWL**  
Description: **Water Level**

Distance (ft): **41.9**  
Structural Grade: **0**  
O&M Grade: **0**  
Clock Start/From:  
Clock To:  
1st Value:  
2nd Value:  
Value Percent: **40.000**  
Continuous Index:  
Within 8" of Joint: **NO**  
Remarks:

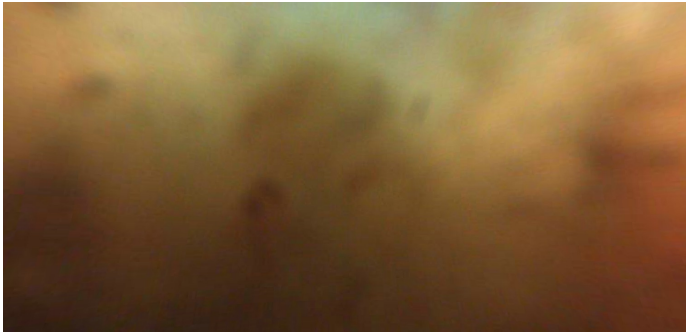
Code: **MWL**  
Description: **Water Level**

Distance (ft): **45.6**  
Structural Grade: **0**  
O&M Grade: **0**  
Clock Start/From:  
Clock To:  
1st Value:  
2nd Value:  
Value Percent: **60.000**  
Continuous Index:  
Within 8" of Joint: **NO**  
Remarks:

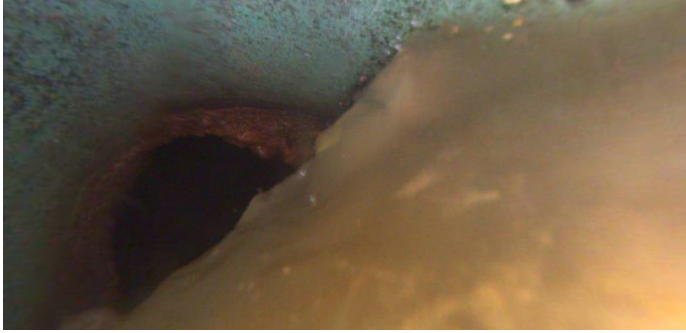
Code: **MSA**  
Description: **Abandoned Survey**

Distance (ft): **52.6**  
Structural Grade: **0**  
O&M Grade: **0**  
Clock Start/From:  
Clock To:  
1st Value:  
2nd Value:  
Value Percent:  
Continuous Index:  
Within 8" of Joint: **NO**  
Remarks: **overturned**

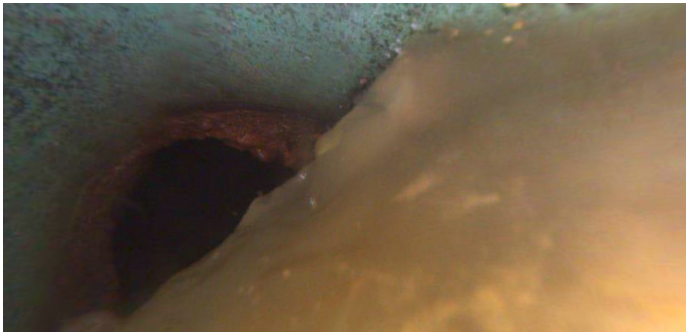
Code: **MCU**  
Description: **Camera Underwater**

Distance (ft): **52.6**  
Structural Grade: **0**  
O&M Grade: **4**  
Clock Start/From:  
Clock To:  
1st Value:  
2nd Value:  
Value Percent:  
Continuous Index: **F01**  
Within 8" of Joint: **NO**  
Remarks:
