Profile/Photo Observation Report

Date:	03/28/2018	Weather:		Coding:	PACP 6.0
Pipe Length (ft):	239.0	Owner:	NA	Pre Clean:	No Pre-Cleaning
P.O.#:		Surveyor:	Selasie Honu	PSR:	P-507-012-011
Customer:		Clean Date:	01/01/1900	Shape:	C

Street:	ALLEY BETWEEN S DELAWARE ST & S	Flow Control:	Not Controlled
City:	Hobart, IN	Year Renewed:	
Location:	Yard	Tape/Media #:	
Purpose:	Routine Assessment	Dia/Height:	12"
Use:	Sanitary	Material:	VCP
Drain Area:	NA	Lining:	
Category:	NA		
Comment:	F_S_P_C at 1 ft debris .Flow direction wrong		
Location Details:		Direction of Survey:	Downstream
US MH:	M-507-011	DS MH:	M-507-012
		Total Length Surveyed (ft):	3.3

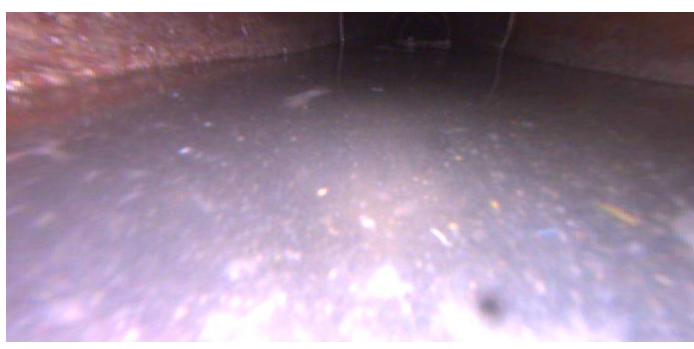
Code: **AMH**
Description: **Manhole**

Distance (ft): **.0**
Structural Grade: **0**
O&M Grade: **0**
Clock Start/From:
Clock To:
1st Value:
2nd Value:
Value Percent:
Continuous Index:
Within 8" of Joint: **NO**
Remarks: **M-507-011**

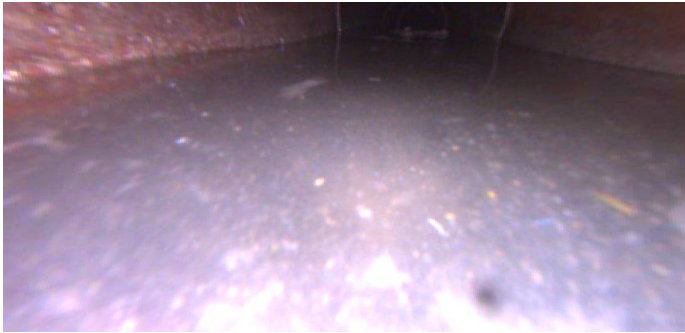
Code:	MWL
Description:	Water Level

Distance (ft):	.0
Structural Grade:	0
O&M Grade:	0
Clock Start/From:	
Clock To:	
1st Value:	
2nd Value:	
Value Percent:	5.000
Continuous Index:	
Within 8" of Joint:	NO
Remarks:

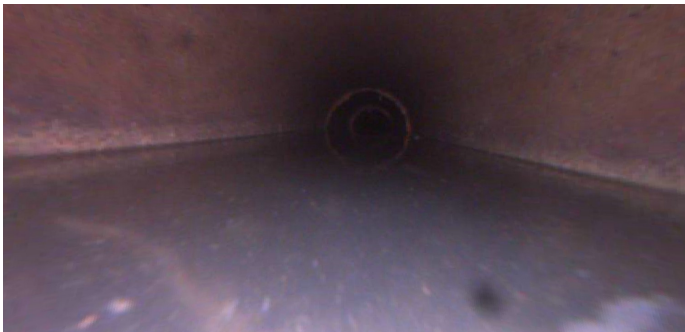
Code:	MSA
Description:	Abandoned Survey

Distance (ft):	3.3
Structural Grade:	0
O&M Grade:	0
Clock Start/From:	
Clock To:	
1st Value:	
2nd Value:	
Value Percent:	
Continuous Index:	
Within 8" of Joint:	NO
Remarks:	camera stopped
