Profile/Photo Observation Report

Date:	03/28/2018	Weather:		Coding:	PACP 6.0
Pipe Length (ft):	239.0	Owner:	NA	Pre Clean:	No Pre-Cleaning
P.O.#:		Surveyor:	Selasie Honu	PSR:	P-507-012-011
Customer:		Clean Date:	01/01/1900	Shape:	C

Street:	FOXCROFT STREET	Flow Control:	Not Controlled
City:	Hobart, IN	Year Renewed:	
Location:	Yard	Tape/Media #:	
Purpose:	Routine Assessment	Dia/Height:	12"
Use:	Sanitary	Material:	VCP
Drain Area:	NA	Lining:	
Category:	NA		
Comment:	F_S_P_C at 1 ft debris .Flow direction wrong		
Location Details:		Direction of Survey:	Downstream
US MH:	M-507-011	DS MH:	M-507-012
		Total Length Surveyed (ft):	3.3

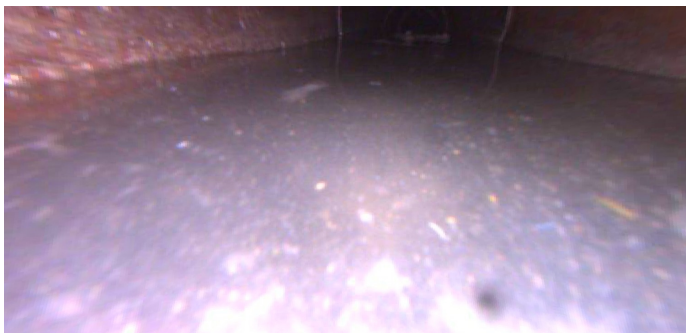
Code: **AMH**
Description: **Manhole**

Distance (ft): **.0**
Structural Grade: **0**
O&M Grade: **0**
Clock Start/From:
Clock To:
1st Value:
2nd Value:
Value Percent:
Continuous Index:
Within 8" of Joint: **NO**
Remarks: **M-507-011**

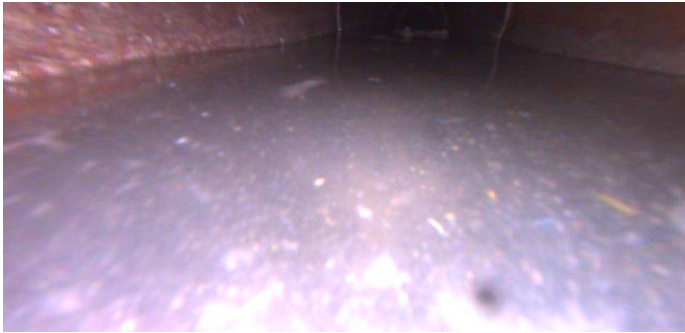
Code:	MWL
Description:	Water Level

Distance (ft):	.0
Structural Grade:	0
O&M Grade:	0
Clock Start/From:	
Clock To:	
1st Value:	
2nd Value:	
Value Percent:	5.000
Continuous Index:	
Within 8" of Joint:	NO
Remarks:

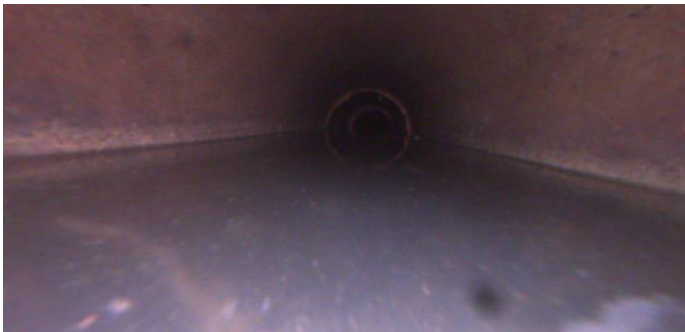
Code:	MSA
Description:	Abandoned Survey

Distance (ft):	3.3
Structural Grade:	0
O&M Grade:	0
Clock Start/From:	
Clock To:	
1st Value:	
2nd Value:	
Value Percent:	
Continuous Index:	
Within 8" of Joint:	NO
Remarks:	camera stopped
