## Profile/Photo Observation Report

Date:	<b>03/29/2018</b>	Weather:		Coding:	<b>PACP 6.0</b>
Pipe Length (ft):	<b>239.0</b>	Owner:	<b>NA</b>	Pre Clean:	<b>No Pre-Cleaning</b>
P.O.#:		Surveyor:	<b>Jen Costello</b>	PSR:	<b>P-507-012-011</b>
Customer:		Clean Date:	<b>01/01/1900</b>	Shape:	<b>C</b>

Street:	<b>ALLEY BETWEEN S DELAWARE ST &amp; S</b>	Flow Control:	<b>Not Controlled</b>
City:	<b>Hobart, IN</b>	Year Renewed:	
Location:	<b>Yard</b>	Tape/Media #:	
Purpose:	<b>Routine Assessment</b>	Dia/Height:	<b>12"</b>
Use:	<b>Sanitary</b>	Material:	<b>VCP</b>
Drain Area:	<b>NA</b>	Lining:	
Category:	<b>NA</b>		
Comment:	<b>P_C at 36 ft debris . Flow direction wrong</b>		
Location Details:		Direction of Survey:	<b>Upstream</b>
US MH:	<b>M-507-011</b>	DS MH:	<b>M-507-012</b>
		Total Length Surveyed (ft):	<b>37.6</b>

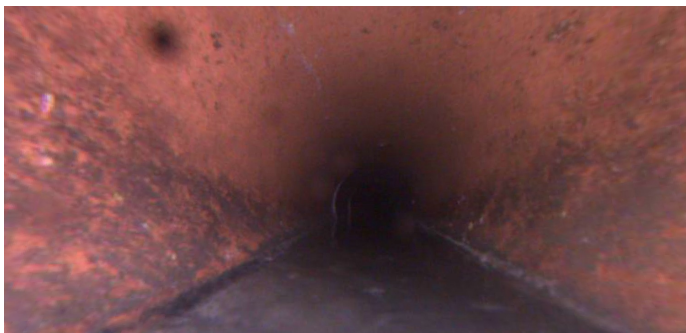
Code: **AMH**  
Description: **Manhole**

Distance (ft): **.0**  
Structural Grade: **0**  
O&M Grade: **0**  
Clock Start/From:  
Clock To:  
1st Value:  
2nd Value:  
Value Percent:  
Continuous Index:  
Within 8" of Joint: **NO**  
Remarks: **M-507-012**

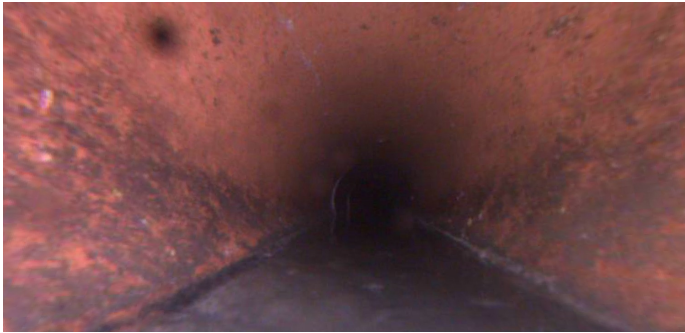
Code:	<b>MWL</b>
Description:	<b>Water Level</b>

Distance (ft):	<b>.0</b>
Structural Grade:	<b>0</b>
O&M Grade:	<b>0</b>
Clock Start/From:	
Clock To:	
1st Value:	
2nd Value:	
Value Percent:	<b>20.000</b>
Continuous Index:	
Within 8" of Joint:	<b>NO</b>
Remarks:

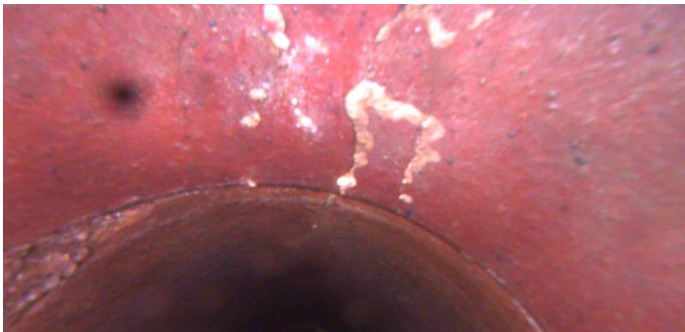
Code:	<b>FM</b>
Description:	<b>Fracture Multiple</b>

Distance (ft):	<b>6.5</b>
Structural Grade:	<b>4</b>
O&M Grade:	<b>0</b>
Clock Start/From:	<b>11</b>
Clock To:	<b>1</b>
1st Value:	
2nd Value:	
Value Percent:	
Continuous Index:	
Within 8" of Joint:	<b>YES</b>
Remarks:

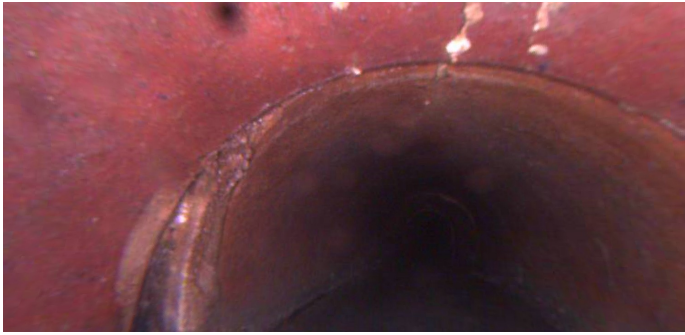
Code: **IW**  
Description: **Infil Weeper**

Distance (ft): **6.5**  
Structural Grade: **0**  
O&M Grade: **2**  
Clock Start/From: **8**  
Clock To: **11**  
1st Value:  
2nd Value:  
Value Percent:  
Continuous Index:  
Within 8" of Joint: **YES**  
Remarks:

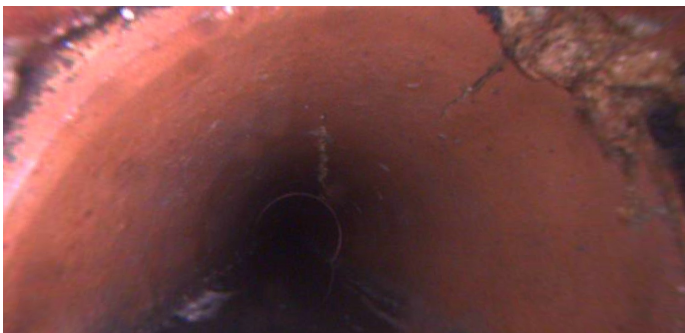
Code: **FL**  
Description: **Fracture Longitudinal**

Distance (ft): **9.6**  
Structural Grade: **3**  
O&M Grade: **0**  
Clock Start/From: **1**  
Clock To:  
1st Value:  
2nd Value:  
Value Percent:  
Continuous Index:  
Within 8" of Joint: **YES**  
Remarks:

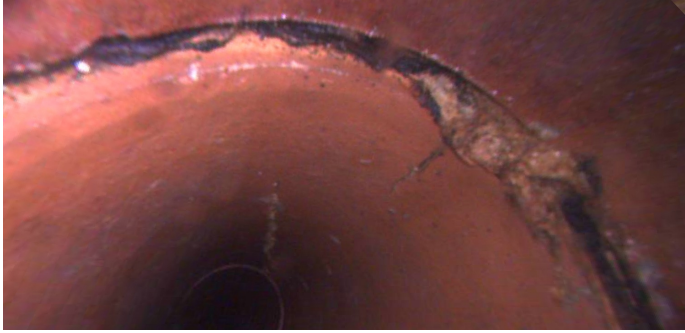
Code: **DAE**  
Description: **Deposits Attached Encrustation**

Distance (ft): **9.6**  
Structural Grade: **0**  
O&M Grade: **2**  
Clock Start/From: **10**  
Clock To: **2**  
1st Value:  
2nd Value:  
Value Percent: **5.000**  
Continuous Index:  
Within 8" of Joint: **YES**  
Remarks:

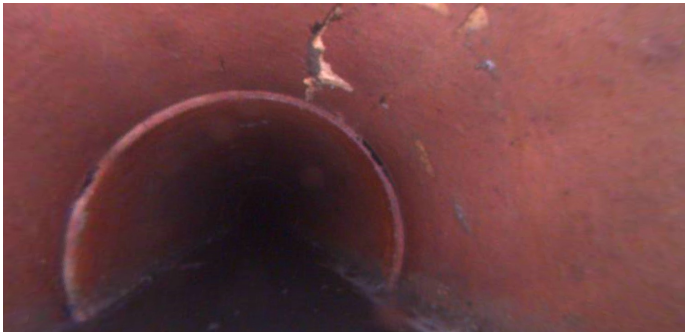
Code: **FL**  
Description: **Fracture Longitudinal**

Distance (ft): **12.0**  
Structural Grade: **3**  
O&M Grade: **0**  
Clock Start/From: **1**  
Clock To:  
1st Value:  
2nd Value:  
Value Percent:  
Continuous Index:  
Within 8" of Joint: **YES**  
Remarks:

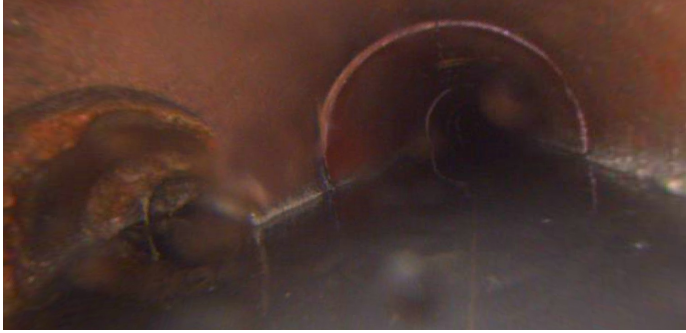
Code: **TFA**  
Description: **Tap Factory Active**

Distance (ft): **29.4**  
Structural Grade: **0**  
O&M Grade: **0**  
Clock Start/From: **3**  
Clock To:  
1st Value: **4.000**  
2nd Value:  
Value Percent:  
Continuous Index:  
Within 8" of Joint:  
Remarks:

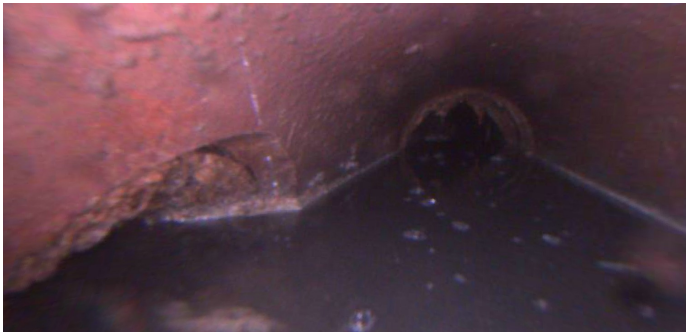
Code: **TFA**  
Description: **Tap Factory Active**

Distance (ft): **31.5**  
Structural Grade: **0**  
O&M Grade: **0**  
Clock Start/From: **9**  
Clock To:  
1st Value: **4.000**  
2nd Value:  
Value Percent:  
Continuous Index:  
Within 8" of Joint:  
Remarks:

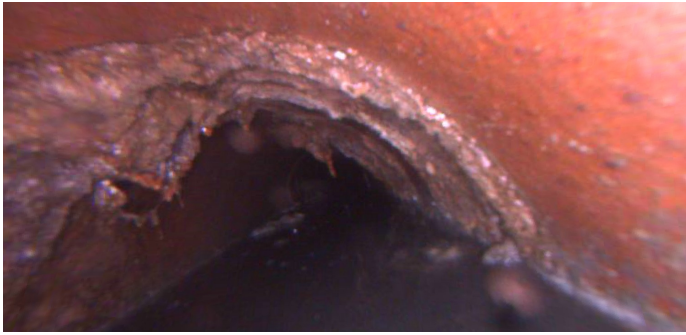
Code: **DAE**  
Description: **Deposits Attached Encrustation**

Distance (ft): **33.6**  
Structural Grade: **0**  
O&M Grade: **2**  
Clock Start/From: **8**  
Clock To: **4**  
1st Value:  
2nd Value:  
Value Percent: **10.000**  
Continuous Index:  
Within 8" of Joint: **YES**  
Remarks:

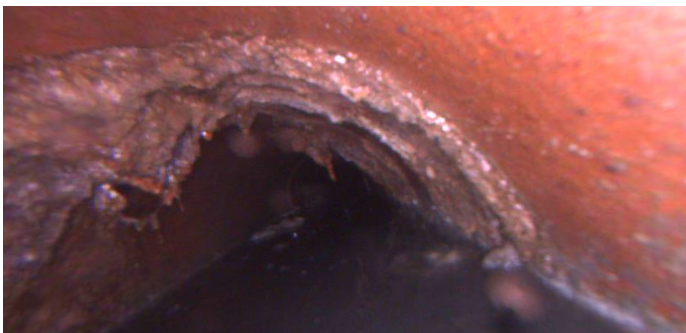
Code: **ID**  
Description: **Infil Dripper**

Distance (ft): **33.6**  
Structural Grade: **0**  
O&M Grade: **3**  
Clock Start/From: **11**  
Clock To: **1**  
1st Value:  
2nd Value:  
Value Percent:  
Continuous Index:  
Within 8" of Joint: **YES**  
Remarks:

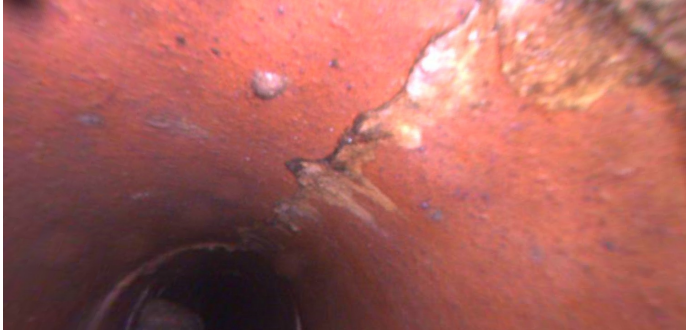
Code: **FL**  
Description: **Fracture Longitudinal**

Distance (ft): **35.4**  
Structural Grade: **3**  
O&M Grade: **0**  
Clock Start/From: **1**  
Clock To:  
1st Value:  
2nd Value:  
Value Percent:  
Continuous Index:  
Within 8" of Joint:  
Remarks:

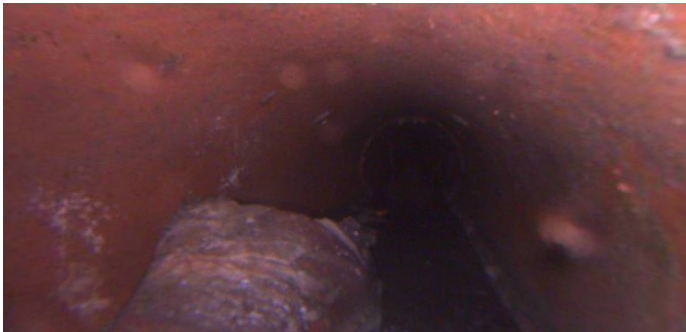
Code: **OBM**  
Description: **Obstacle Pipe Material**

Distance (ft): **37.6**  
Structural Grade: **0**  
O&M Grade: **4**  
Clock Start/From: **6**  
Clock To: **9**  
1st Value:  
2nd Value:  
Value Percent: **30.000**  
Continuous Index:  
Within 8" of Joint: **NO**  
Remarks:

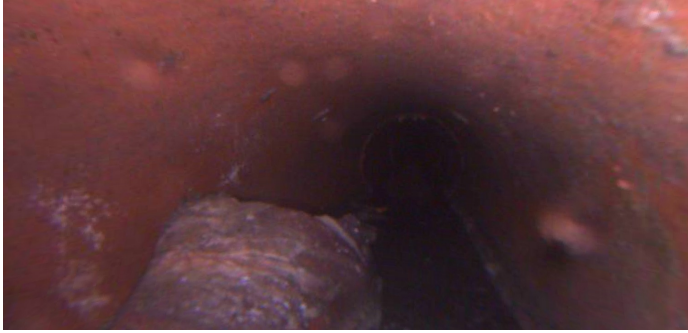
Code:	<b>MSA</b>
Description:	<b>Abandoned Survey</b>
Distance (ft):	<b>37.6</b>
Structural Grade:	<b>0</b>
O&M Grade:	<b>0</b>
Clock Start/From:	
Clock To:	
1st Value:	
2nd Value:	
Value Percent:	
Continuous Index:	
Within 8" of Joint:	<b>NO</b>
Remarks:	<b>OBM</b>
