Profile/Photo Observation Report

Date:	03/29/2018	Weather:		Coding:	PACP 6.0
Pipe Length (ft):	239.0	Owner:	NA	Pre Clean:	No Pre-Cleaning
P.O.#:		Surveyor:	Jen Costello	PSR:	P-507-012-011
Customer:		Clean Date:	01/01/1900	Shape:	C

Street:	FOXCROFT STREET	Flow Control:	Not Controlled
City:	Hobart, IN	Year Renewed:	
Location:	Yard	Tape/Media #:	
Purpose:	Routine Assessment	Dia/Height:	12"
Use:	Sanitary	Material:	VCP
Drain Area:	NA	Lining:	
Category:	NA		
Comment:	P_C at 36 ft debris . Flow direction wrong		
Location Details:		Direction of Survey:	Upstream
US MH:	M-507-011	DS MH:	M-507-012
		Total Length Surveyed (ft):	37.6

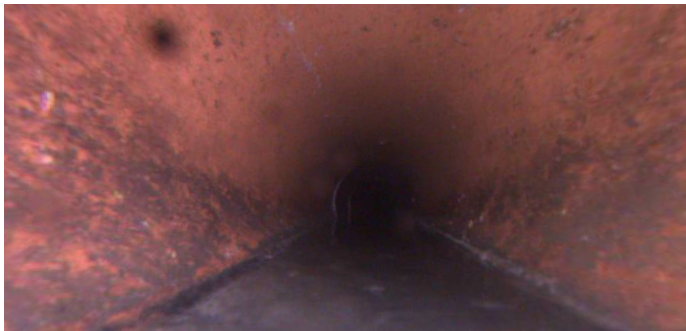
Code: **AMH**
Description: **Manhole**

Distance (ft): **.0**
Structural Grade: **0**
O&M Grade: **0**
Clock Start/From:
Clock To:
1st Value:
2nd Value:
Value Percent:
Continuous Index:
Within 8" of Joint: **NO**
Remarks: **M-507-012**

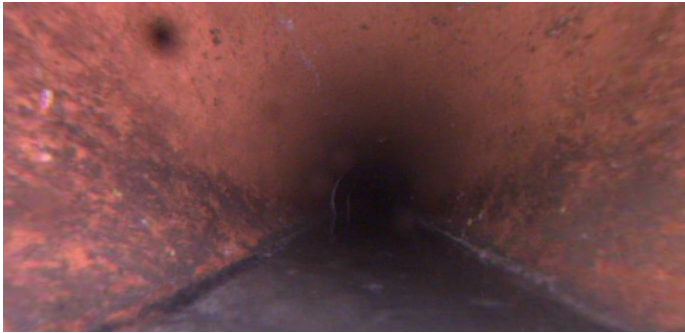
Code:	MWL
Description:	Water Level

Distance (ft):	.0
Structural Grade:	0
O&M Grade:	0
Clock Start/From:	
Clock To:	
1st Value:	
2nd Value:	
Value Percent:	20.000
Continuous Index:	
Within 8" of Joint:	NO
Remarks:

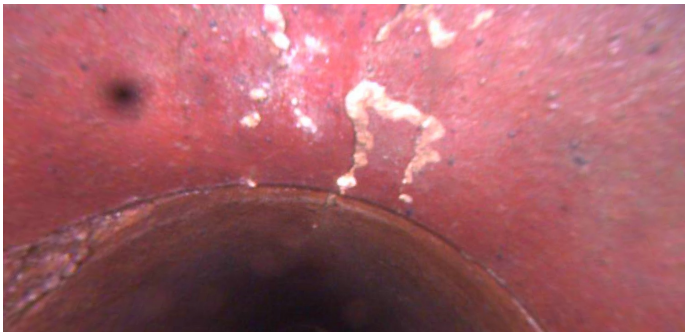
Code:	FM
Description:	Fracture Multiple

Distance (ft):	6.5
Structural Grade:	4
O&M Grade:	0
Clock Start/From:	11
Clock To:	1
1st Value:	
2nd Value:	
Value Percent:	
Continuous Index:	
Within 8" of Joint:	YES
Remarks:

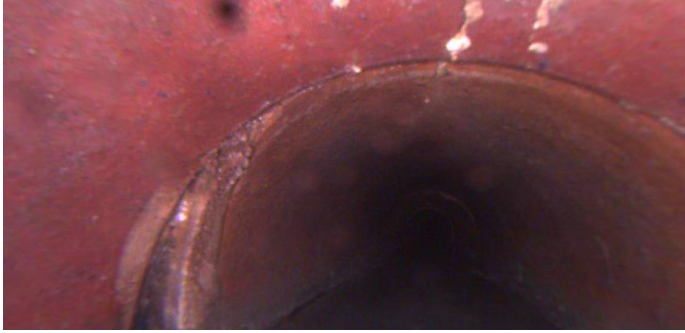
Code: **IW**
Description: **Infil Weeper**

Distance (ft): **6.5**
Structural Grade: **0**
O&M Grade: **2**
Clock Start/From: **8**
Clock To: **11**
1st Value:
2nd Value:
Value Percent:
Continuous Index:
Within 8" of Joint: **YES**
Remarks:

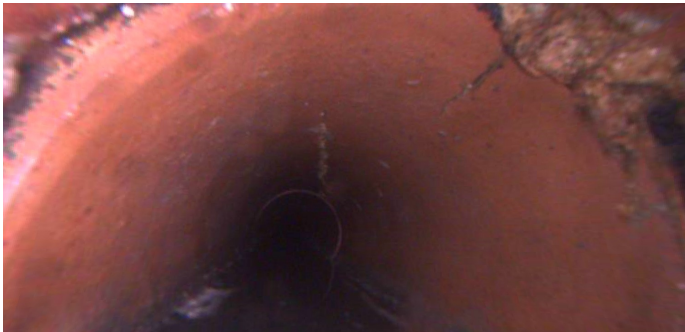
Code: **FL**
Description: **Fracture Longitudinal**

Distance (ft): **9.6**
Structural Grade: **3**
O&M Grade: **0**
Clock Start/From: **1**
Clock To:
1st Value:
2nd Value:
Value Percent:
Continuous Index:
Within 8" of Joint: **YES**
Remarks:

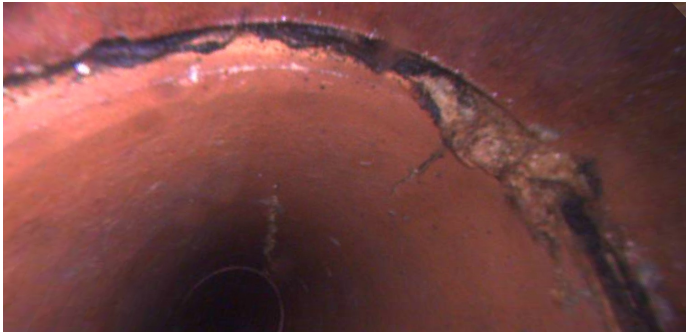
Code: **DAE**
Description: **Deposits Attached Encrustation**

Distance (ft): **9.6**
Structural Grade: **0**
O&M Grade: **2**
Clock Start/From: **10**
Clock To: **2**
1st Value:
2nd Value:
Value Percent: **5.000**
Continuous Index:
Within 8" of Joint: **YES**
Remarks:

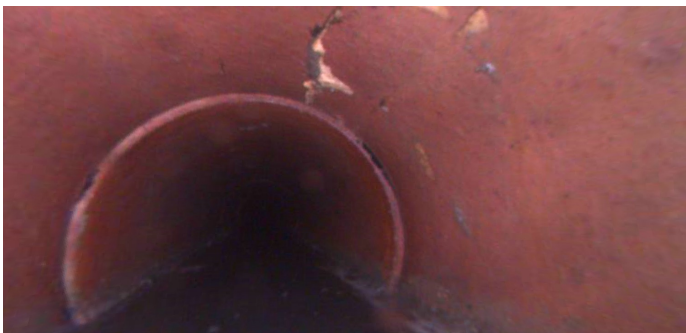
Code: **FL**
Description: **Fracture Longitudinal**

Distance (ft): **12.0**
Structural Grade: **3**
O&M Grade: **0**
Clock Start/From: **1**
Clock To:
1st Value:
2nd Value:
Value Percent:
Continuous Index:
Within 8" of Joint: **YES**
Remarks:

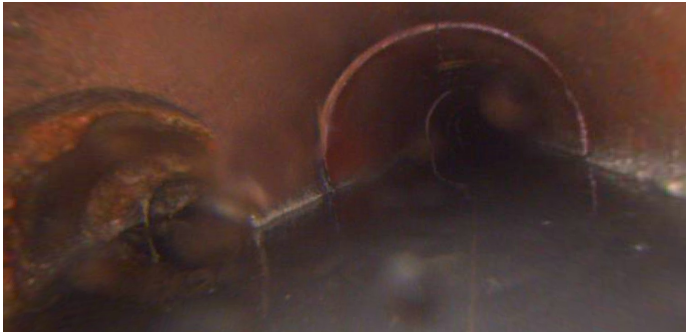
Code: **TFA**
Description: **Tap Factory Active**

Distance (ft): **29.4**
Structural Grade: **0**
O&M Grade: **0**
Clock Start/From: **3**
Clock To:
1st Value: **4.000**
2nd Value:
Value Percent:
Continuous Index:
Within 8" of Joint:
Remarks:

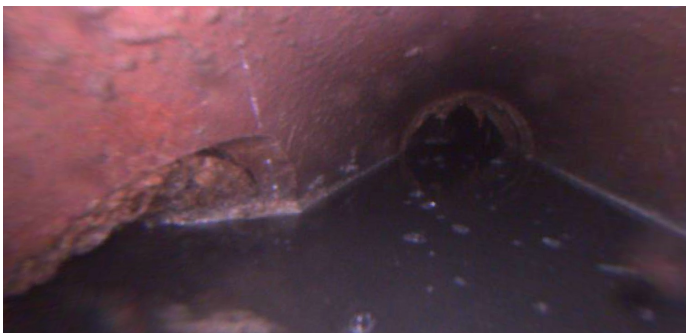
Code: **TFA**
Description: **Tap Factory Active**

Distance (ft): **31.5**
Structural Grade: **0**
O&M Grade: **0**
Clock Start/From: **9**
Clock To:
1st Value: **4.000**
2nd Value:
Value Percent:
Continuous Index:
Within 8" of Joint:
Remarks:

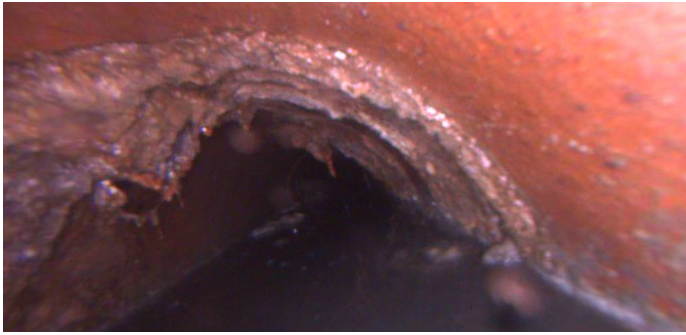
Code: **DAE**
Description: **Deposits Attached Encrustation**

Distance (ft): **33.6**
Structural Grade: **0**
O&M Grade: **2**
Clock Start/From: **8**
Clock To: **4**
1st Value:
2nd Value:
Value Percent: **10.000**
Continuous Index:
Within 8" of Joint: **YES**
Remarks:

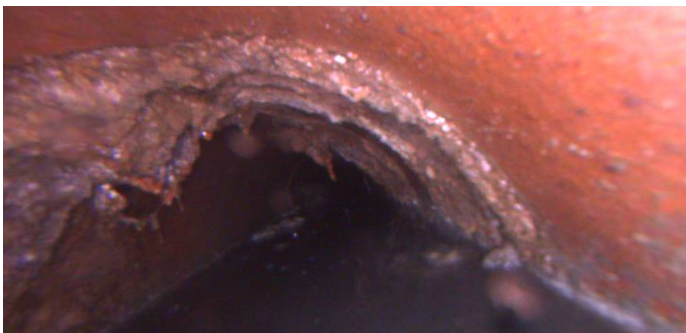
Code: **ID**
Description: **Infil Dripper**

Distance (ft): **33.6**
Structural Grade: **0**
O&M Grade: **3**
Clock Start/From: **11**
Clock To: **1**
1st Value:
2nd Value:
Value Percent:
Continuous Index:
Within 8" of Joint: **YES**
Remarks:

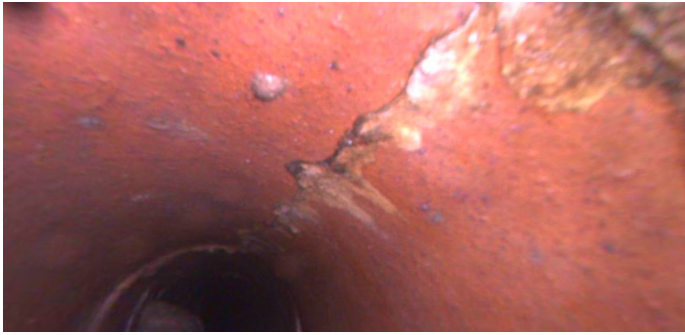
Code: **FL**
Description: **Fracture Longitudinal**

Distance (ft): **35.4**
Structural Grade: **3**
O&M Grade: **0**
Clock Start/From: **1**
Clock To:
1st Value:
2nd Value:
Value Percent:
Continuous Index:
Within 8" of Joint:
Remarks:

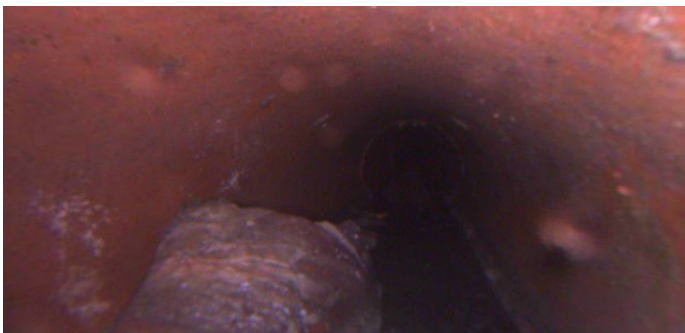
Code: **OBM**
Description: **Obstacle Pipe Material**

Distance (ft): **37.6**
Structural Grade: **0**
O&M Grade: **4**
Clock Start/From: **6**
Clock To: **9**
1st Value:
2nd Value:
Value Percent: **30.000**
Continuous Index:
Within 8" of Joint: **NO**
Remarks:

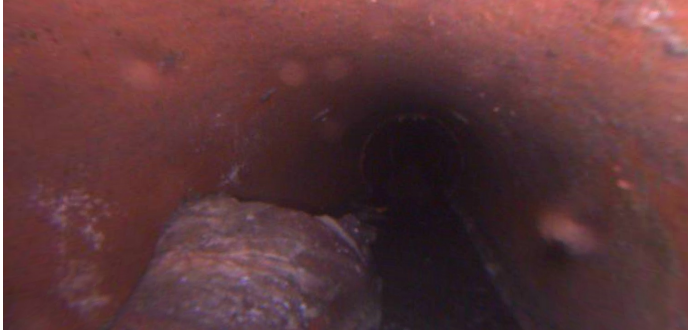
Code:	MSA
Description:	Abandoned Survey
Distance (ft):	37.6
Structural Grade:	0
O&M Grade:	0
Clock Start/From:	
Clock To:	
1st Value:	
2nd Value:	
Value Percent:	
Continuous Index:	
Within 8" of Joint:	NO
Remarks:	OBM
