Profile/Photo Observation Report

Date:	10/09/2018	Weather:		Coding:	PACP 6.0
Pipe Length (ft):	239.0	Owner:	NA	Pre Clean:	Not Known
P.O.#:		Surveyor:	Selasie Honu	PSR:	P-507-012-011
Customer:		Clean Date:	01/01/1900	Shape:	C

Street:	ALLEY BETWEEN S DELAWARE ST & S	Flow Control:	Not Controlled
City:	Hobart, IN	Year Renewed:	
Location:	Light Highway	Tape/Media #:	
Purpose:	Routine Assessment	Dia/Height:	12"
Use:	Sanitary	Material:	VCP
Drain Area:	NA	Lining:	
Category:	NA		
Comment:

Location Details:		Direction of Survey:	Downstream
US MH:	M-507-011	DS MH:	M-507-012
		Total Length Surveyed (ft):	3.3

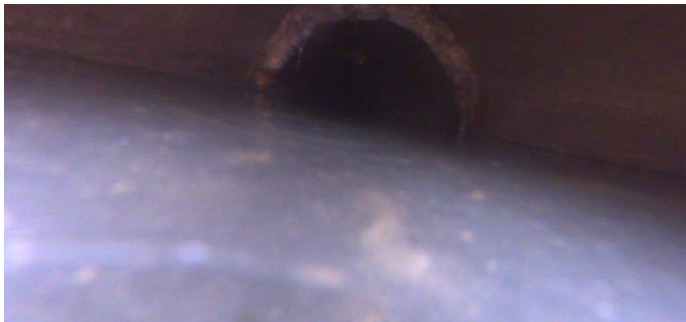
Code: **AMH**
Description: **Manhole**

Distance (ft): **.0**
Structural Grade: **0**
O&M Grade: **0**
Clock Start/From:
Clock To:
1st Value:
2nd Value:
Value Percent:
Continuous Index:
Within 8" of Joint: **NO**
Remarks: **M-507-011**

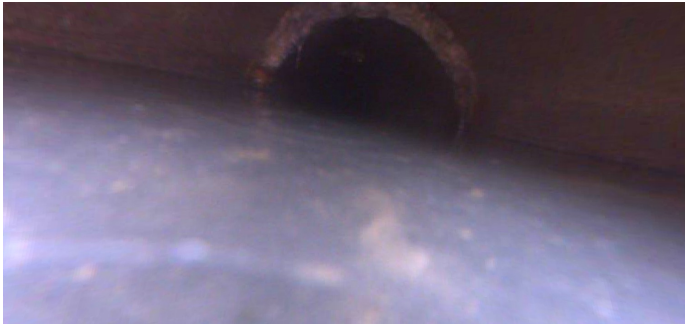
Code:	MWL
Description:	Water Level

Distance (ft):	.0
Structural Grade:	0
O&M Grade:	0
Clock Start/From:	
Clock To:	
1st Value:	
2nd Value:	
Value Percent:	5.000
Continuous Index:	
Within 8" of Joint:	NO
Remarks:

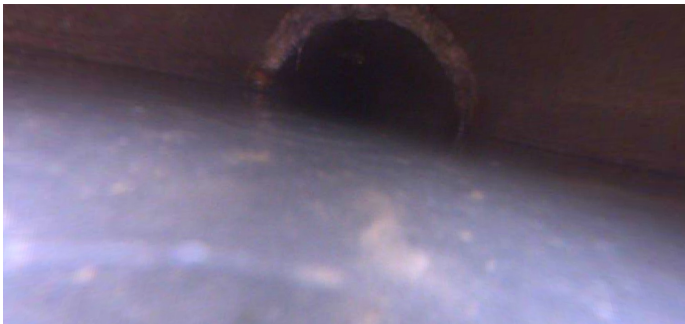
Code:	DAE
Description:	Deposits Attached Encrustation

Distance (ft):	.0
Structural Grade:	0
O&M Grade:	2
Clock Start/From:	9
Clock To:	3
1st Value:	
2nd Value:	
Value Percent:	10.000
Continuous Index:	
Within 8" of Joint:	YES
Remarks:

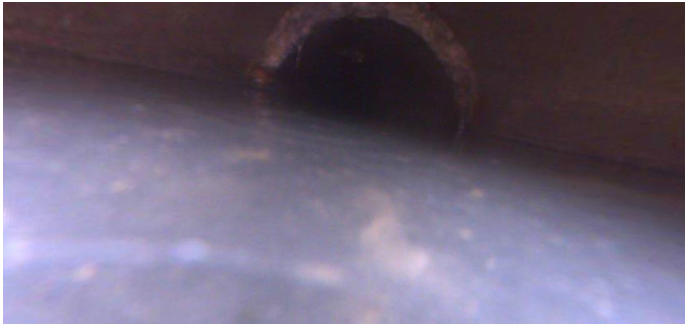
Code: **RFJ**
Description: **Roots Fine Joint**

Distance (ft): **.0**
Structural Grade: **0**
O&M Grade: **1**
Clock Start/From: **9**
Clock To: **3**
1st Value:
2nd Value:
Value Percent:
Continuous Index:
Within 8" of Joint: **YES**
Remarks:

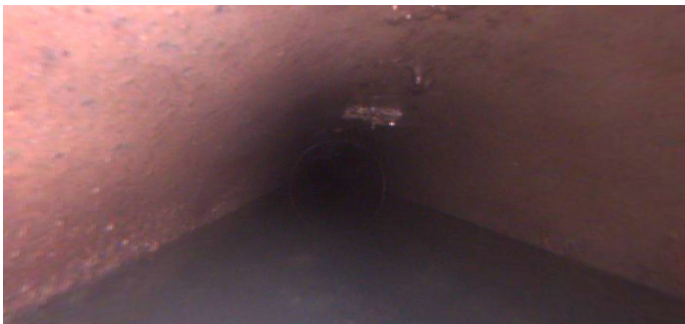
Code: **MSA**
Description: **Abandoned Survey**

Distance (ft): **3.3**
Structural Grade: **0**
O&M Grade: **0**
Clock Start/From:
Clock To:
1st Value:
2nd Value:
Value Percent:
Continuous Index:
Within 8" of Joint: **NO**
Remarks: **camera stopped**
