## Profile/Photo Observation Report

Street:	<b>ALLEY BETWEEN S DELAWARE ST &amp; S</b>	Flow Control:	<b>Not Controlled</b>
City:	<b>Hobart, IN</b>	Year Renewed:	
Location:	<b>Light Highway</b>	Tape/Media #:	
Purpose:	<b>Routine Assessment</b>	Dia/Height:	<b>12"</b>
Use:	<b>Sanitary</b>	Material:	<b>VCP</b>
Drain Area:	<b>NA</b>	Lining:	
Category:	<b>NA</b>		
Comment:

Location Details:		Direction of Survey:	<b>Upstream</b>
US MH:	<b>M-507-011</b>	DS MH:	<b>M-507-012</b>
		Total Length Surveyed (ft):	<b>36.6</b>

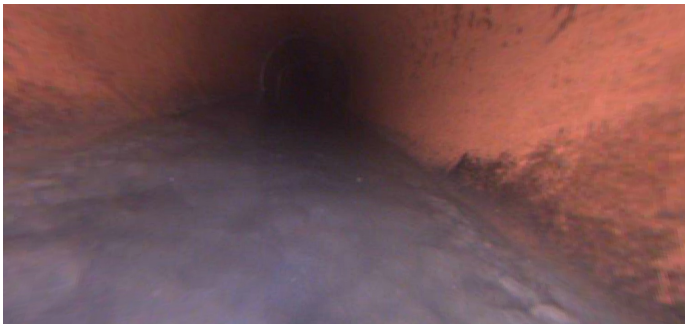
Code: **AMH**  
Description: **Manhole**

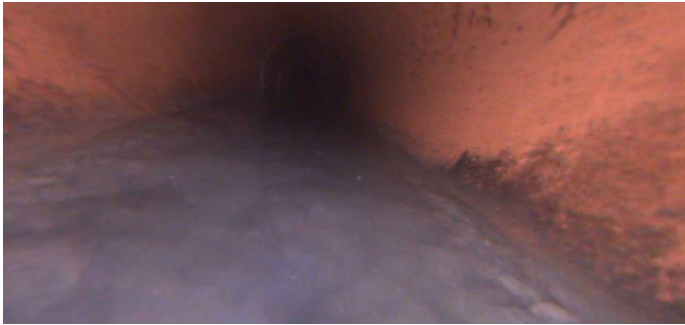
Code:	<b>MWL</b>
Description:	<b>Water Level</b>

Distance (ft):	<b>.0</b>
Structural Grade:	<b>0</b>
O&M Grade:	<b>0</b>
Clock Start/From:	
Clock To:	
1st Value:	
2nd Value:	
Value Percent:	<b>5.000</b>
Continuous Index:	
Within 8" of Joint:	<b>NO</b>
Remarks:

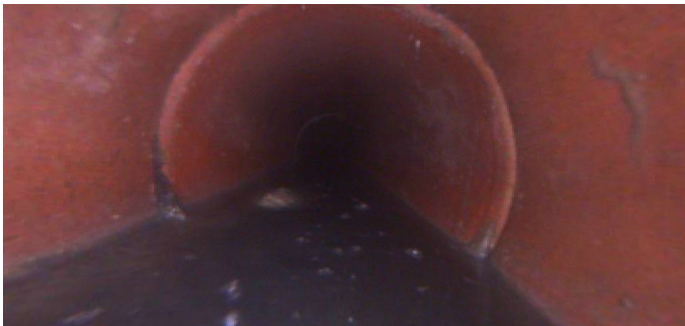
Code:	<b>RFJ</b>
Description:	<b>Roots Fine Joint</b>

Distance (ft):	<b>15.0</b>
Structural Grade:	<b>0</b>
O&M Grade:	<b>1</b>
Clock Start/From:	<b>8</b>
Clock To:	<b>9</b>
1st Value:	
2nd Value:	
Value Percent:	
Continuous Index:	
Within 8" of Joint:	<b>YES</b>
Remarks:

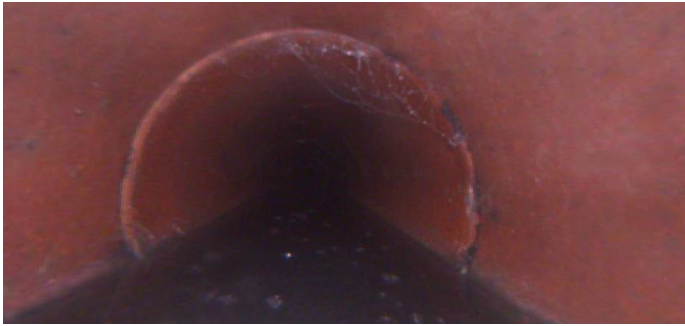
Code: **RFJ**  
Description: **Roots Fine Joint**

Distance (ft): **20.6**  
Structural Grade: **0**  
O&M Grade: **1**  
Clock Start/From: **8**  
Clock To: **4**  
1st Value:  
2nd Value:  
Value Percent:  
Continuous Index:  
Within 8" of Joint: **YES**  
Remarks:

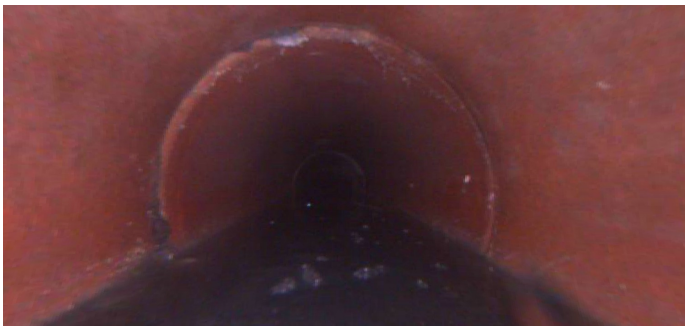
Code: **RFJ**  
Description: **Roots Fine Joint**

Distance (ft): **23.4**  
Structural Grade: **0**  
O&M Grade: **1**  
Clock Start/From: **8**  
Clock To: **4**  
1st Value:  
2nd Value:  
Value Percent:  
Continuous Index:  
Within 8" of Joint: **YES**  
Remarks:

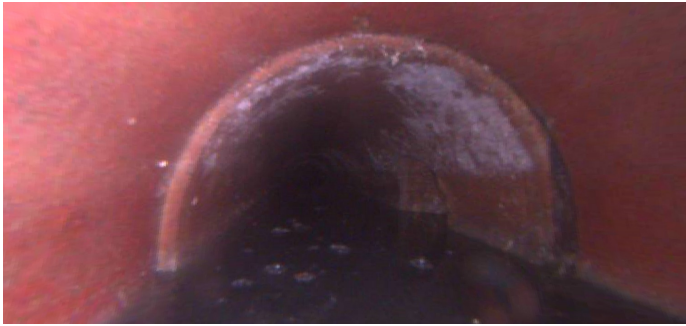
Code: **RFJ**  
Description: **Roots Fine Joint**

Distance (ft): **26.6**  
Structural Grade: **0**  
O&M Grade: **1**  
Clock Start/From: **12**  
Clock To: **4**  
1st Value:  
2nd Value:  
Value Percent:  
Continuous Index:  
Within 8" of Joint: **YES**  
Remarks:

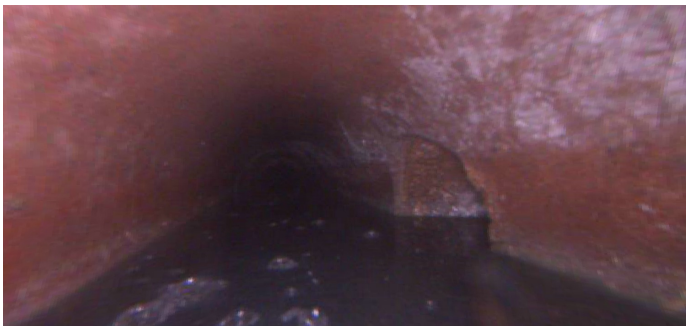
Code: **TF**  
Description: **Tap Factory**

Distance (ft): **27.1**  
Structural Grade: **0**  
O&M Grade: **0**  
Clock Start/From: **3**  
Clock To:  
1st Value: **4.000**  
2nd Value:  
Value Percent:  
Continuous Index:  
Within 8" of Joint:  
Remarks:

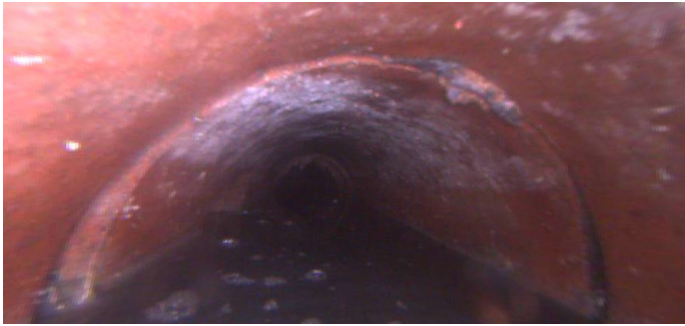
Code: **RFJ**  
Description: **Roots Fine Joint**

Distance (ft): **29.7**  
Structural Grade: **0**  
O&M Grade: **1**  
Clock Start/From: **8**  
Clock To: **4**  
1st Value:  
2nd Value:  
Value Percent:  
Continuous Index:  
Within 8" of Joint: **YES**  
Remarks:

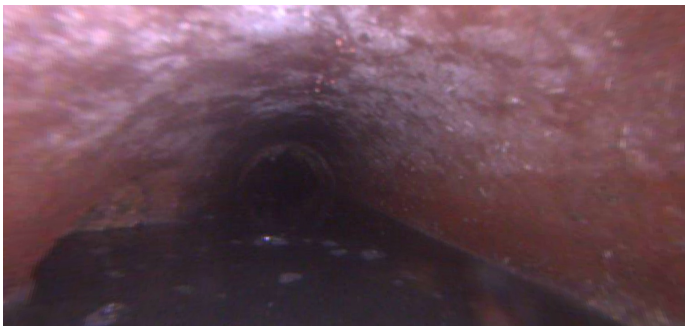
Code: **TF**  
Description: **Tap Factory**

Distance (ft): **30.1**  
Structural Grade: **0**  
O&M Grade: **0**  
Clock Start/From: **9**  
Clock To:  
1st Value: **4.000**  
2nd Value:  
Value Percent:  
Continuous Index:  
Within 8" of Joint:  
Remarks:

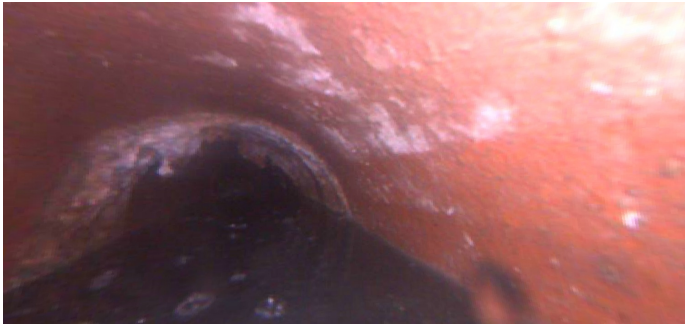
Code: **DAE**  
Description: **Deposits Attached Encrustation**

Distance (ft): **32.0**  
Structural Grade: **0**  
O&M Grade: **2**  
Clock Start/From: **8**  
Clock To: **4**  
1st Value:  
2nd Value:  
Value Percent: **10.000**  
Continuous Index:  
Within 8" of Joint: **YES**  
Remarks:

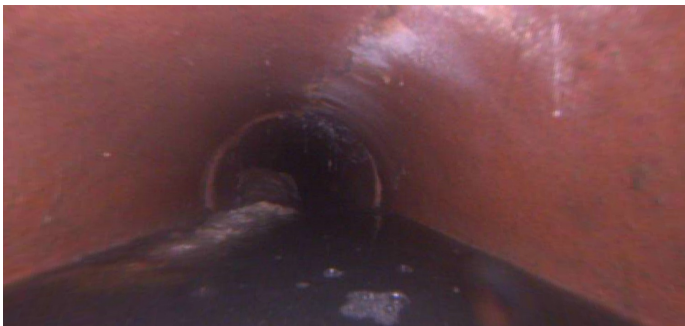
Code: **FL**  
Description: **Fracture Longitudinal**

Distance (ft): **34.5**  
Structural Grade: **3**  
O&M Grade: **0**  
Clock Start/From: **12**  
Clock To:  
1st Value:  
2nd Value:  
Value Percent:  
Continuous Index:  
Within 8" of Joint:  
Remarks:

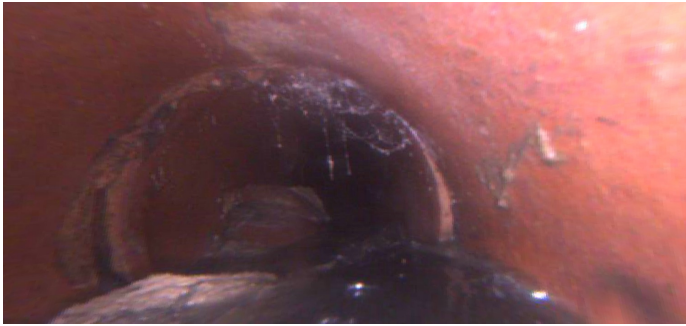
Code: **RFJ**  
Description: **Roots Fine Joint**

Distance (ft): **35.4**  
Structural Grade: **0**  
O&M Grade: **1**  
Clock Start/From: **8**  
Clock To: **4**  
1st Value:  
2nd Value:  
Value Percent:  
Continuous Index:  
Within 8" of Joint: **YES**  
Remarks:

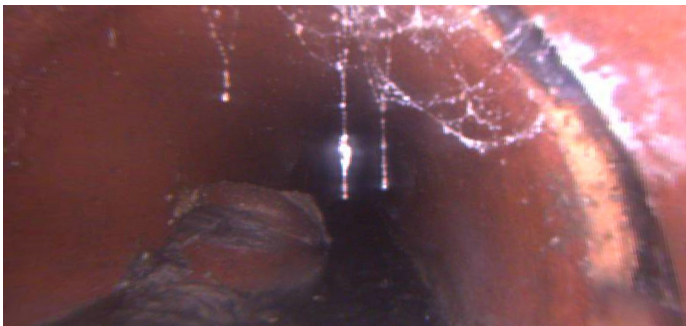
Code: **DSC**  
Description: **Deposits Settled Compacted**

Distance (ft): **35.9**  
Structural Grade: **0**  
O&M Grade: **3**  
Clock Start/From: **6**  
Clock To: **9**  
1st Value:  
2nd Value:  
Value Percent: **20.000**  
Continuous Index:  
Within 8" of Joint: **NO**  
Remarks:

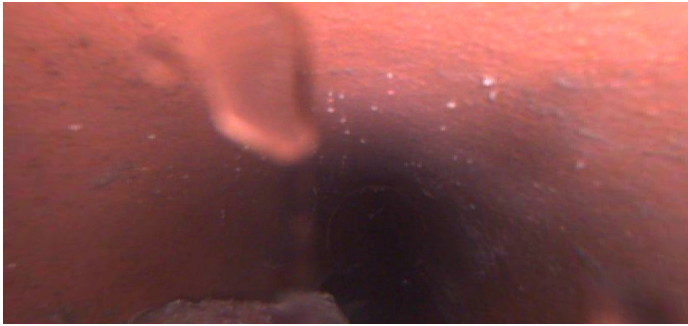
Code:	<b>MSA</b>
Description:	<b>Abandoned Survey</b>
Distance (ft):	<b>36.6</b>
Structural Grade:	<b>0</b>
O&M Grade:	<b>0</b>
Clock Start/From:	
Clock To:	
1st Value:	
2nd Value:	
Value Percent:	
Continuous Index:	
Within 8" of Joint:	<b>NO</b>
Remarks:	<b>obstacle</b>
