## Profile/Photo Observation Report

Street:	<b>Colorado St.</b>	Flow Control:	<b>Not Controlled</b>
City:	<b>Hobart, IN</b>	Year Renewed:	
Location:	<b>Light Highway</b>	Tape/Media #:	
Purpose:	<b>Routine Assessment</b>	Dia/Height:	<b>12"</b>
Use:	<b>Sanitary</b>	Material:	<b>VCP</b>
Drain Area:	<b>NA</b>	Lining:	
Category:	<b>NA</b>		
Comment:

Location Details:		Direction of Survey:	<b>Upstream</b>
US MH:	<b>M-507-011</b>	DS MH:	<b>M-507-012</b>
		Total Length Surveyed (ft):	<b>36.6</b>

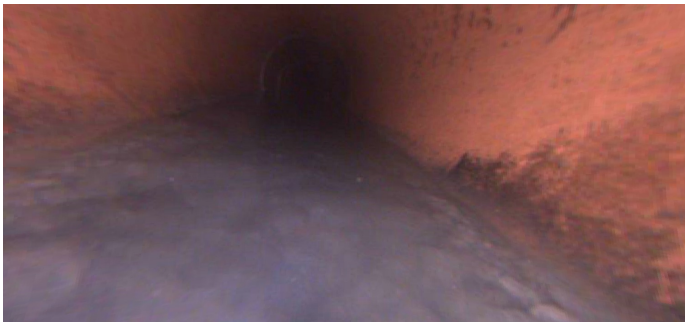
Code: **AMH**  
Description: **Manhole**

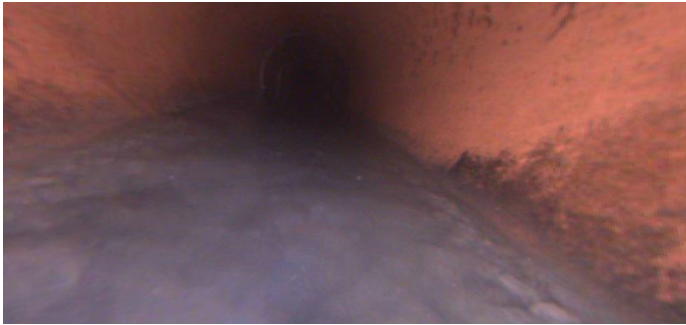
Code:	<b>MWL</b>
Description:	<b>Water Level</b>

Distance (ft):	<b>.0</b>
Structural Grade:	<b>0</b>
O&M Grade:	<b>0</b>
Clock Start/From:	
Clock To:	
1st Value:	
2nd Value:	
Value Percent:	<b>5.000</b>
Continuous Index:	
Within 8" of Joint:	<b>NO</b>
Remarks:

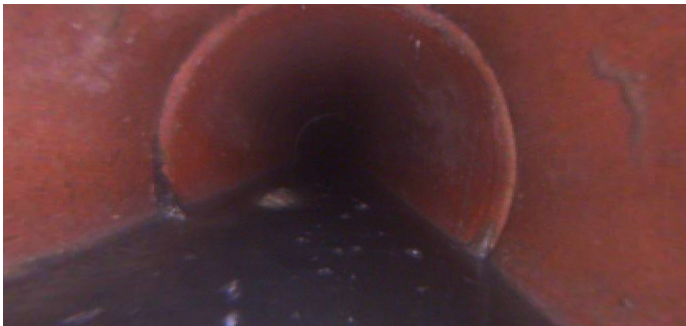
Code:	<b>RFJ</b>
Description:	<b>Roots Fine Joint</b>

Distance (ft):	<b>15.0</b>
Structural Grade:	<b>0</b>
O&M Grade:	<b>1</b>
Clock Start/From:	<b>8</b>
Clock To:	<b>9</b>
1st Value:	
2nd Value:	
Value Percent:	
Continuous Index:	
Within 8" of Joint:	<b>YES</b>
Remarks:

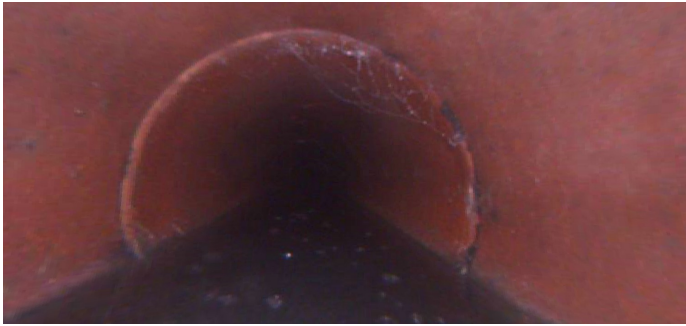
Code: **RFJ**  
Description: **Roots Fine Joint**

Distance (ft): **20.6**  
Structural Grade: **0**  
O&M Grade: **1**  
Clock Start/From: **8**  
Clock To: **4**  
1st Value:  
2nd Value:  
Value Percent:  
Continuous Index:  
Within 8" of Joint: **YES**  
Remarks:

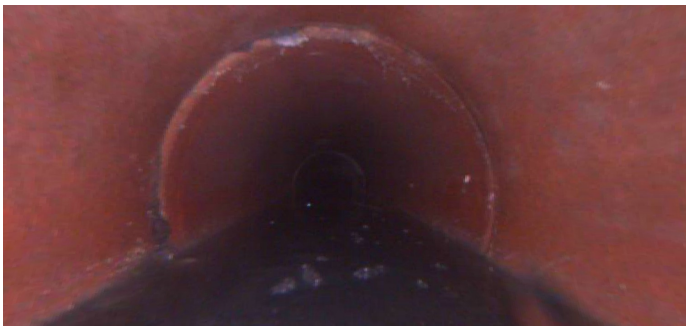
Code: **RFJ**  
Description: **Roots Fine Joint**

Distance (ft): **23.4**  
Structural Grade: **0**  
O&M Grade: **1**  
Clock Start/From: **8**  
Clock To: **4**  
1st Value:  
2nd Value:  
Value Percent:  
Continuous Index:  
Within 8" of Joint: **YES**  
Remarks:

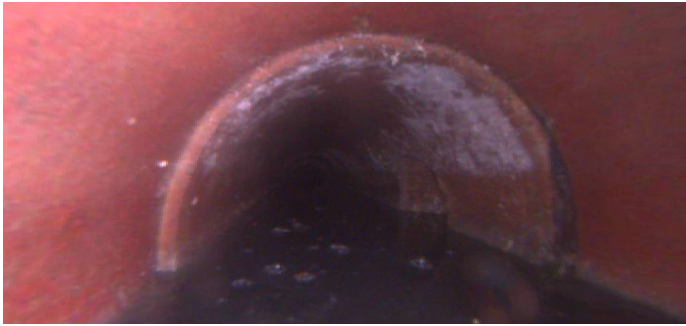
Code: **RFJ**  
Description: **Roots Fine Joint**

Distance (ft): **26.6**  
Structural Grade: **0**  
O&M Grade: **1**  
Clock Start/From: **12**  
Clock To: **4**  
1st Value:  
2nd Value:  
Value Percent:  
Continuous Index:  
Within 8" of Joint: **YES**  
Remarks:

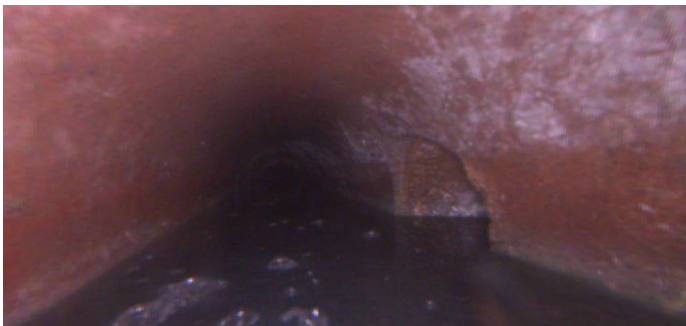
Code: **TF**  
Description: **Tap Factory**

Distance (ft): **27.1**  
Structural Grade: **0**  
O&M Grade: **0**  
Clock Start/From: **3**  
Clock To:  
1st Value: **4.000**  
2nd Value:  
Value Percent:  
Continuous Index:  
Within 8" of Joint:  
Remarks:

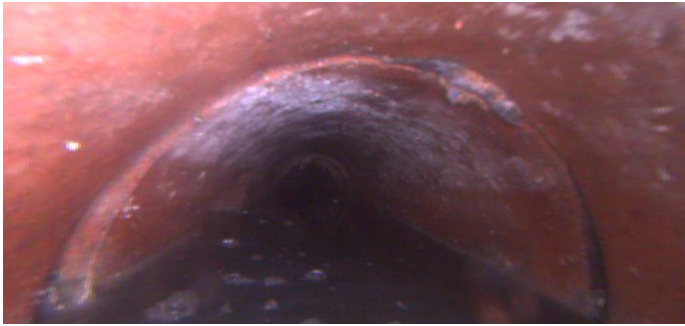
Code: **RFJ**  
Description: **Roots Fine Joint**

Distance (ft): **29.7**  
Structural Grade: **0**  
O&M Grade: **1**  
Clock Start/From: **8**  
Clock To: **4**  
1st Value:  
2nd Value:  
Value Percent:  
Continuous Index:  
Within 8" of Joint: **YES**  
Remarks:

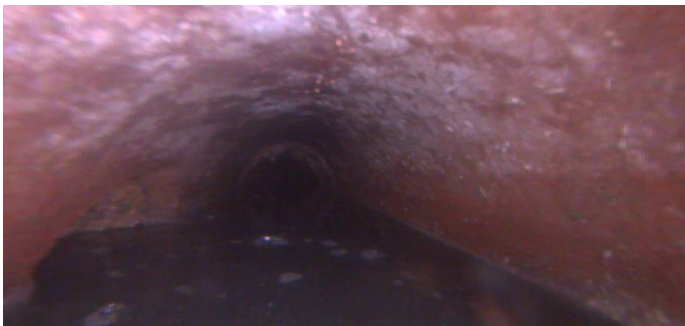
Code: **TF**  
Description: **Tap Factory**

Distance (ft): **30.1**  
Structural Grade: **0**  
O&M Grade: **0**  
Clock Start/From: **9**  
Clock To:  
1st Value: **4.000**  
2nd Value:  
Value Percent:  
Continuous Index:  
Within 8" of Joint:  
Remarks:

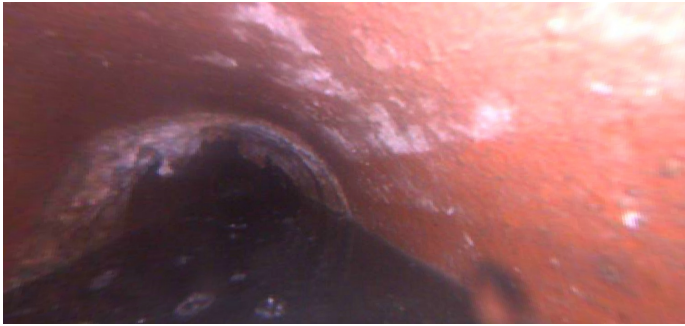
Code: **DAE**  
Description: **Deposits Attached Encrustation**

Distance (ft): **32.0**  
Structural Grade: **0**  
O&M Grade: **2**  
Clock Start/From: **8**  
Clock To: **4**  
1st Value:  
2nd Value:  
Value Percent: **10.000**  
Continuous Index:  
Within 8" of Joint: **YES**  
Remarks:

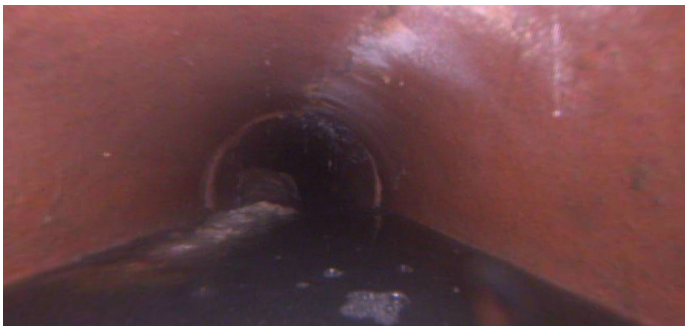
Code: **FL**  
Description: **Fracture Longitudinal**

Distance (ft): **34.5**  
Structural Grade: **3**  
O&M Grade: **0**  
Clock Start/From: **12**  
Clock To:  
1st Value:  
2nd Value:  
Value Percent:  
Continuous Index:  
Within 8" of Joint:  
Remarks:

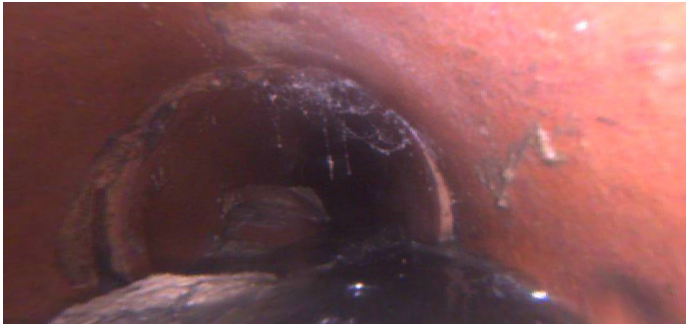
Code: **RFJ**  
Description: **Roots Fine Joint**

Distance (ft): **35.4**  
Structural Grade: **0**  
O&M Grade: **1**  
Clock Start/From: **8**  
Clock To: **4**  
1st Value:  
2nd Value:  
Value Percent:  
Continuous Index:  
Within 8" of Joint: **YES**  
Remarks:

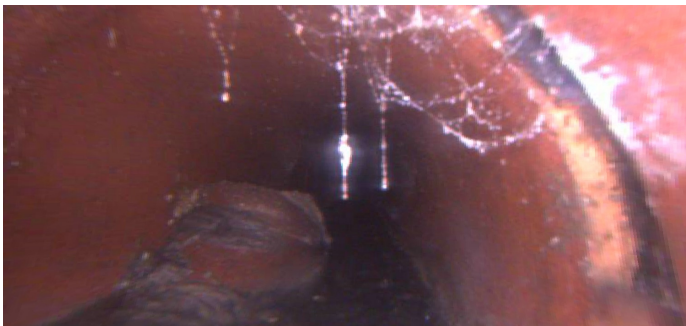
Code: **DSC**  
Description: **Deposits Settled Compacted**

Distance (ft): **35.9**  
Structural Grade: **0**  
O&M Grade: **3**  
Clock Start/From: **6**  
Clock To: **9**  
1st Value:  
2nd Value:  
Value Percent: **20.000**  
Continuous Index:  
Within 8" of Joint: **NO**  
Remarks:

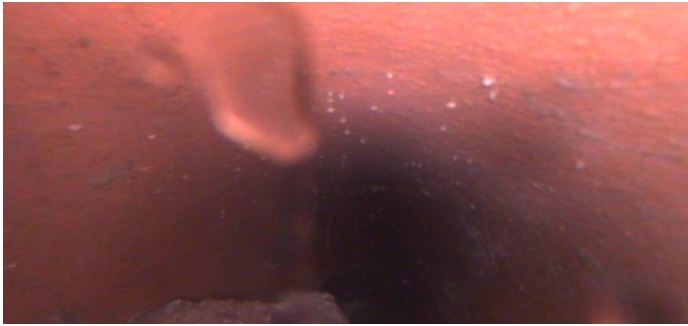
Code:	<b>MSA</b>
Description:	<b>Abandoned Survey</b>
Distance (ft):	<b>36.6</b>
Structural Grade:	<b>0</b>
O&M Grade:	<b>0</b>
Clock Start/From:	
Clock To:	
1st Value:	
2nd Value:	
Value Percent:	
Continuous Index:	
Within 8" of Joint:	<b>NO</b>
Remarks:	<b>obstacle</b>
