## Profile/Photo Observation Report

Date:	<b>03/29/2018</b>	Weather:		Coding:	<b>PACP 6.0</b>
Pipe Length (ft):	<b>208.6</b>	Owner:	<b>NA</b>	Pre Clean:	<b>No Pre-Cleaning</b>
P.O.#:		Surveyor:	<b>Jen Costello</b>	PSR:	<b>P-507-013-012</b>
Customer:		Clean Date:	<b>01/01/1900</b>	Shape:	<b>C</b>

Street:	<b>CSOKASY LN</b>	Flow Control:	<b>Not Controlled</b>
City:	<b>Hobart, IN</b>	Year Renewed:	
Location:	<b>Yard</b>	Tape/Media #:	
Purpose:	<b>Routine Assessment</b>	Dia/Height:	<b>12"</b>
Use:	<b>Sanitary</b>	Material:	<b>VCP</b>
Drain Area:	<b>NA</b>	Lining:	
Category:	<b>NA</b>		
Comment:	<b>F_S_P_C at 1 ft debris / CU . Flow direction wrong</b>		
Location Details:		Direction of Survey:	<b>Downstream</b>
US MH:	<b>M-507-012</b>	DS MH:	<b>M-507-013</b>
		Total Length Surveyed (ft):	<b>2.8</b>

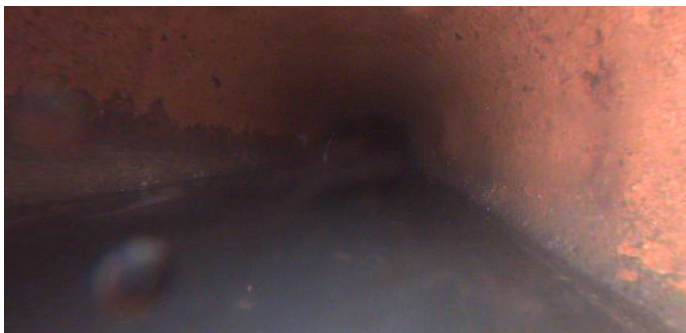
Code: **AMH**  
Description: **Manhole**

Distance (ft): **.0**  
Structural Grade: **0**  
O&M Grade: **0**  
Clock Start/From:  
Clock To:  
1st Value:  
2nd Value:  
Value Percent:  
Continuous Index:  
Within 8" of Joint: **NO**  
Remarks: **M-507-012**

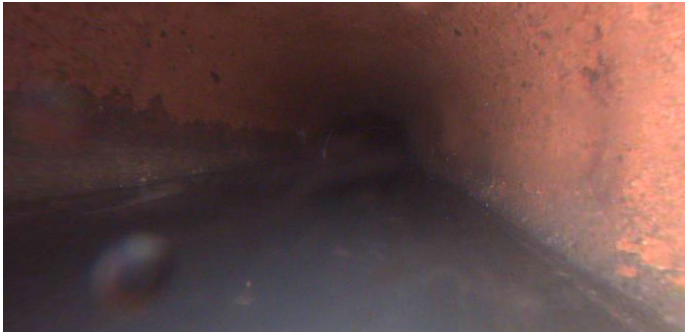
Code:	<b>MWL</b>
Description:	<b>Water Level</b>

Distance (ft):	<b>.0</b>
Structural Grade:	<b>0</b>
O&M Grade:	<b>0</b>
Clock Start/From:	
Clock To:	
1st Value:	
2nd Value:	
Value Percent:	<b>30.000</b>
Continuous Index:	
Within 8" of Joint:	<b>NO</b>
Remarks:

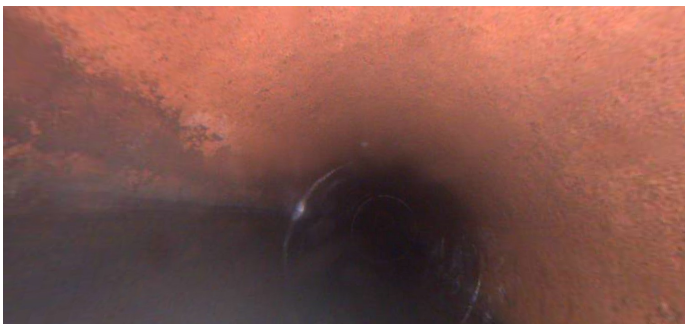
Code:	<b>MSA</b>
Description:	<b>Abandoned Survey</b>

Distance (ft):	<b>2.8</b>
Structural Grade:	<b>0</b>
O&M Grade:	<b>0</b>
Clock Start/From:	
Clock To:	
1st Value:	
2nd Value:	
Value Percent:	
Continuous Index:	
Within 8" of Joint:	<b>NO</b>
Remarks:	<b>overturned</b>
