## Profile/Photo Observation Report

Street:	<b>FOXCROFT STREET</b>	Flow Control:	<b>Not Controlled</b>
City:	<b>Hobart, IN</b>	Year Renewed:	
Location:	<b>Yard</b>	Tape/Media #:	
Purpose:	<b>Routine Assessment</b>	Dia/Height:	<b>12"</b>
Use:	<b>Sanitary</b>	Material:	<b>VCP</b>
Drain Area:	<b>NA</b>	Lining:	
Category:	<b>NA</b>		
Comment:	<b>F_S_P_C at 1 ft debris / CU . Flow direction wrong</b>		
Location Details:		Direction of Survey:	<b>Downstream</b>
US MH:	<b>M-507-012</b>	DS MH:	<b>M-507-013</b>
		Total Length Surveyed (ft):	<b>2.8</b>

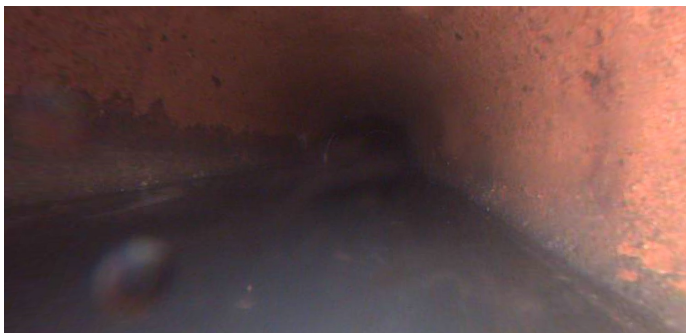
Code: **AMH**  
Description: **Manhole**

Distance (ft): **.0**  
Structural Grade: **0**  
O&M Grade: **0**  
Clock Start/From:  
Clock To:  
1st Value:  
2nd Value:  
Value Percent:  
Continuous Index:  
Within 8" of Joint: **NO**  
Remarks: **M-507-012**

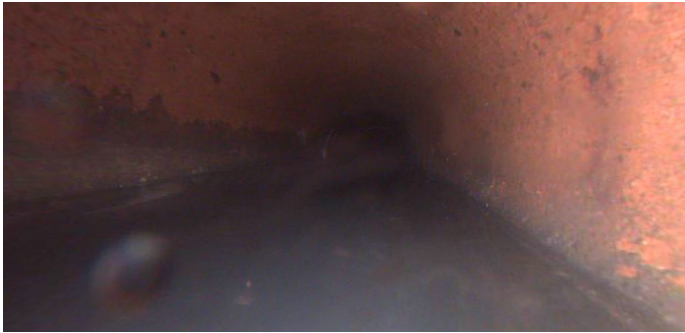
Code:	<b>MWL</b>
Description:	<b>Water Level</b>

Distance (ft):	<b>.0</b>
Structural Grade:	<b>0</b>
O&M Grade:	<b>0</b>
Clock Start/From:	
Clock To:	
1st Value:	
2nd Value:	
Value Percent:	<b>30.000</b>
Continuous Index:	
Within 8" of Joint:	<b>NO</b>
Remarks:

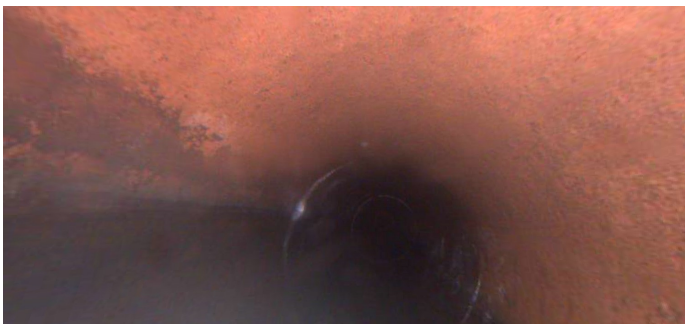
Code:	<b>MSA</b>
Description:	<b>Abandoned Survey</b>

Distance (ft):	<b>2.8</b>
Structural Grade:	<b>0</b>
O&M Grade:	<b>0</b>
Clock Start/From:	
Clock To:	
1st Value:	
2nd Value:	
Value Percent:	
Continuous Index:	
Within 8" of Joint:	<b>NO</b>
Remarks:	<b>overturned</b>
