Profile/Photo Observation Report

Date:	03/29/2018	Weather:		Coding:	PACP 6.0
Pipe Length (ft):	208.6	Owner:	NA	Pre Clean:	No Pre-Cleaning
P.O.#:		Surveyor:	Jen Costello	PSR:	P-507-013-012
Customer:		Clean Date:	01/01/1900	Shape:	C

Street:	CSOKASY LN	Flow Control:	Not Controlled
City:	Hobart, IN	Year Renewed:	
Location:	Yard	Tape/Media #:	
Purpose:	Routine Assessment	Dia/Height:	12"
Use:	Sanitary	Material:	VCP
Drain Area:	NA	Lining:	
Category:	NA		
Comment:	R_M at 24 ft debris . Flow direction wrong		
Location Details:		Direction of Survey:	Upstream
US MH:	M-507-012	DS MH:	M-507-013
		Total Length Surveyed (ft):	25.9

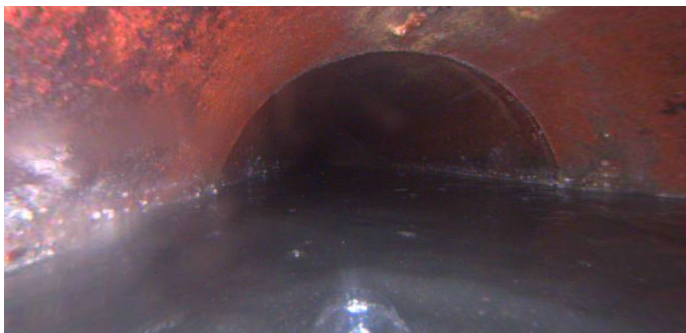
Code: **AMH**
Description: **Manhole**

Distance (ft): **.0**
Structural Grade: **0**
O&M Grade: **0**
Clock Start/From:
Clock To:
1st Value:
2nd Value:
Value Percent:
Continuous Index:
Within 8" of Joint: **NO**
Remarks: **M-507-013**

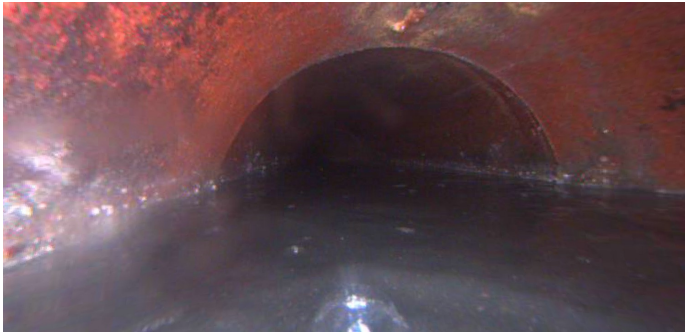
Code:	MWL
Description:	Water Level

Distance (ft):	.0
Structural Grade:	0
O&M Grade:	0
Clock Start/From:	
Clock To:	
1st Value:	
2nd Value:	
Value Percent:	40.000
Continuous Index:	
Within 8" of Joint:	NO
Remarks:

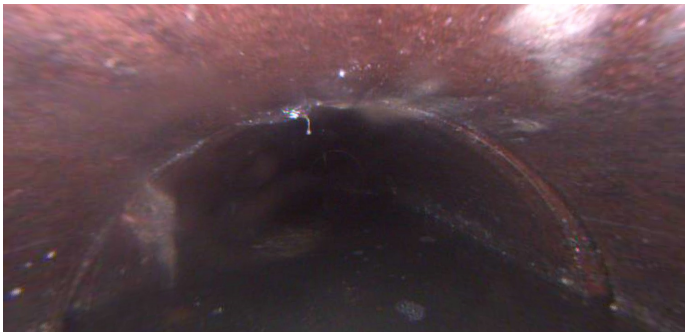
Code:	RFJ
Description:	Roots Fine Joint

Distance (ft):	13.4
Structural Grade:	0
O&M Grade:	1
Clock Start/From:	10
Clock To:	
1st Value:	
2nd Value:	
Value Percent:	
Continuous Index:	
Within 8" of Joint:	YES
Remarks:

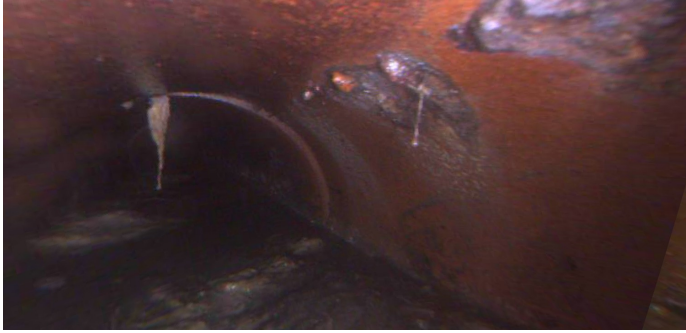
Code: **CL**
Description: **Crack Longitudinal**

Distance (ft): **16.9**
Structural Grade: **2**
O&M Grade: **0**
Clock Start/From: **1**
Clock To:
1st Value:
2nd Value:
Value Percent:
Continuous Index:
Within 8" of Joint:
Remarks:

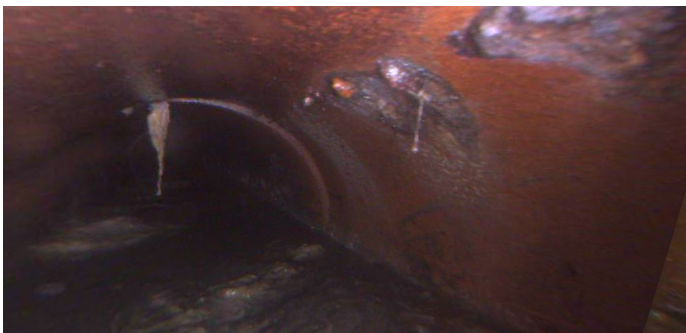
Code: **DAE**
Description: **Deposits Attached Encrustation**

Distance (ft): **16.9**
Structural Grade: **0**
O&M Grade: **2**
Clock Start/From: **1**
Clock To:
1st Value:
2nd Value:
Value Percent: **5.000**
Continuous Index:
Within 8" of Joint: **NO**
Remarks:

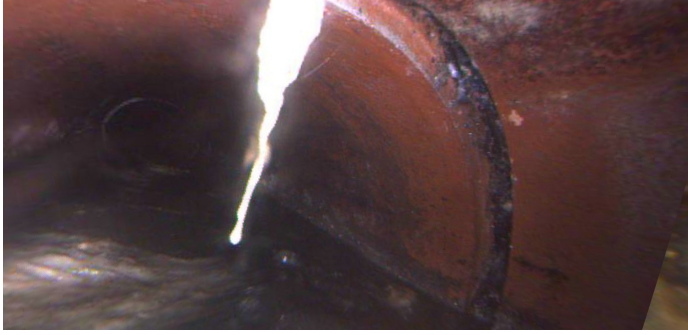
Code:	DAR
Description:	Deposits Attached Ragging
Distance (ft):	17.6
Structural Grade:	0
O&M Grade:	2
Clock Start/From:	12
Clock To:	
1st Value:	
2nd Value:	
Value Percent:	5.000
Continuous Index:	
Within 8" of Joint:	NO
Remarks:

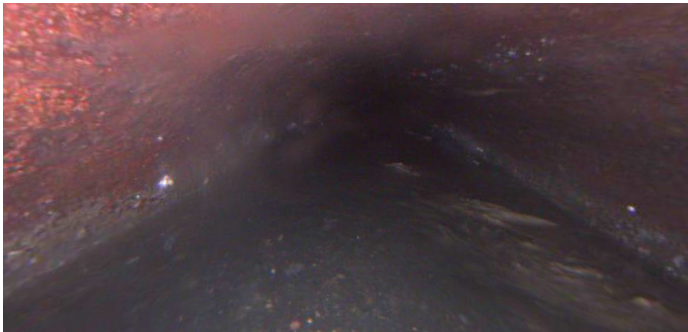
Code:	MSA
Description:	Abandoned Survey
Distance (ft):	25.9
Structural Grade:	0
O&M Grade:	0
Clock Start/From:	
Clock To:	
1st Value:	
2nd Value:	
Value Percent:	
Continuous Index:	
Within 8" of Joint:	NO
Remarks:	DEBRIS UNDER WATER
