Profile/Photo Observation Report

Date:	03/29/2018	Weather:		Coding:	PACP 6.0
Pipe Length (ft):	208.6	Owner:	NA	Pre Clean:	No Pre-Cleaning
P.O.#:		Surveyor:	Jen Costello	PSR:	P-507-013-012
Customer:		Clean Date:	01/01/1900	Shape:	C

Street:	FOXCROFT STREET	Flow Control:	Not Controlled
City:	Hobart, IN	Year Renewed:	
Location:	Yard	Tape/Media #:	
Purpose:	Routine Assessment	Dia/Height:	12"
Use:	Sanitary	Material:	VCP
Drain Area:	NA	Lining:	
Category:	NA		
Comment:	R_M at 24 ft debris . Flow direction wrong		
Location Details:		Direction of Survey:	Upstream
US MH:	M-507-012	DS MH:	M-507-013
		Total Length Surveyed (ft):	25.9

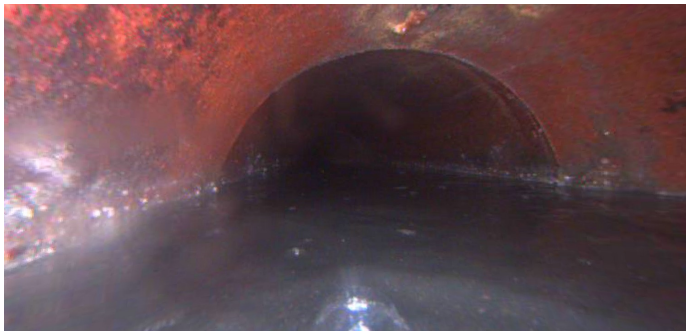
Code: **AMH**
Description: **Manhole**

Distance (ft): **.0**
Structural Grade: **0**
O&M Grade: **0**
Clock Start/From:
Clock To:
1st Value:
2nd Value:
Value Percent:
Continuous Index:
Within 8" of Joint: **NO**
Remarks: **M-507-013**

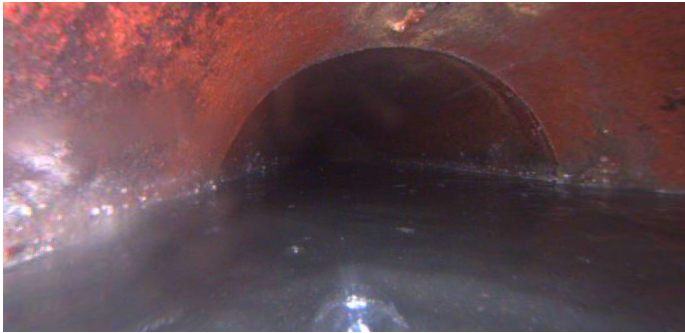
Code:	MWL
Description:	Water Level

Distance (ft):	.0
Structural Grade:	0
O&M Grade:	0
Clock Start/From:	
Clock To:	
1st Value:	
2nd Value:	
Value Percent:	40.000
Continuous Index:	
Within 8" of Joint:	NO
Remarks:

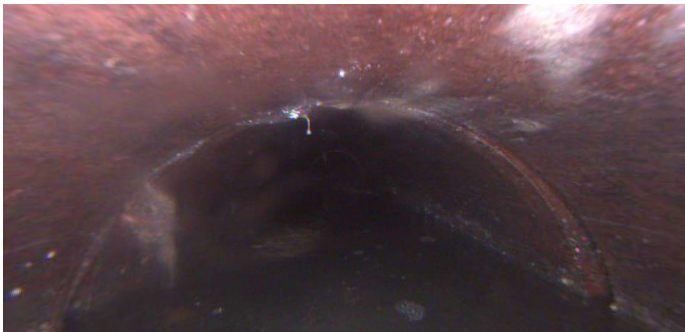
Code:	RFJ
Description:	Roots Fine Joint

Distance (ft):	13.4
Structural Grade:	0
O&M Grade:	1
Clock Start/From:	10
Clock To:	
1st Value:	
2nd Value:	
Value Percent:	
Continuous Index:	
Within 8" of Joint:	YES
Remarks:

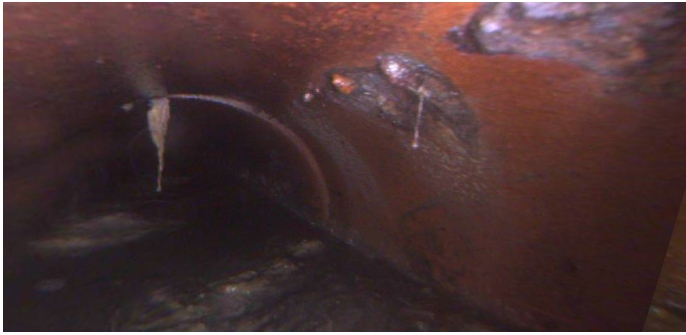
Code: **CL**
Description: **Crack Longitudinal**

Distance (ft): **16.9**
Structural Grade: **2**
O&M Grade: **0**
Clock Start/From: **1**
Clock To:
1st Value:
2nd Value:
Value Percent:
Continuous Index:
Within 8" of Joint:
Remarks:

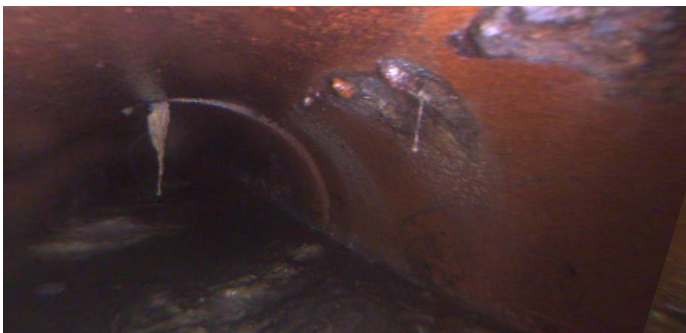
Code: **DAE**
Description: **Deposits Attached Encrustation**

Distance (ft): **16.9**
Structural Grade: **0**
O&M Grade: **2**
Clock Start/From: **1**
Clock To:
1st Value:
2nd Value:
Value Percent: **5.000**
Continuous Index:
Within 8" of Joint: **NO**
Remarks:

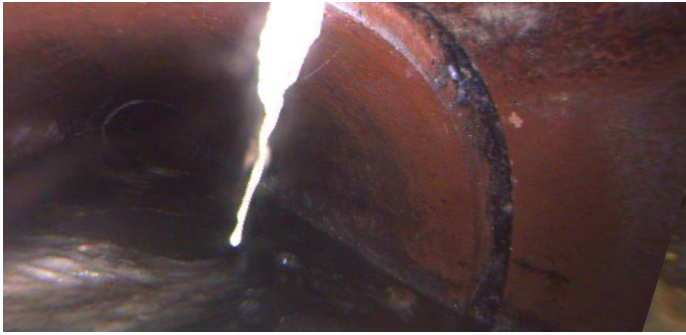
Code: **DAR**
Description: **Deposits Attached Ragging**

Distance (ft): **17.6**
Structural Grade: **0**
O&M Grade: **2**
Clock Start/From: **12**
Clock To:
1st Value:
2nd Value:
Value Percent: **5.000**
Continuous Index:
Within 8" of Joint: **NO**
Remarks:

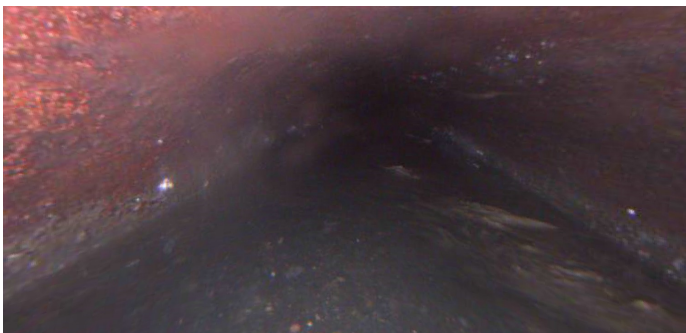
Code: **MSA**
Description: **Abandoned Survey**

Distance (ft): **25.9**
Structural Grade: **0**
O&M Grade: **0**
Clock Start/From:
Clock To:
1st Value:
2nd Value:
Value Percent:
Continuous Index:
Within 8" of Joint: **NO**
Remarks: **DEBRIS UNDER WATER**
