## Profile/Photo Observation Report

Date:	<b>10/08/2018</b>	Weather:		Coding:	<b>PACP 6.0</b>
Pipe Length (ft):	<b>208.6</b>	Owner:	<b>NA</b>	Pre Clean:	<b>Not Known</b>
P.O.#:		Surveyor:	<b>Selasie Honu</b>	PSR:	<b>P-507-013-012</b>
Customer:		Clean Date:	<b>01/01/1900</b>	Shape:	<b>C</b>

Location Details:		Direction of Survey:	<b>Upstream</b>
US MH:	<b>M-507-012</b>	DS MH:	<b>M-507-013</b>
		Total Length Surveyed (ft):	<b>3.2</b>

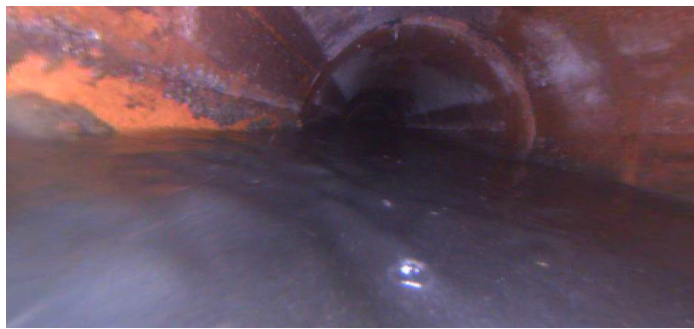
Code: **AMH**  
Description: **Manhole**

Distance (ft): **.0**  
Structural Grade: **0**  
O&M Grade: **0**  
Clock Start/From:  
Clock To:  
1st Value:  
2nd Value:  
Value Percent:  
Continuous Index:  
Within 8" of Joint: **NO**  
Remarks: **M-507-013**

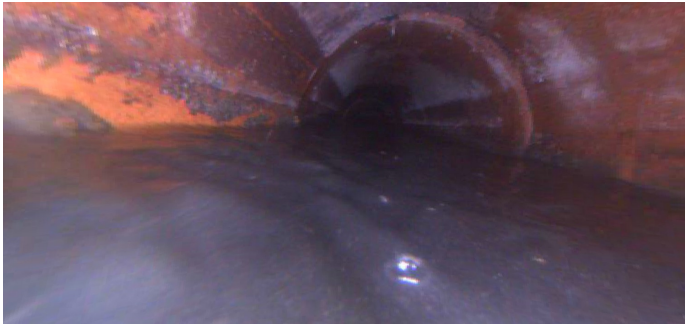
Code:	<b>MWL</b>
Description:	<b>Water Level</b>

Distance (ft):	<b>.0</b>
Structural Grade:	<b>0</b>
O&M Grade:	<b>0</b>
Clock Start/From:	
Clock To:	
1st Value:	
2nd Value:	
Value Percent:	<b>5.000</b>
Continuous Index:	
Within 8" of Joint:	<b>NO</b>
Remarks:
