## Profile/Photo Observation Report

Date:	<b>10/08/2018</b>	Weather:		Coding:	<b>PACP 6.0</b>
Pipe Length (ft):	<b>208.6</b>	Owner:	<b>NA</b>	Pre Clean:	<b>Not Known</b>
P.O.#:		Surveyor:	<b>Selasie Honu</b>	PSR:	<b>P-507-013-012</b>
Customer:		Clean Date:	<b>01/01/1900</b>	Shape:	<b>C</b>

Street:	<b>CSOKASY LN</b>	Flow Control:	<b>Not Controlled</b>
City:	<b>Hobart, IN</b>	Year Renewed:	
Location:	<b>Light Highway</b>	Tape/Media #:	
Purpose:	<b>Routine Assessment</b>	Dia/Height:	<b>12"</b>
Use:	<b>Sanitary</b>	Material:	<b>VCP</b>
Drain Area:	<b>NA</b>	Lining:	
Category:	<b>NA</b>		
Comment:

Location Details:		Direction of Survey:	<b>Upstream</b>
US MH:	<b>M-507-012</b>	DS MH:	<b>M-507-013</b>
		Total Length Surveyed (ft):	<b>4.9</b>

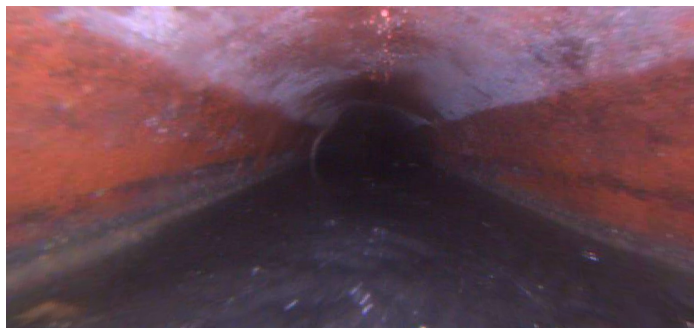
Code: **AMH**  
Description: **Manhole**

Distance (ft): **.0**  
Structural Grade: **0**  
O&M Grade: **0**  
Clock Start/From:  
Clock To:  
1st Value:  
2nd Value:  
Value Percent:  
Continuous Index:  
Within 8" of Joint: **NO**  
Remarks: **M-507-013**

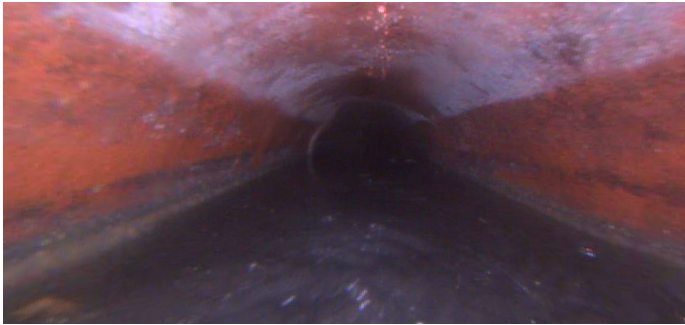
Code:	<b>MWL</b>
Description:	<b>Water Level</b>

Distance (ft):	<b>.0</b>
Structural Grade:	<b>0</b>
O&M Grade:	<b>0</b>
Clock Start/From:	
Clock To:	
1st Value:	
2nd Value:	
Value Percent:	<b>5.000</b>
Continuous Index:	
Within 8" of Joint:	<b>NO</b>
Remarks:

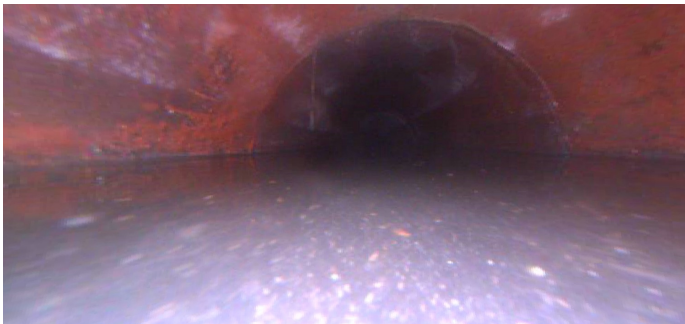
Code:	<b>MSA</b>
Description:	<b>Abandoned Survey</b>

Distance (ft):	<b>4.9</b>
Structural Grade:	<b>0</b>
O&M Grade:	<b>0</b>
Clock Start/From:	
Clock To:	
1st Value:	
2nd Value:	
Value Percent:	
Continuous Index:	
Within 8" of Joint:	<b>NO</b>
Remarks:	<b>camera stopped</b>
