## Profile/Photo Observation Report

Street:	<b>Csokasy Ln.</b>	Flow Control:	<b>Not Controlled</b>
City:	<b>Hobart, IN</b>	Year Renewed:	
Location:	<b>Light Highway</b>	Tape/Media #:	
Purpose:	<b>Routine Assessment</b>	Dia/Height:	<b>12"</b>
Use:	<b>Sanitary</b>	Material:	<b>VCP</b>
Drain Area:	<b>NA</b>	Lining:	
Category:	<b>NA</b>		
Comment:

Location Details:		Direction of Survey:	<b>Upstream</b>
US MH:	<b>M-507-012</b>	DS MH:	<b>M-507-013</b>
		Total Length Surveyed (ft):	<b>4.9</b>

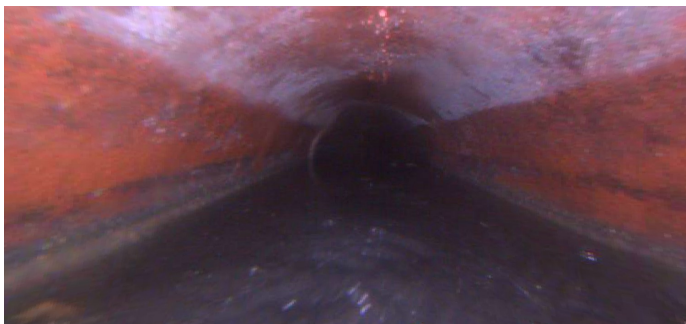
Code: **AMH**  
Description: **Manhole**

Distance (ft): **.0**  
Structural Grade: **0**  
O&M Grade: **0**  
Clock Start/From:  
Clock To:  
1st Value:  
2nd Value:  
Value Percent:  
Continuous Index:  
Within 8" of Joint: **NO**  
Remarks: **M-507-013**

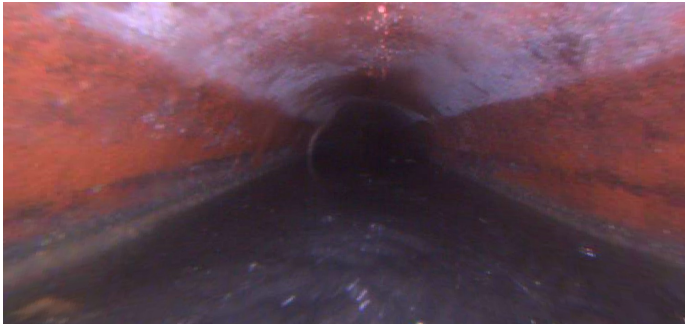
Code:	<b>MWL</b>
Description:	<b>Water Level</b>

Distance (ft):	<b>.0</b>
Structural Grade:	<b>0</b>
O&M Grade:	<b>0</b>
Clock Start/From:	
Clock To:	
1st Value:	
2nd Value:	
Value Percent:	<b>5.000</b>
Continuous Index:	
Within 8" of Joint:	<b>NO</b>
Remarks:

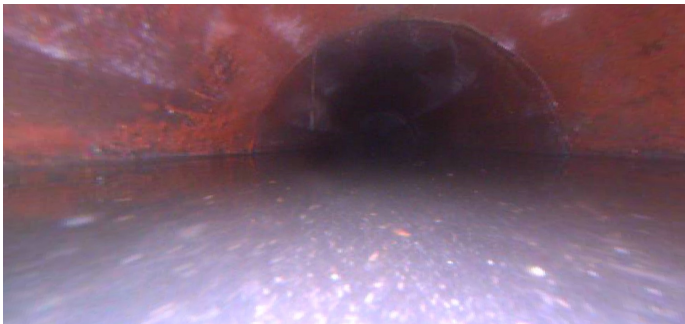
Code:	<b>MSA</b>
Description:	<b>Abandoned Survey</b>

Distance (ft):	<b>4.9</b>
Structural Grade:	<b>0</b>
O&M Grade:	<b>0</b>
Clock Start/From:	
Clock To:	
1st Value:	
2nd Value:	
Value Percent:	
Continuous Index:	
Within 8" of Joint:	<b>NO</b>
Remarks:	<b>camera stopped</b>
