Profile/Photo Observation Report

Street:	FOXCROFT STREET	Flow Control:	Not Controlled
City:	Hobart, IN	Year Renewed:	
Location:	Yard	Tape/Media #:	
Purpose:	Not Known	Dia/Height:	10"
Use:	Sanitary	Material:	VCP
Drain Area:	NA	Lining:	
Category:	NA		
Comment:	P_C at 50 ft nothing visible . Flow direction wrong		
Location Details:		Direction of Survey:	Downstream
US MH:	M-507-013	DS MH:	M-507-014
		Total Length Surveyed (ft):	51.8

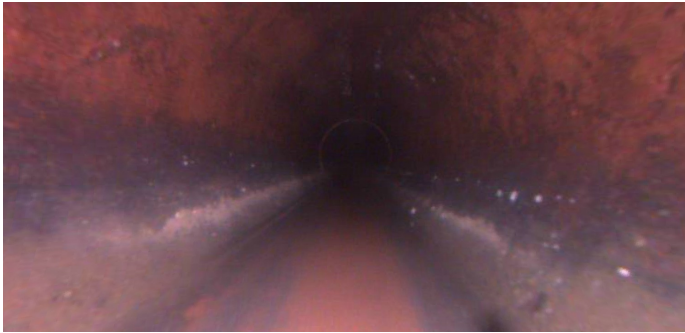
Code:	MWL
Description:	Water Level

Distance (ft):	.0
Structural Grade:	0
O&M Grade:	0
Clock Start/From:	
Clock To:	
1st Value:	
2nd Value:	
Value Percent:	10.000
Continuous Index:	
Within 8" of Joint:	NO
Remarks:

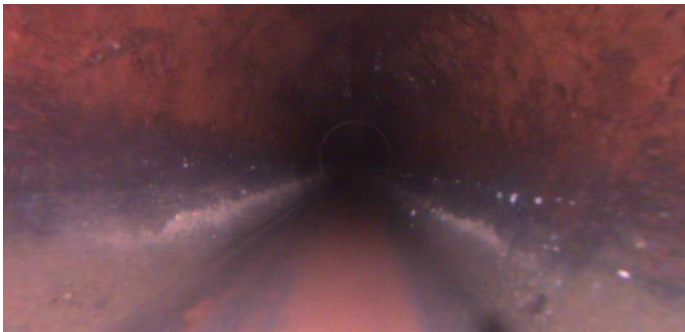
Code:	DAGS
Description:	Deposits Attached Grease

Distance (ft):	.0
Structural Grade:	0
O&M Grade:	2
Clock Start/From:	7
Clock To:	5
1st Value:	
2nd Value:	
Value Percent:	5.000
Continuous Index:	S01
Within 8" of Joint:	NO
Remarks:

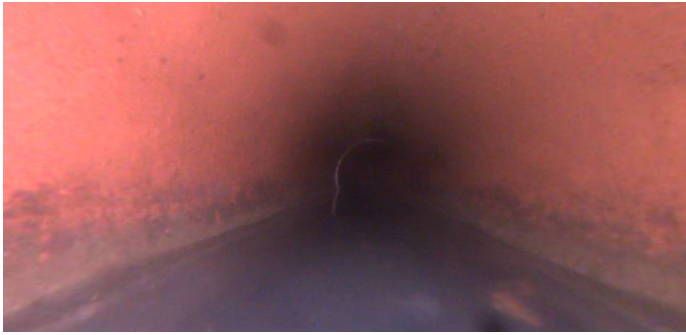
Code: **MWL**
Description: **Water Level**

Distance (ft): **26.4**
Structural Grade: **0**
O&M Grade: **0**
Clock Start/From:
Clock To:
1st Value:
2nd Value:
Value Percent: **30.000**
Continuous Index:
Within 8" of Joint: **NO**
Remarks:

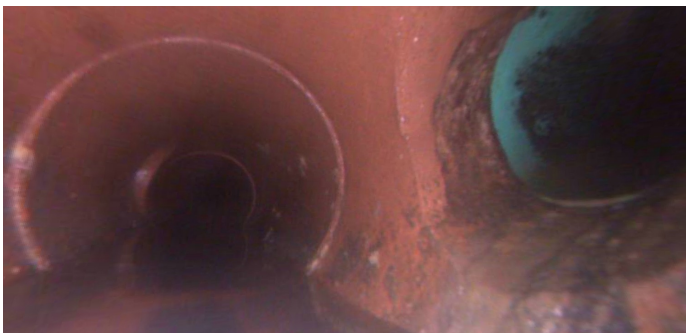
Code: **TF**
Description: **Tap Factory**

Distance (ft): **40.8**
Structural Grade: **0**
O&M Grade: **0**
Clock Start/From: **3**
Clock To:
1st Value: **4.000**
2nd Value:
Value Percent:
Continuous Index:
Within 8" of Joint:
Remarks:

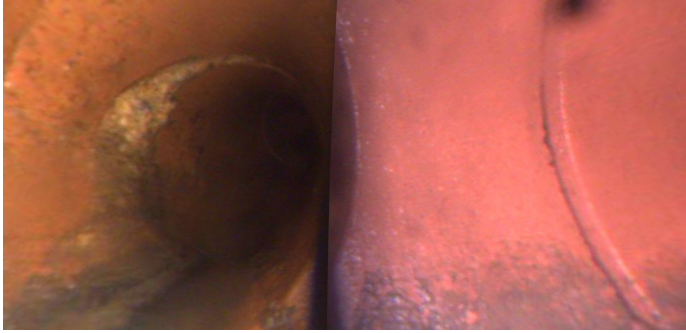
Code: **TF**
Description: **Tap Factory**

Distance (ft): **43.2**
Structural Grade: **0**
O&M Grade: **0**
Clock Start/From: **9**
Clock To:
1st Value: **4.000**
2nd Value:
Value Percent:
Continuous Index:
Within 8" of Joint:
Remarks:

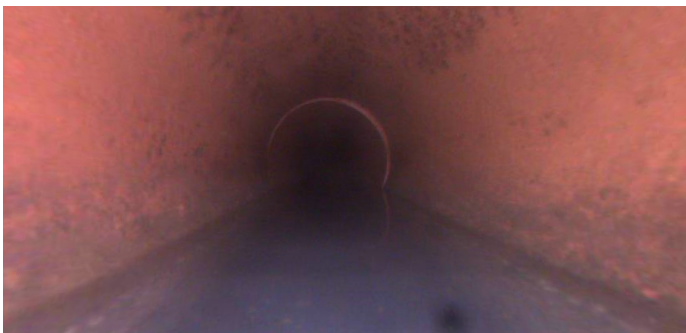
Code: **MSA**
Description: **Abandoned Survey**

Distance (ft): **51.8**
Structural Grade: **0**
O&M Grade: **0**
Clock Start/From:
Clock To:
1st Value:
2nd Value:
Value Percent:
Continuous Index:
Within 8" of Joint: **NO**
Remarks: **DEBRIS UNDER WATER**

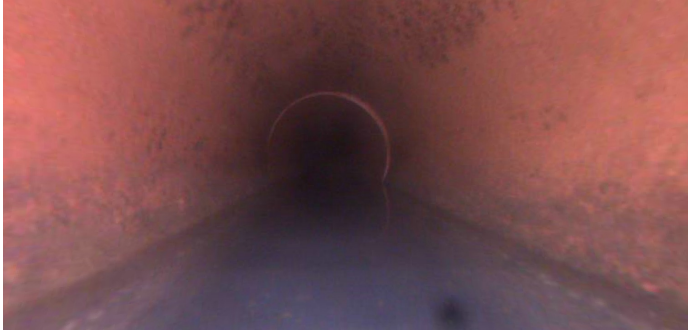
Code:	DAGS
Description:	Deposits Attached Grease
Distance (ft):	51.8
Structural Grade:	0
O&M Grade:	2
Clock Start/From:	7
Clock To:	5
1st Value:	
2nd Value:	
Value Percent:	5.000
Continuous Index:	F01
Within 8" of Joint:	NO
Remarks:
