Profile/Photo Observation Report

Street:	CSOKASY LN	Flow Control:	Not Controlled
City:	Hobart, IN	Year Renewed:	
Location:	Yard	Tape/Media #:	
Purpose:	Routine Assessment	Dia/Height:	10"
Use:	Sanitary	Material:	VCP
Drain Area:	NA	Lining:	
Category:	NA		
Comment:	F_S_P_C at 2 ft debris .Flow direction wrong		
Location Details:		Direction of Survey:	Upstream
US MH:	M-507-013	DS MH:	M-507-014
		Total Length Surveyed (ft):	3.5

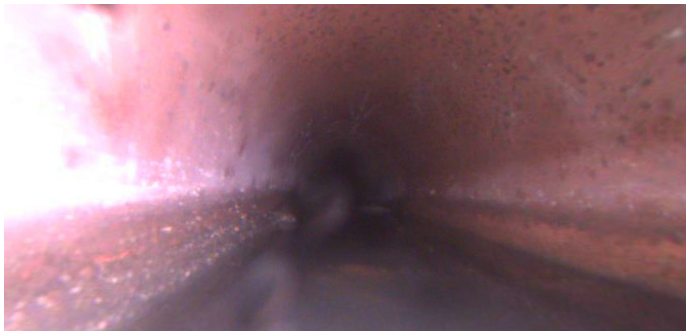
Code: **AMH**
Description: **Manhole**

Distance (ft): **.0**
Structural Grade: **0**
O&M Grade: **0**
Clock Start/From:
Clock To:
1st Value:
2nd Value:
Value Percent:
Continuous Index:
Within 8" of Joint: **NO**
Remarks: **M-507-014**

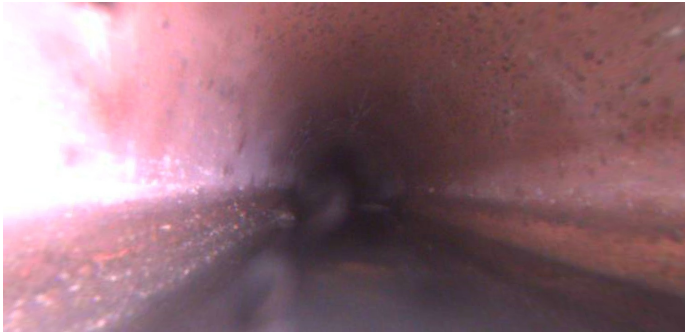
Code:	MWL
Description:	Water Level

Distance (ft):	.0
Structural Grade:	0
O&M Grade:	0
Clock Start/From:	
Clock To:	
1st Value:	
2nd Value:	
Value Percent:	40.000
Continuous Index:	
Within 8" of Joint:	NO
Remarks:

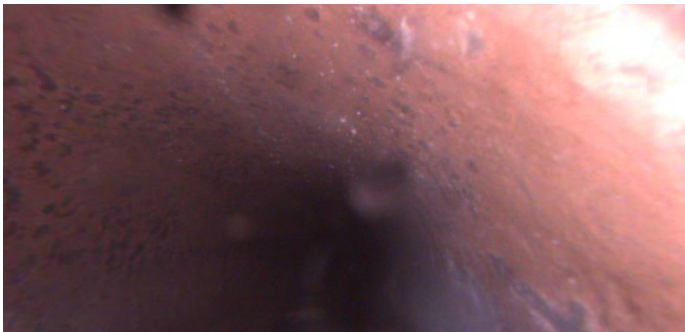
Code:	MSA
Description:	Abandoned Survey

Distance (ft):	3.5
Structural Grade:	0
O&M Grade:	0
Clock Start/From:	
Clock To:	
1st Value:	
2nd Value:	
Value Percent:	
Continuous Index:	
Within 8" of Joint:	NO
Remarks:	DEBRIS UNDER WATER
