Profile/Photo Observation Report

| Street: | FOXCROFT STREET | Flow Control: | Not Controlled |
| City: | Hobart, IN | Year Renewed: | |
| US MH: | M-507-013 | DS MH: | M-507-014 |

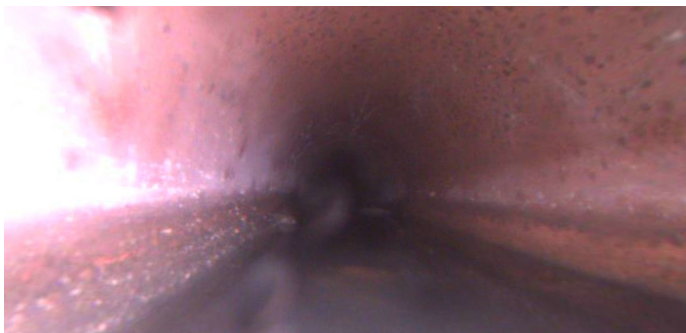
Code: **AMH**
Description: **Manhole**

Distance (ft): **.0**
Structural Grade: **0**
O&M Grade: **0**
Clock Start/From:
Clock To:
1st Value:
2nd Value:
Value Percent:
Continuous Index:
Within 8" of Joint: **NO**
Remarks: **M-507-014**

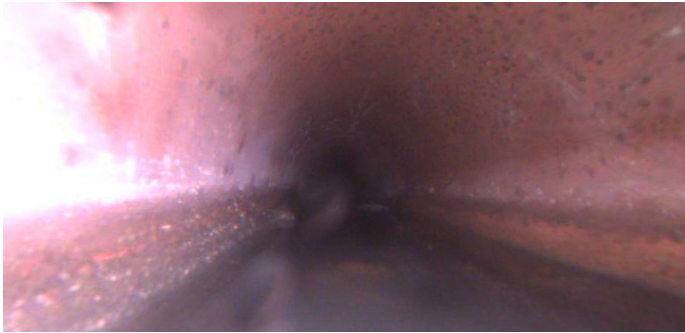
| Code: | MWL |

| Description: | Water Level |

| Value Percent: | 40.000 |

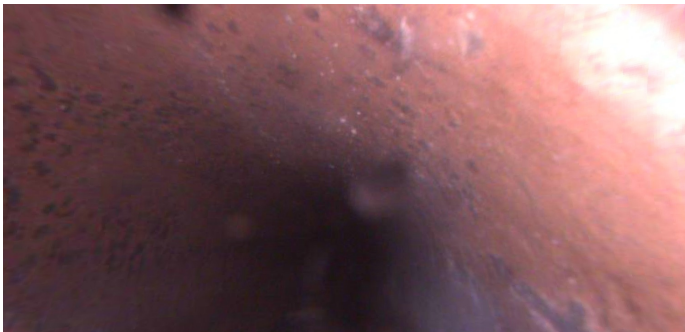
| Code: | MSA |

| Comment: | F_S_P_C at 2 ft debris .Flow direction wrong | | |

| Description: | Abandoned Survey |

| Distance (ft): | 3.5 |
| Remarks: | DEBRIS UNDER WATER |
