Profile/Ph	oto Observation I	Report				RedZon
Date:	10/08/2018	Weather:			Coding:	PACP 6.0
Pipe Length (ft)	: 248.6	Owner:	NA		Pre Clean:	Not Known
P.O.#:		Surveyor:	Selasie Honu		PSR:	P-507-014-013
Customer:		Clean Date:	01/01/1900		Shape:	с
Street:	CSOKASY LN		Flow Control:		Not Controlled	
City:	Hobart, IN		Year Renewed	:		
Location:	Light Highway		Tape/Media #:			
Purpose:	Routine Assessment		Dia/Height:		10"	
Use:	Sanitary		Material:		VCP	
Drain Area:	NA		Lining:			
Category:	NA					
Comment:						
Location Details	5:		Direction of Su	irvey:	Downstream	
US MH:	M-507-013	DS MH:	M-507-014	Total Leng	th Surveyed (ft):	76.1
0&M Index:	0.00	O&M Quick:	00	30 0 000	&M Rating:	0.00
tructural Index:	0.00	 Structural Qu	uick: 00	500 Str	ructural Rating:	0.00
Overall Index:	0.00	Overall Quick	c: 00	000 Ov	verall Rating:	0.00

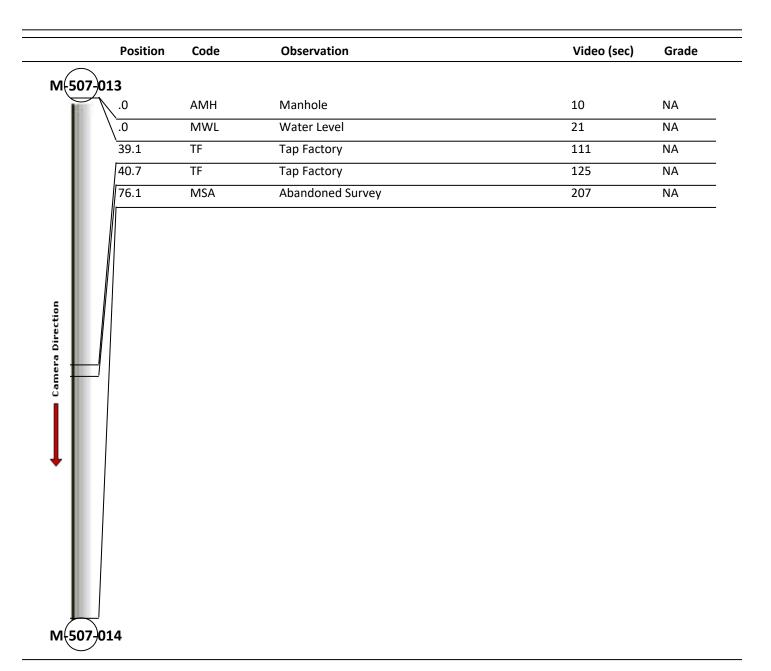
Code: Description:	AMH Manhole
Distance (ft):	.0
Structural Grade:	0
O&M Grade:	0
Clock Start/From:	
Clock To:	
1st Value:	
2nd Value:	
Value Percent:	
Continuous Index:	
Within 8" of Joint:	NO
Remarks:	M-507-013
