## Profile/Photo Observation Report

Street:	<b>CSOKASY LN &amp; S COLORADO ST</b>	Flow Control:	<b>Not Controlled</b>
City:	<b>Hobart, IN</b>	Year Renewed:	
Location:	<b>Light Highway</b>	Tape/Media #:	
Purpose:	<b>Routine Assessment</b>	Dia/Height:	<b>10"</b>
Use:	<b>Sanitary</b>	Material:	<b>VCP</b>
Drain Area:	<b>NA</b>	Lining:	
Category:	<b>NA</b>		
Comment:			
Location Details:		Direction of Survey:	<b>Downstream</b>
US MH:	<b>M-507-013</b>	DS MH:	<b>M-507-023</b>
		Total Length Surveyed (ft):	<b>4.9</b>

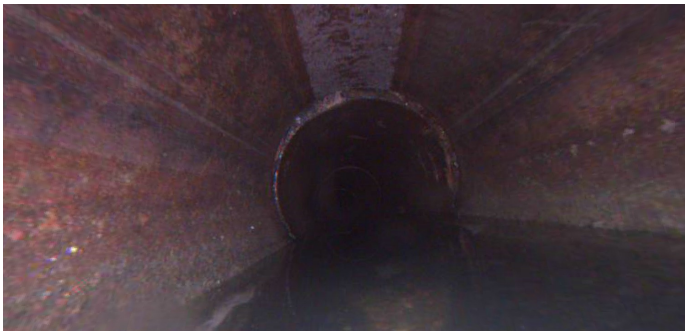
Code: **AMH**  
Description: **Manhole**

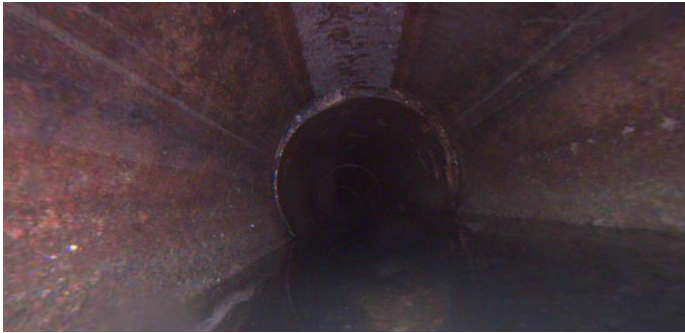
Code:	<b>MWL</b>
Description:	<b>Water Level</b>

Distance (ft):	<b>.0</b>
Structural Grade:	<b>0</b>
O&M Grade:	<b>0</b>
Clock Start/From:	
Clock To:	
1st Value:	
2nd Value:	
Value Percent:	<b>30.000</b>
Continuous Index:	
Within 8" of Joint:	<b>NO</b>
Remarks:

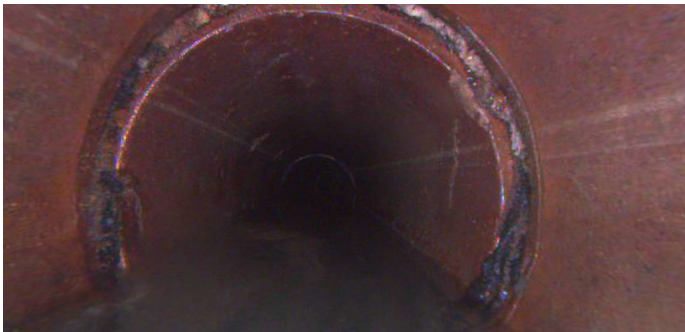
Code:	<b>IS</b>
Description:	<b>Infil Stain</b>

Distance (ft):	<b>4.9</b>
Structural Grade:	<b>0</b>
O&M Grade:	<b>0</b>
Clock Start/From:	<b>8</b>
Clock To:	<b>4</b>
1st Value:	
2nd Value:	
Value Percent:	
Continuous Index:	
Within 8" of Joint:	<b>YES</b>
Remarks:

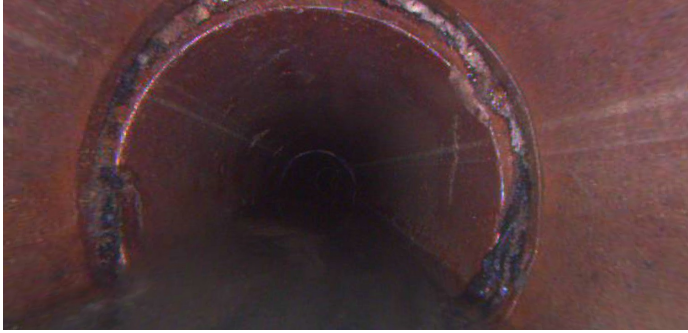
Code:	<b>MSA</b>
Description:	<b>Abandoned Survey</b>
Distance (ft):	<b>4.9</b>
Structural Grade:	<b>0</b>
O&M Grade:	<b>0</b>
Clock Start/From:	
Clock To:	
1st Value:	
2nd Value:	
Value Percent:	
Continuous Index:	
Within 8" of Joint:	<b>NO</b>
Remarks:	<b>debris under water</b>
