## Profile/Photo Observation Report

Street:	<b>CSOKASY LN &amp; S COLORADO ST</b>	Flow Control:	<b>Not Controlled</b>
City:	<b>Hobart, IN</b>	Year Renewed:	
Location:	<b>Light Highway</b>	Tape/Media #:	
Purpose:	<b>Routine Assessment</b>	Dia/Height:	<b>12"</b>
Use:	<b>Sanitary</b>	Material:	<b>VCP</b>
Drain Area:	<b>NA</b>	Lining:	
Category:	<b>NA</b>		
Comment:

Location Details:		Direction of Survey:	<b>Downstream</b>
US MH:	<b>M-507-013</b>	DS MH:	<b>M-507-023</b>
		Total Length Surveyed (ft):	<b>79.3</b>

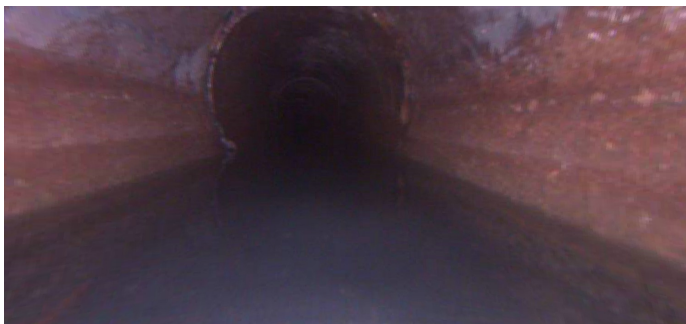
Code: **AMH**  
Description: **Manhole**

Distance (ft): **.0**  
Structural Grade: **0**  
O&M Grade: **0**  
Clock Start/From:  
Clock To:  
1st Value:  
2nd Value:  
Value Percent:  
Continuous Index:  
Within 8" of Joint: **NO**  
Remarks: **M-507-013**

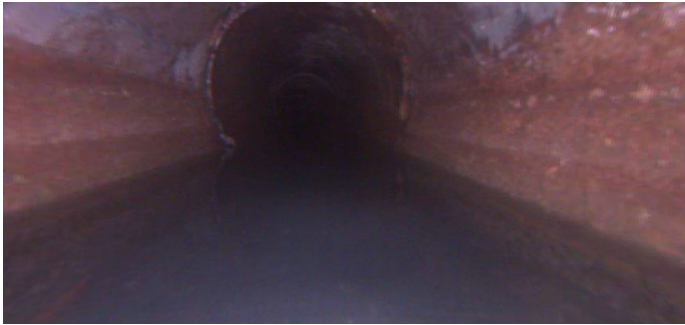
Code:	<b>MWL</b>
Description:	<b>Water Level</b>

Distance (ft):	<b>.0</b>
Structural Grade:	<b>0</b>
O&M Grade:	<b>0</b>
Clock Start/From:	
Clock To:	
1st Value:	
2nd Value:	
Value Percent:	<b>5.000</b>
Continuous Index:	
Within 8" of Joint:	<b>NO</b>
Remarks:

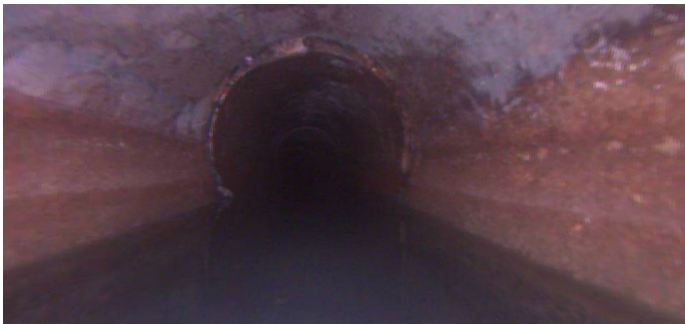
Code:	<b>DAE</b>
Description:	<b>Deposits Attached Encrustation</b>

Distance (ft):	<b>.1</b>
Structural Grade:	<b>0</b>
O&M Grade:	<b>3</b>
Clock Start/From:	<b>8</b>
Clock To:	<b>4</b>
1st Value:	
2nd Value:	
Value Percent:	<b>15.000</b>
Continuous Index:	<b>S01</b>
Within 8" of Joint:	<b>YES</b>
Remarks:

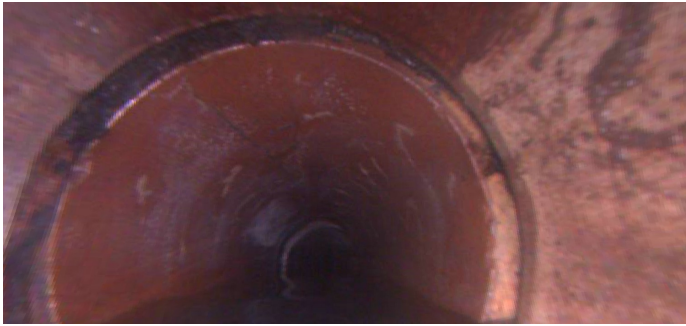
Code: **FL**  
Description: **Fracture Longitudinal**

Distance (ft): **13.9**  
Structural Grade: **3**  
O&M Grade: **0**  
Clock Start/From: **11**  
Clock To:  
1st Value:  
2nd Value:  
Value Percent:  
Continuous Index:  
Within 8" of Joint: **YES**  
Remarks:

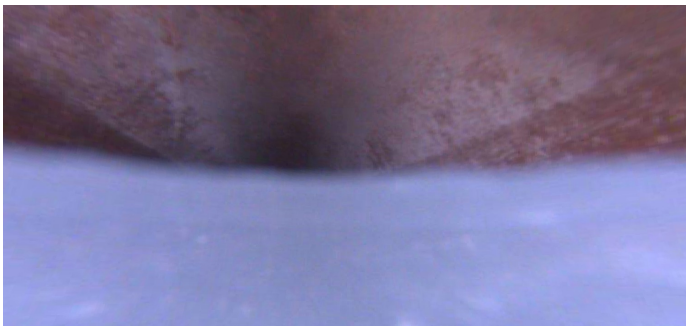
Code: **MWLS**  
Description: **Water Level Sag**

Distance (ft): **18.0**  
Structural Grade: **2**  
O&M Grade: **3**  
Clock Start/From:  
Clock To:  
1st Value:  
2nd Value:  
Value Percent: **15.000**  
Continuous Index: **S02**  
Within 8" of Joint: **NO**  
Remarks:

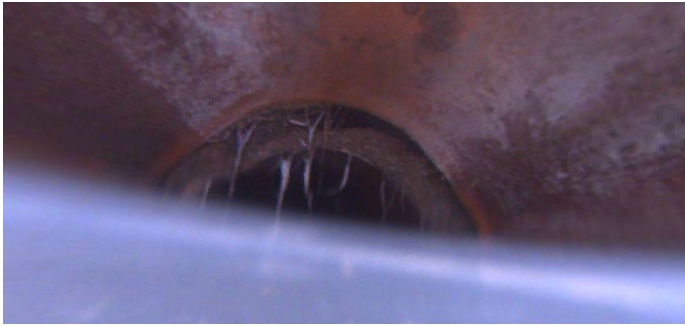
Code: **JOM**  
Description: **Joint Offset Medium**

Distance (ft): **19.9**  
Structural Grade: **1**  
O&M Grade: **0**  
Clock Start/From:  
Clock To:  
1st Value:  
2nd Value:  
Value Percent:  
Continuous Index:  
Within 8" of Joint: **NO**  
Remarks:

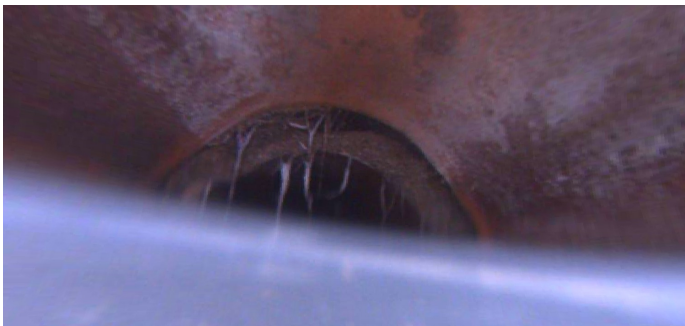
Code: **RFJ**  
Description: **Roots Fine Joint**

Distance (ft): **19.9**  
Structural Grade: **0**  
O&M Grade: **1**  
Clock Start/From: **9**  
Clock To: **3**  
1st Value:  
2nd Value:  
Value Percent:  
Continuous Index:  
Within 8" of Joint: **YES**  
Remarks:

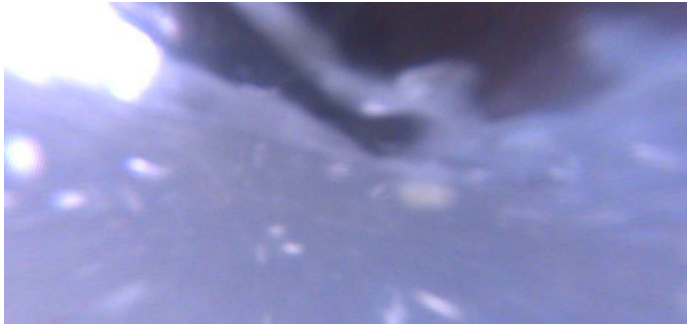
Code: **MWLS**  
Description: **Water Level Sag**

Distance (ft): **21.9**  
Structural Grade: **2**  
O&M Grade: **3**  
Clock Start/From:  
Clock To:  
1st Value:  
2nd Value:  
Value Percent: **15.000**  
Continuous Index: **F02**  
Within 8" of Joint: **NO**  
Remarks:

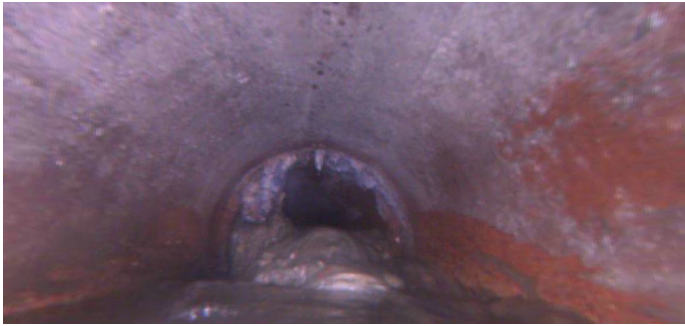
Code: **DSZ**  
Description: **Deposits Settled Other**

Distance (ft): **58.7**  
Structural Grade: **0**  
O&M Grade: **5**  
Clock Start/From: **3**  
Clock To: **10**  
1st Value:  
2nd Value:  
Value Percent: **60.000**  
Continuous Index:  
Within 8" of Joint: **YES**  
Remarks: **mixed material**

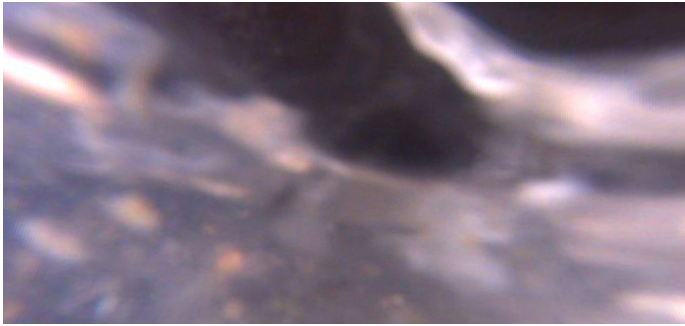
Code: **MWLS**  
Description: **Water Level Sag**

Distance (ft): **76.3**  
Structural Grade: **2**  
O&M Grade: **3**  
Clock Start/From:  
Clock To:  
1st Value:  
2nd Value:  
Value Percent: **20.000**  
Continuous Index: **F03**  
Within 8" of Joint: **NO**  
Remarks:

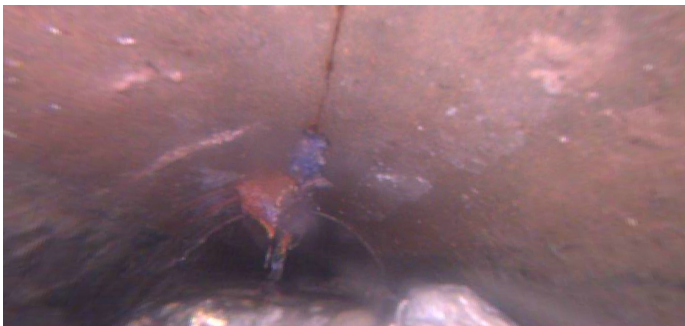
Code: **FL**  
Description: **Fracture Longitudinal**

Distance (ft): **77.9**  
Structural Grade: **3**  
O&M Grade: **0**  
Clock Start/From: **12**  
Clock To:  
1st Value:  
2nd Value:  
Value Percent:  
Continuous Index:  
Within 8" of Joint:  
Remarks:

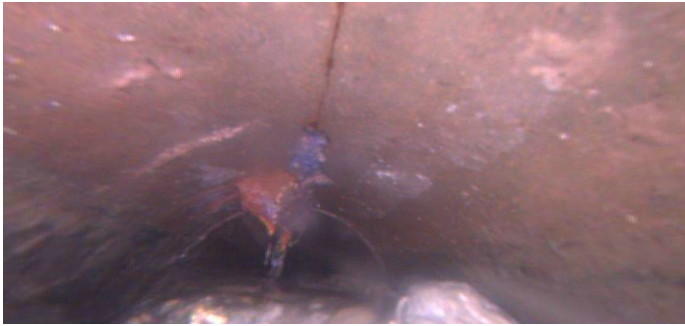
Code: **DAE**  
Description: **Deposits Attached Encrustation**

Distance (ft): **77.9**  
Structural Grade: **0**  
O&M Grade: **3**  
Clock Start/From: **9**  
Clock To: **1**  
1st Value:  
2nd Value:  
Value Percent: **15.000**  
Continuous Index:  
Within 8" of Joint:  
Remarks:

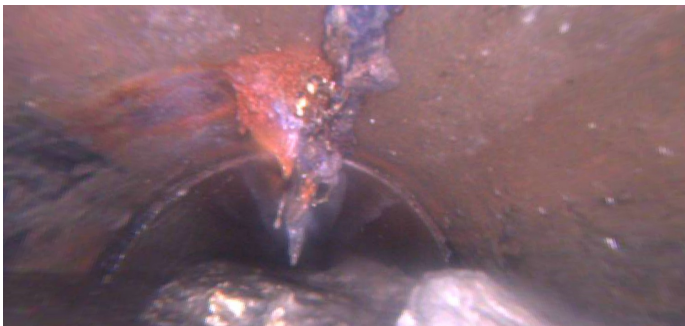
Code: **DAE**  
Description: **Deposits Attached Encrustation**

Distance (ft): **79.3**  
Structural Grade: **0**  
O&M Grade: **3**  
Clock Start/From: **8**  
Clock To: **4**  
1st Value:  
2nd Value:  
Value Percent: **15.000**  
Continuous Index: **F01**  
Within 8" of Joint: **YES**  
Remarks:

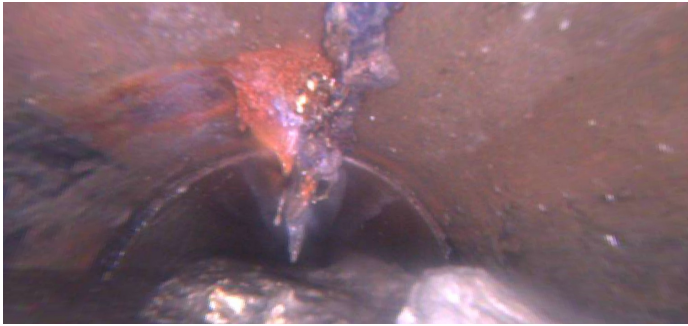
Code:	<b>MSA</b>
Description:	<b>Abandoned Survey</b>
Distance (ft):	<b>79.3</b>
Structural Grade:	<b>0</b>
O&M Grade:	<b>0</b>
Clock Start/From:	
Clock To:	
1st Value:	
2nd Value:	
Value Percent:	
Continuous Index:	
Within 8" of Joint:	<b>NO</b>
Remarks:	<b>camera stopped</b>
