## Profile/Photo Observation Report

Date:	<b>10/08/2018</b>	Weather:		Coding:	<b>PACP 6.0</b>
Pipe Length (ft):	<b>325.0</b>	Owner:	<b>NA</b>	Pre Clean:	<b>Not Known</b>
P.O.#:		Surveyor:	<b>Selasie Honu</b>	PSR:	<b>P-507-023-013</b>
Customer:		Clean Date:	<b>01/01/1900</b>	Shape:	<b>C</b>

Street:	<b>Csokasy Ln.</b>	Flow Control:	<b>Not Controlled</b>
City:	<b>Hobart, IN</b>	Year Renewed:	
Location:	<b>Light Highway</b>	Tape/Media #:	
Purpose:	<b>Routine Assessment</b>	Dia/Height:	<b>12"</b>
Use:	<b>Sanitary</b>	Material:	<b>VCP</b>
Drain Area:	<b>NA</b>	Lining:	
Category:	<b>NA</b>		
Comment:

Location Details:		Direction of Survey:	<b>Downstream</b>
US MH:	<b>M-507-013</b>	DS MH:	<b>M-507-023</b>
		Total Length Surveyed (ft):	<b>79.3</b>

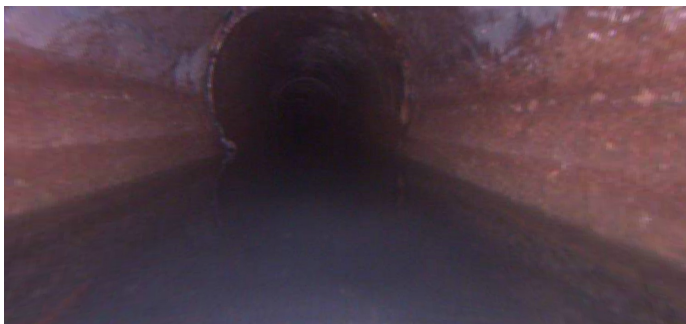
Code: **AMH**  
Description: **Manhole**

Distance (ft): **.0**  
Structural Grade: **0**  
O&M Grade: **0**  
Clock Start/From:  
Clock To:  
1st Value:  
2nd Value:  
Value Percent:  
Continuous Index:  
Within 8" of Joint: **NO**  
Remarks: **M-507-013**

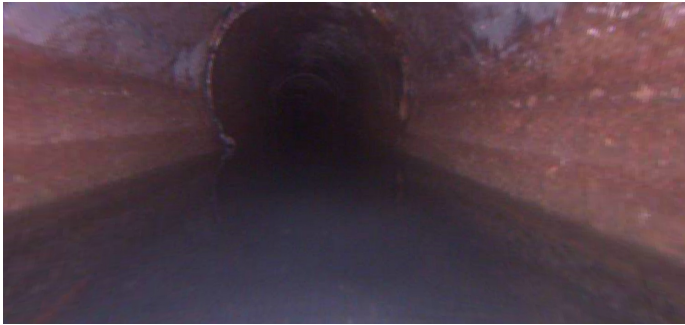
Code:	<b>MWL</b>
Description:	<b>Water Level</b>

Distance (ft):	<b>.0</b>
Structural Grade:	<b>0</b>
O&M Grade:	<b>0</b>
Clock Start/From:	
Clock To:	
1st Value:	
2nd Value:	
Value Percent:	<b>5.000</b>
Continuous Index:	
Within 8" of Joint:	<b>NO</b>
Remarks:

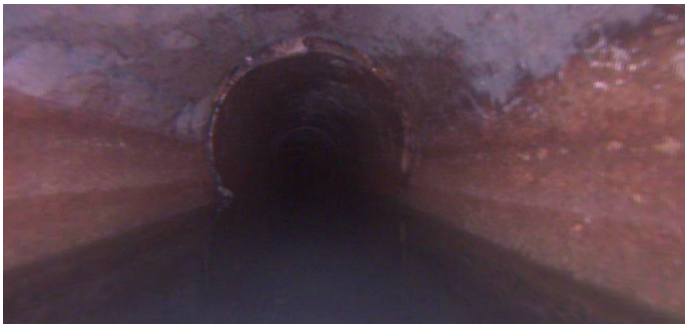
Code:	<b>DAE</b>
Description:	<b>Deposits Attached Encrustation</b>

Distance (ft):	<b>.1</b>
Structural Grade:	<b>0</b>
O&M Grade:	<b>3</b>
Clock Start/From:	<b>8</b>
Clock To:	<b>4</b>
1st Value:	
2nd Value:	
Value Percent:	<b>15.000</b>
Continuous Index:	<b>S01</b>
Within 8" of Joint:	<b>YES</b>
Remarks:

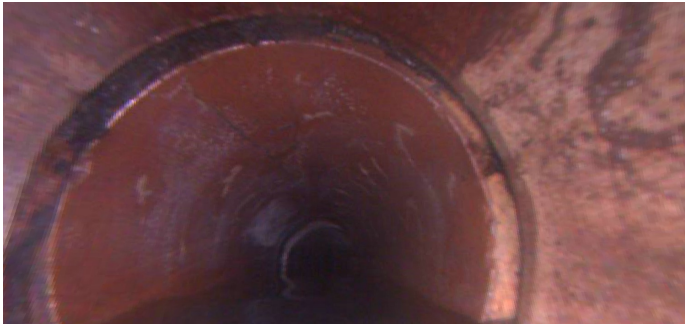
Code: **FL**  
Description: **Fracture Longitudinal**

Distance (ft): **13.9**  
Structural Grade: **3**  
O&M Grade: **0**  
Clock Start/From: **11**  
Clock To:  
1st Value:  
2nd Value:  
Value Percent:  
Continuous Index:  
Within 8" of Joint: **YES**  
Remarks:

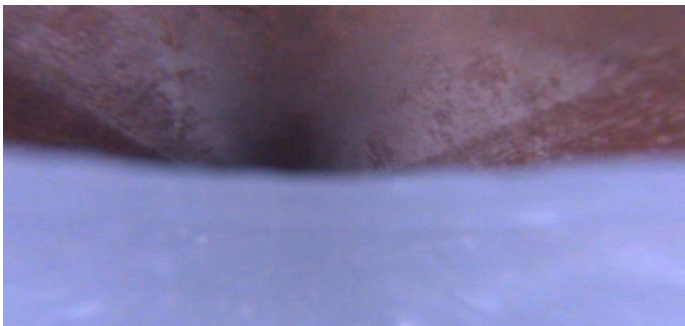
Code: **MWLS**  
Description: **Water Level Sag**

Distance (ft): **18.0**  
Structural Grade: **2**  
O&M Grade: **3**  
Clock Start/From:  
Clock To:  
1st Value:  
2nd Value:  
Value Percent: **15.000**  
Continuous Index: **S02**  
Within 8" of Joint: **NO**  
Remarks:

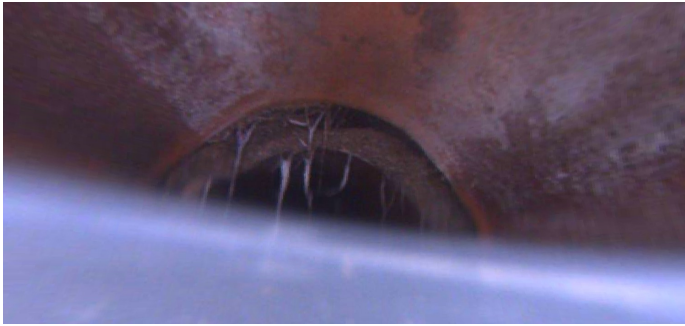
Code: **JOM**  
Description: **Joint Offset Medium**

Distance (ft): **19.9**  
Structural Grade: **1**  
O&M Grade: **0**  
Clock Start/From:  
Clock To:  
1st Value:  
2nd Value:  
Value Percent:  
Continuous Index:  
Within 8" of Joint: **NO**  
Remarks:

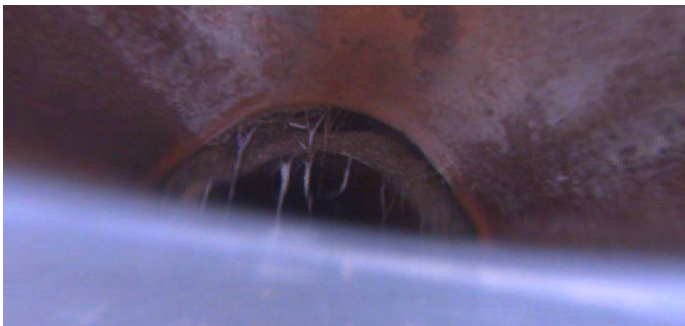
Code: **RFJ**  
Description: **Roots Fine Joint**

Distance (ft): **19.9**  
Structural Grade: **0**  
O&M Grade: **1**  
Clock Start/From: **9**  
Clock To: **3**  
1st Value:  
2nd Value:  
Value Percent:  
Continuous Index:  
Within 8" of Joint: **YES**  
Remarks:

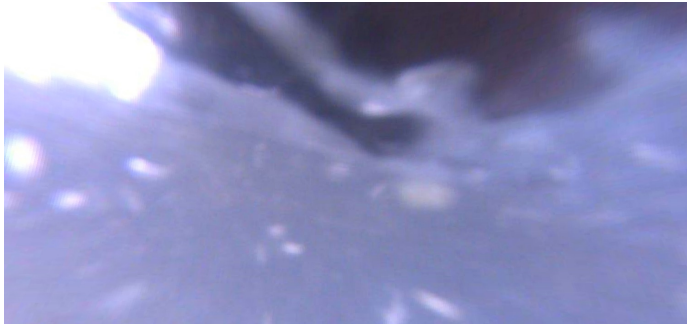
Code: **MWLS**  
Description: **Water Level Sag**

Distance (ft): **21.9**  
Structural Grade: **2**  
O&M Grade: **3**  
Clock Start/From:  
Clock To:  
1st Value:  
2nd Value:  
Value Percent: **15.000**  
Continuous Index: **F02**  
Within 8" of Joint: **NO**  
Remarks:

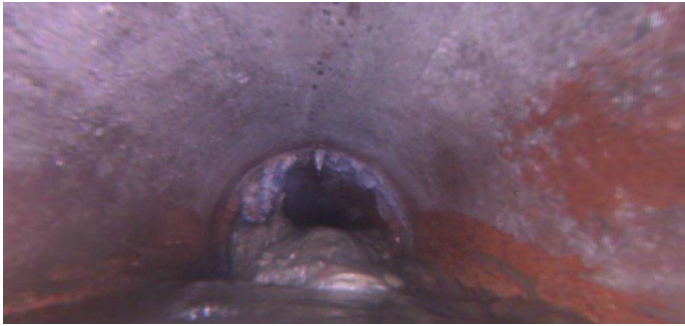
Code: **DSZ**  
Description: **Deposits Settled Other**

Distance (ft): **58.7**  
Structural Grade: **0**  
O&M Grade: **5**  
Clock Start/From: **3**  
Clock To: **10**  
1st Value:  
2nd Value:  
Value Percent: **60.000**  
Continuous Index:  
Within 8" of Joint: **YES**  
Remarks: **mixed material**

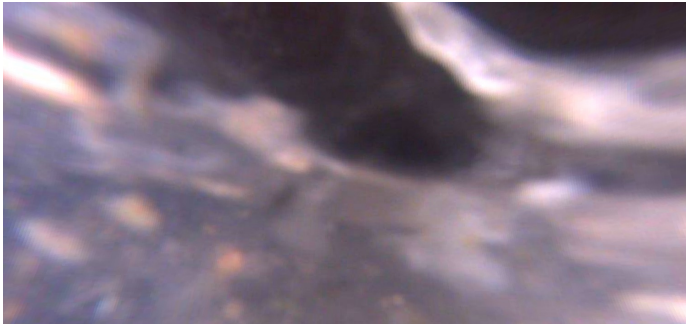
Code: **MWLS**  
Description: **Water Level Sag**

Distance (ft): **76.3**  
Structural Grade: **2**  
O&M Grade: **3**  
Clock Start/From:  
Clock To:  
1st Value:  
2nd Value:  
Value Percent: **20.000**  
Continuous Index: **F03**  
Within 8" of Joint: **NO**  
Remarks:

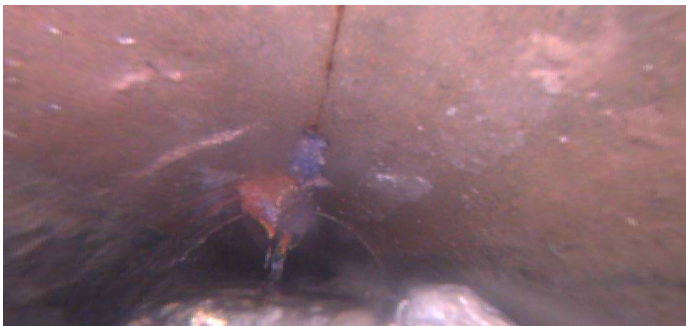
Code: **FL**  
Description: **Fracture Longitudinal**

Distance (ft): **77.9**  
Structural Grade: **3**  
O&M Grade: **0**  
Clock Start/From: **12**  
Clock To:  
1st Value:  
2nd Value:  
Value Percent:  
Continuous Index:  
Within 8" of Joint:  
Remarks:

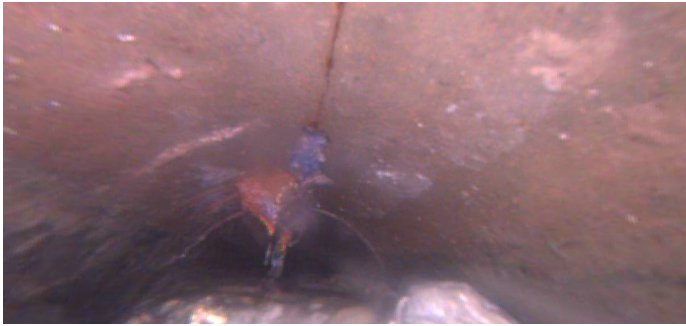
Code: **DAE**  
Description: **Deposits Attached Encrustation**

Distance (ft): **77.9**  
Structural Grade: **0**  
O&M Grade: **3**  
Clock Start/From: **9**  
Clock To: **1**  
1st Value:  
2nd Value:  
Value Percent: **15.000**  
Continuous Index:  
Within 8" of Joint:  
Remarks:

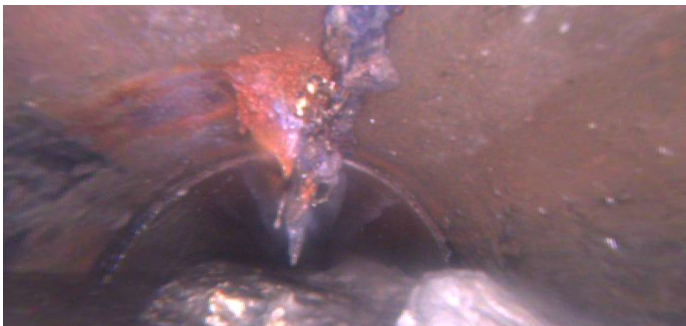
Code: **DAE**  
Description: **Deposits Attached Encrustation**

Distance (ft): **79.3**  
Structural Grade: **0**  
O&M Grade: **3**  
Clock Start/From: **8**  
Clock To: **4**  
1st Value:  
2nd Value:  
Value Percent: **15.000**  
Continuous Index: **F01**  
Within 8" of Joint: **YES**  
Remarks:

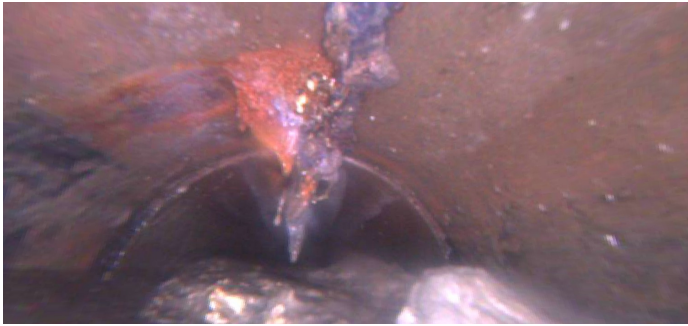
Code:	<b>MSA</b>
Description:	<b>Abandoned Survey</b>
Distance (ft):	<b>79.3</b>
Structural Grade:	<b>0</b>
O&M Grade:	<b>0</b>
Clock Start/From:	
Clock To:	
1st Value:	
2nd Value:	
Value Percent:	
Continuous Index:	
Within 8" of Joint:	<b>NO</b>
Remarks:	<b>camera stopped</b>
