## Profile/Photo Observation Report

Street:	<b>CSOKASY LN &amp; S COLORADO ST</b>	Flow Control:	<b>Not Controlled</b>
City:	<b>Hobart, IN</b>	Year Renewed:	
Location:	<b>Light Highway</b>	Tape/Media #:	
Purpose:	<b>Routine Assessment</b>	Dia/Height:	<b>12"</b>
Use:	<b>Sanitary</b>	Material:	<b>VCP</b>
Drain Area:	<b>NA</b>	Lining:	
Category:	<b>NA</b>		
Comment:

Location Details:		Direction of Survey:	<b>Upstream</b>
US MH:	<b>M-507-013</b>	DS MH:	<b>M-507-023</b>
		Total Length Surveyed (ft):	<b>3.8</b>

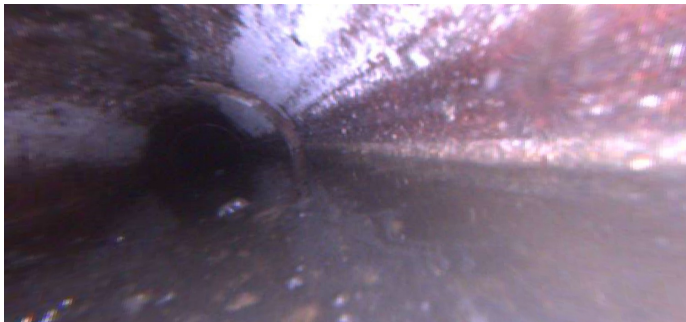
Code: **AMH**  
Description: **Manhole**

Distance (ft): **.0**  
Structural Grade: **0**  
O&M Grade: **0**  
Clock Start/From:  
Clock To:  
1st Value:  
2nd Value:  
Value Percent:  
Continuous Index:  
Within 8" of Joint: **NO**  
Remarks: **M-507-023**

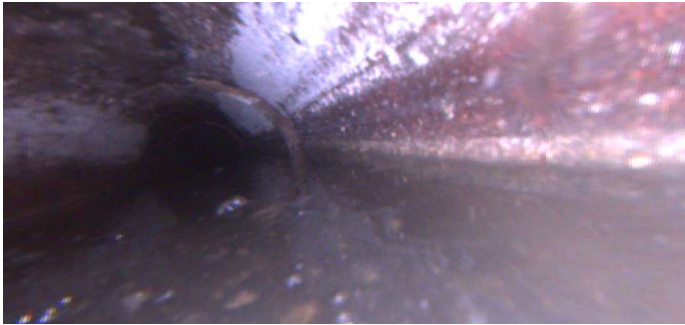
Code:	<b>MWL</b>
Description:	<b>Water Level</b>

Distance (ft):	<b>.0</b>
Structural Grade:	<b>0</b>
O&M Grade:	<b>0</b>
Clock Start/From:	
Clock To:	
1st Value:	
2nd Value:	
Value Percent:	<b>5.000</b>
Continuous Index:	
Within 8" of Joint:	<b>NO</b>
Remarks:

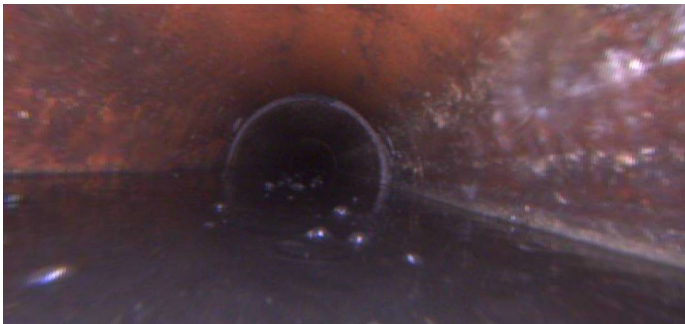
Code:	<b>MSA</b>
Description:	<b>Abandoned Survey</b>

Distance (ft):	<b>3.8</b>
Structural Grade:	<b>0</b>
O&M Grade:	<b>0</b>
Clock Start/From:	
Clock To:	
1st Value:	
2nd Value:	
Value Percent:	
Continuous Index:	
Within 8" of Joint:	<b>NO</b>
Remarks:	<b>camera stopped</b>
