## Profile/Photo Observation Report

Date:	<b>10/08/2018</b>	Weather:		Coding:	<b>PACP 6.0</b>
Pipe Length (ft):	<b>325.0</b>	Owner:	<b>NA</b>	Pre Clean:	<b>Not Known</b>
P.O.#:		Surveyor:	<b>Selasie Honu</b>	PSR:	<b>P-507-023-013</b>
Customer:		Clean Date:	<b>01/01/1900</b>	Shape:	<b>C</b>

Street:	<b>CSOKASY LN &amp; S COLORADO ST</b>	Flow Control:	<b>Not Controlled</b>
City:	<b>Hobart, IN</b>	Year Renewed:	
Location:	<b>Light Highway</b>	Tape/Media #:	
Purpose:	<b>Routine Assessment</b>	Dia/Height:	<b>12"</b>
Use:	<b>Sanitary</b>	Material:	<b>VCP</b>
Drain Area:	<b>NA</b>	Lining:	
Category:	<b>NA</b>		
Comment:

Location Details:		Direction of Survey:	<b>Downstream</b>
US MH:	<b>M-507-013</b>	DS MH:	<b>M-507-023</b>
		Total Length Surveyed (ft):	<b>60.7</b>

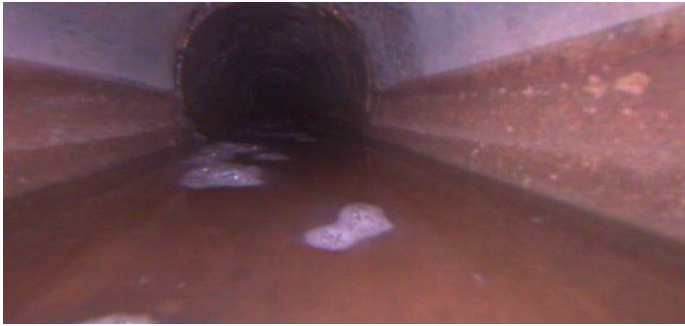
Code: **AMH**  
Description: **Manhole**

Distance (ft): **.0**  
Structural Grade: **0**  
O&M Grade: **0**  
Clock Start/From:  
Clock To:  
1st Value:  
2nd Value:  
Value Percent:  
Continuous Index:  
Within 8" of Joint: **NO**  
Remarks: **M-507-013**

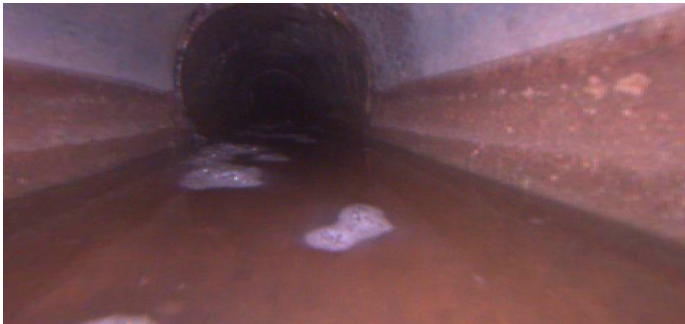
Code: **MWL**  
Description: **Water Level**

Distance (ft): **.0**  
Structural Grade: **0**  
O&M Grade: **0**  
Clock Start/From:  
Clock To:  
1st Value:  
2nd Value:  
Value Percent: **5.000**  
Continuous Index:  
Within 8" of Joint: **NO**  
Remarks:

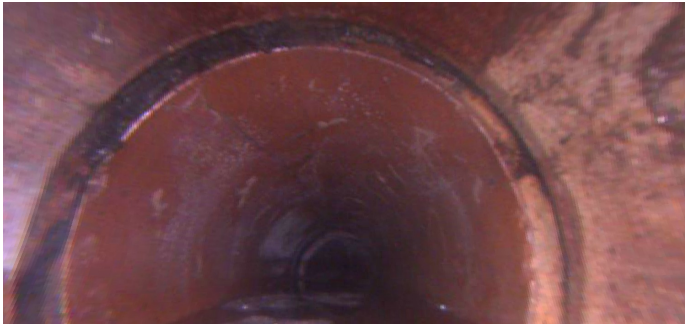
Code: **FL**  
Description: **Fracture Longitudinal**

Distance (ft): **14.4**  
Structural Grade: **3**  
O&M Grade: **0**  
Clock Start/From: **11**  
Clock To:  
1st Value:  
2nd Value:  
Value Percent:  
Continuous Index:  
Within 8" of Joint: **YES**  
Remarks:

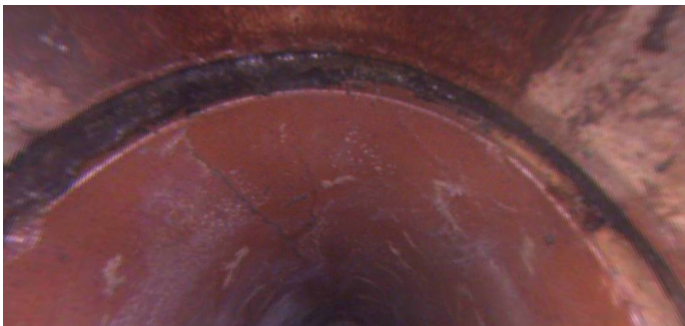
Code: **FL**  
Description: **Fracture Longitudinal**

Distance (ft): **14.6**  
Structural Grade: **3**  
O&M Grade: **0**  
Clock Start/From: **12**  
Clock To:  
1st Value:  
2nd Value:  
Value Percent:  
Continuous Index:  
Within 8" of Joint:  
Remarks:

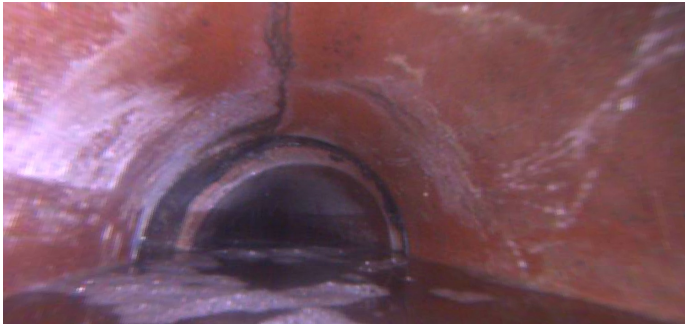
Code: **FL**  
Description: **Fracture Longitudinal**

Distance (ft): **16.8**  
Structural Grade: **3**  
O&M Grade: **0**  
Clock Start/From: **12**  
Clock To:  
1st Value:  
2nd Value:  
Value Percent:  
Continuous Index:  
Within 8" of Joint:  
Remarks:

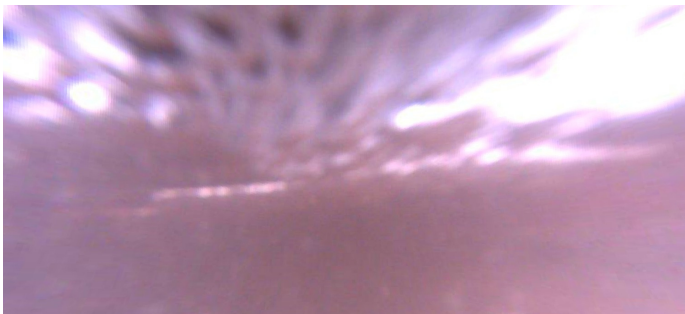
Code: **MWLS**  
Description: **Water Level Sag**

Distance (ft): **20.0**  
Structural Grade: **2**  
O&M Grade: **3**  
Clock Start/From:  
Clock To:  
1st Value:  
2nd Value:  
Value Percent: **15.000**  
Continuous Index:  
Within 8" of Joint: **NO**  
Remarks:

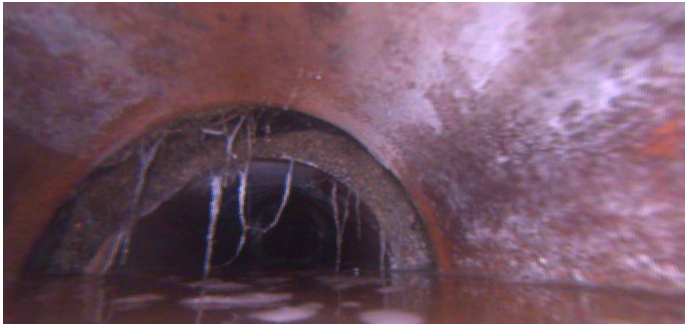
Code: **JOM**  
Description: **Joint Offset Medium**

Distance (ft): **20.4**  
Structural Grade: **1**  
O&M Grade: **0**  
Clock Start/From:  
Clock To:  
1st Value:  
2nd Value:  
Value Percent:  
Continuous Index:  
Within 8" of Joint: **NO**  
Remarks:

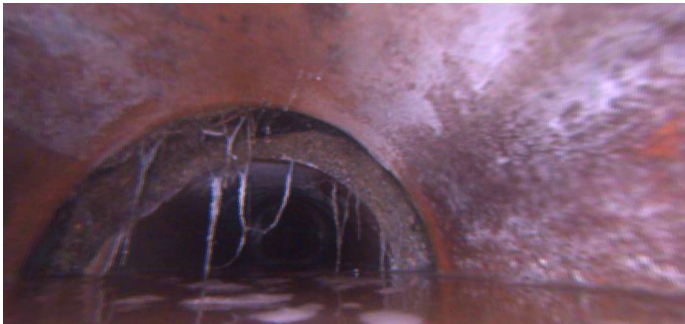
Code: **RFJ**  
Description: **Roots Fine Joint**

Distance (ft): **20.4**  
Structural Grade: **0**  
O&M Grade: **1**  
Clock Start/From: **9**  
Clock To: **3**  
1st Value:  
2nd Value:  
Value Percent:  
Continuous Index:  
Within 8" of Joint: **YES**  
Remarks:

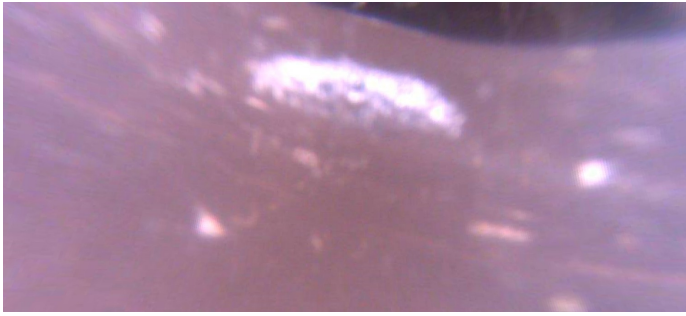
Code: **MWLS**  
Description: **Water Level Sag**

Distance (ft): **20.9**  
Structural Grade: **2**  
O&M Grade: **3**  
Clock Start/From:  
Clock To:  
1st Value:  
2nd Value:  
Value Percent: **15.000**  
Continuous Index:  
Within 8" of Joint: **NO**  
Remarks:

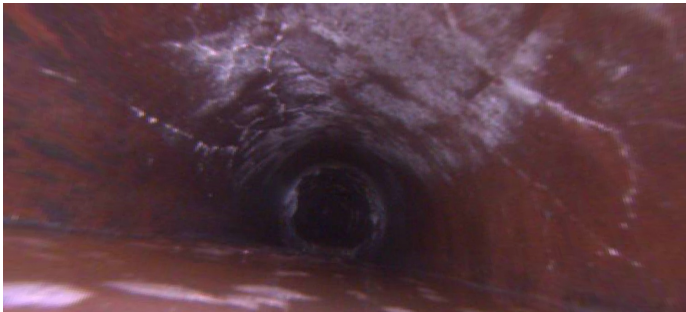
Code: **CM**  
Description: **Crack Multiple**

Distance (ft): **21.7**  
Structural Grade: **3**  
O&M Grade: **0**  
Clock Start/From: **9**  
Clock To: **4**  
1st Value:  
2nd Value:  
Value Percent:  
Continuous Index:  
Within 8" of Joint:  
Remarks:

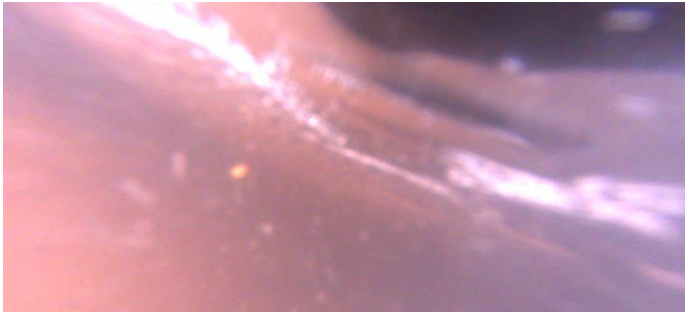
Code: **MWLS**  
Description: **Water Level Sag**

Distance (ft): **22.1**  
Structural Grade: **2**  
O&M Grade: **3**  
Clock Start/From:  
Clock To:  
1st Value:  
2nd Value:  
Value Percent: **15.000**  
Continuous Index:  
Within 8" of Joint: **NO**  
Remarks:

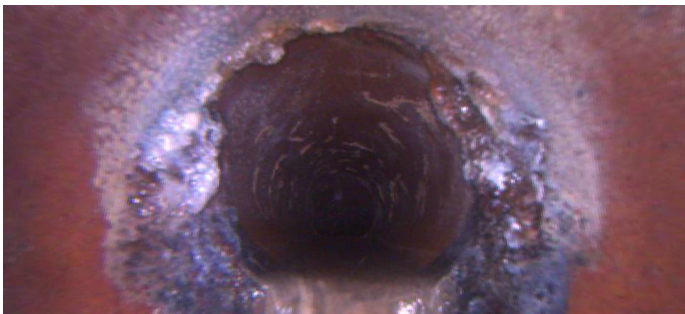
Code: **DAE**  
Description: **Deposits Attached Encrustation**

Distance (ft): **23.7**  
Structural Grade: **0**  
O&M Grade: **4**  
Clock Start/From: **6**  
Clock To: **6**  
1st Value:  
2nd Value:  
Value Percent: **30.000**  
Continuous Index:  
Within 8" of Joint: **YES**  
Remarks:

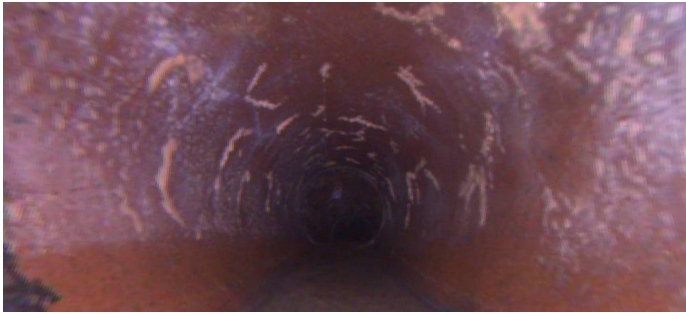
Code: **FM**  
Description: **Fracture Multiple**

Distance (ft): **24.5**  
Structural Grade: **4**  
O&M Grade: **0**  
Clock Start/From: **8**  
Clock To: **4**  
1st Value:  
2nd Value:  
Value Percent:  
Continuous Index:  
Within 8" of Joint:  
Remarks:

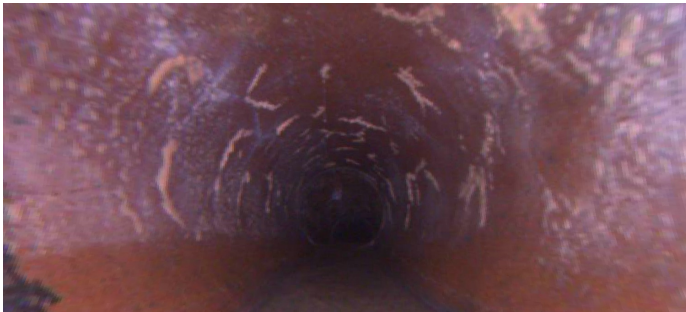
Code: **RFJ**  
Description: **Roots Fine Joint**

Distance (ft): **24.5**  
Structural Grade: **0**  
O&M Grade: **1**  
Clock Start/From: **8**  
Clock To: **4**  
1st Value:  
2nd Value:  
Value Percent:  
Continuous Index:  
Within 8" of Joint: **YES**  
Remarks:

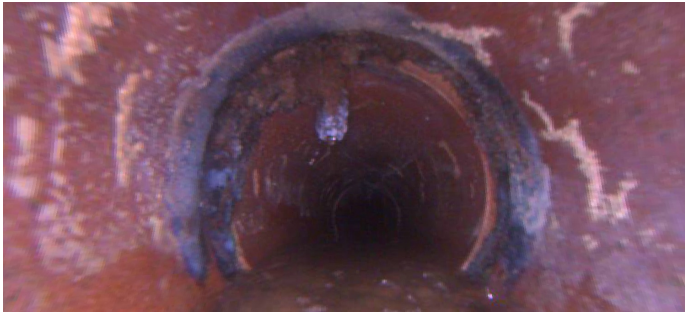
Code: **DAE**  
Description: **Deposits Attached Encrustation**

Distance (ft): **26.6**  
Structural Grade: **0**  
O&M Grade: **3**  
Clock Start/From: **8**  
Clock To: **4**  
1st Value:  
2nd Value:  
Value Percent: **15.000**  
Continuous Index:  
Within 8" of Joint: **YES**  
Remarks:

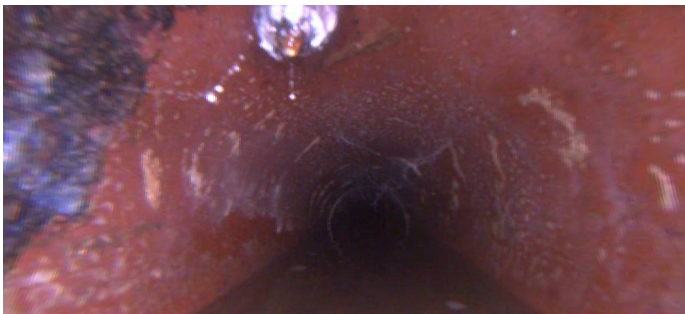
Code: **FM**  
Description: **Fracture Multiple**

Distance (ft): **27.2**  
Structural Grade: **4**  
O&M Grade: **0**  
Clock Start/From: **8**  
Clock To: **4**  
1st Value:  
2nd Value:  
Value Percent:  
Continuous Index:  
Within 8" of Joint:  
Remarks:

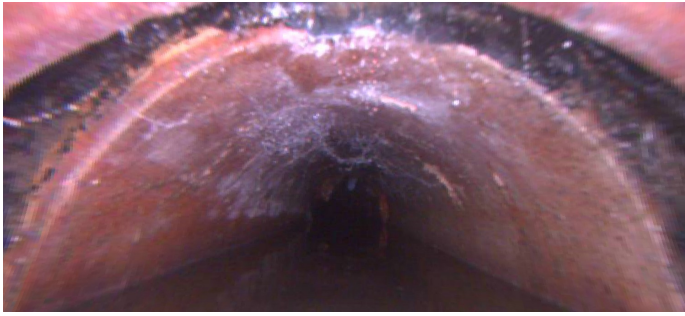
Code: **FM**  
Description: **Fracture Multiple**

Distance (ft): **30.3**  
Structural Grade: **4**  
O&M Grade: **0**  
Clock Start/From: **9**  
Clock To: **3**  
1st Value:  
2nd Value:  
Value Percent:  
Continuous Index:  
Within 8" of Joint:  
Remarks:

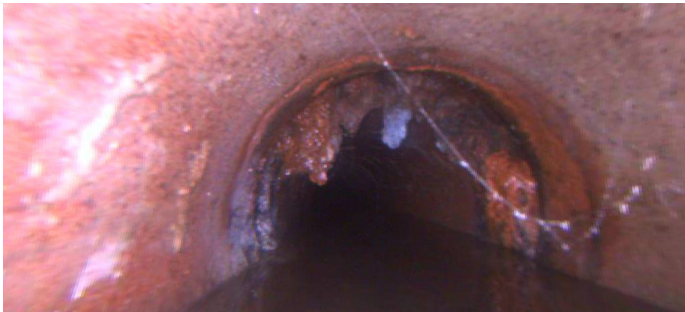
Code: **DAE**  
Description: **Deposits Attached Encrustation**

Distance (ft): **32.7**  
Structural Grade: **0**  
O&M Grade: **3**  
Clock Start/From: **8**  
Clock To: **4**  
1st Value:  
2nd Value:  
Value Percent: **20.000**  
Continuous Index:  
Within 8" of Joint: **YES**  
Remarks:

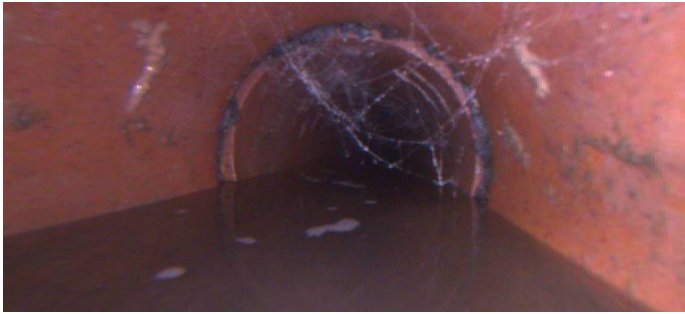
Code: **RFJ**  
Description: **Roots Fine Joint**

Distance (ft): **35.8**  
Structural Grade: **0**  
O&M Grade: **1**  
Clock Start/From: **8**  
Clock To: **4**  
1st Value:  
2nd Value:  
Value Percent:  
Continuous Index:  
Within 8" of Joint: **YES**  
Remarks:

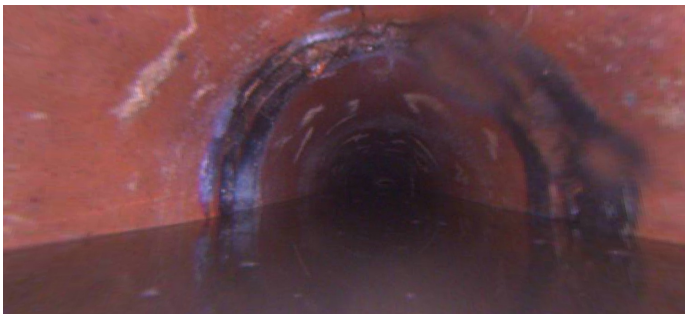
Code: **DAE**  
Description: **Deposits Attached Encrustation**

Distance (ft): **39.0**  
Structural Grade: **0**  
O&M Grade: **3**  
Clock Start/From: **8**  
Clock To: **4**  
1st Value:  
2nd Value:  
Value Percent: **15.000**  
Continuous Index:  
Within 8" of Joint: **YES**  
Remarks:

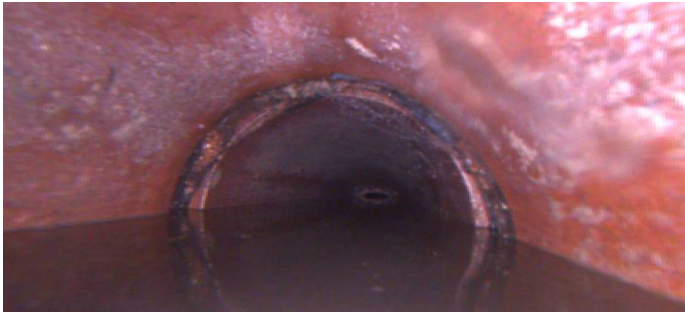
Code: **DAE**  
Description: **Deposits Attached Encrustation**

Distance (ft): **42.1**  
Structural Grade: **0**  
O&M Grade: **3**  
Clock Start/From: **9**  
Clock To: **3**  
1st Value:  
2nd Value:  
Value Percent: **15.000**  
Continuous Index:  
Within 8" of Joint: **YES**  
Remarks:

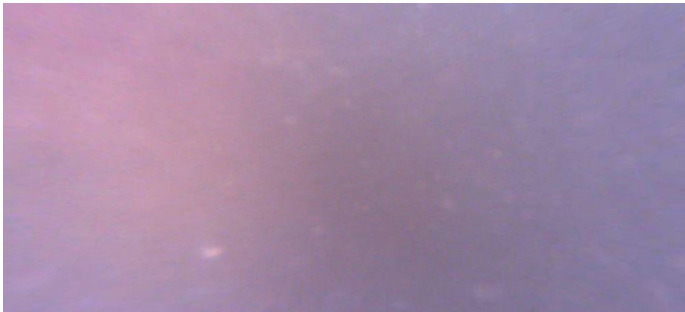
Code: **MWLS**  
Description: **Water Level Sag**

Distance (ft): **44.4**  
Structural Grade: **2**  
O&M Grade: **3**  
Clock Start/From:  
Clock To:  
1st Value:  
2nd Value:  
Value Percent: **30.000**  
Continuous Index:  
Within 8" of Joint: **NO**  
Remarks:

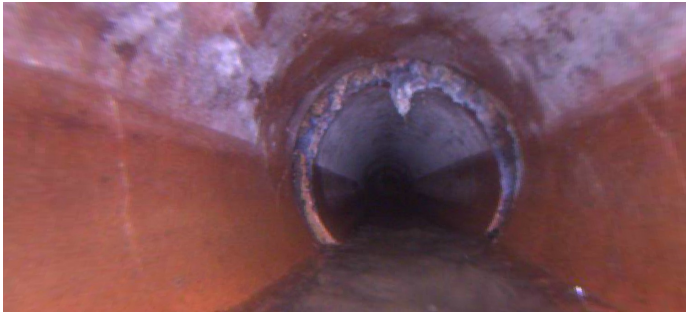
Code: **DAE**  
Description: **Deposits Attached Encrustation**

Distance (ft): **51.8**  
Structural Grade: **0**  
O&M Grade: **3**  
Clock Start/From: **9**  
Clock To: **3**  
1st Value:  
2nd Value:  
Value Percent: **20.000**  
Continuous Index:  
Within 8" of Joint: **YES**  
Remarks:

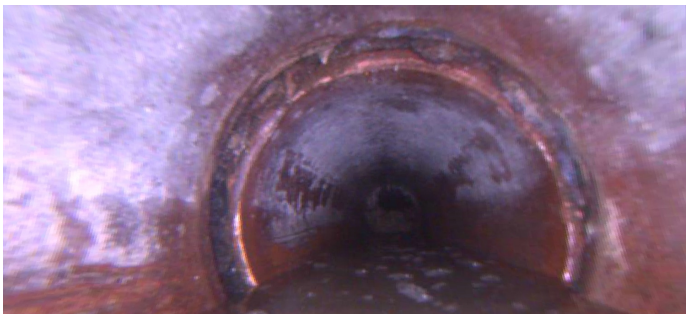
Code: **DAE**  
Description: **Deposits Attached Encrustation**

Distance (ft): **56.3**  
Structural Grade: **0**  
O&M Grade: **3**  
Clock Start/From: **8**  
Clock To: **4**  
1st Value:  
2nd Value:  
Value Percent: **15.000**  
Continuous Index:  
Within 8" of Joint: **YES**  
Remarks:

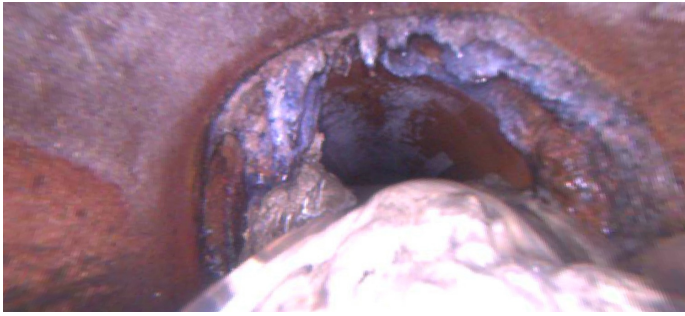
Code: **DSZ**  
Description: **Deposits Settled Other**

Distance (ft): **60.7**  
Structural Grade: **0**  
O&M Grade: **5**  
Clock Start/From: **6**  
Clock To:  
1st Value:  
2nd Value:  
Value Percent: **40.000**  
Continuous Index:  
Within 8" of Joint: **YES**  
Remarks: **mixed material**

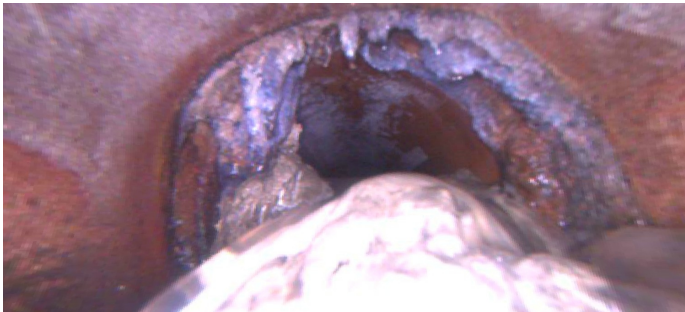
Code: **DAE**  
Description: **Deposits Attached Encrustation**

Distance (ft): **60.7**  
Structural Grade: **0**  
O&M Grade: **4**  
Clock Start/From: **8**  
Clock To: **4**  
1st Value:  
2nd Value:  
Value Percent: **30.000**  
Continuous Index:  
Within 8" of Joint: **YES**  
Remarks:

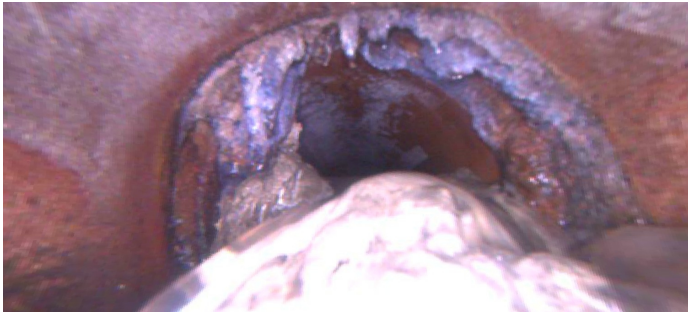
Code:	<b>MSA</b>
Description:	<b>Abandoned Survey</b>
Distance (ft):	<b>60.7</b>
Structural Grade:	<b>0</b>
O&M Grade:	<b>0</b>
Clock Start/From:	
Clock To:	
1st Value:	
2nd Value:	
Value Percent:	
Continuous Index:	
Within 8" of Joint:	<b>NO</b>
Remarks:	<b>mixed material blocking camera passage</b>
