Profile/Photo Observation Report

Date:	10/08/2018	Weather:		Coding:	PACP 6.0
Pipe Length (ft):	325.0	Owner:	NA	Pre Clean:	Not Known
P.O.#:		Surveyor:	Selasie Honu	PSR:	P-507-023-013
Customer:		Clean Date:	01/01/1900	Shape:	C

Street:	Csokasy Ln.	Flow Control:	Not Controlled
City:	Hobart, IN	Year Renewed:	
Location:	Light Highway	Tape/Media #:	
Purpose:	Routine Assessment	Dia/Height:	12"
Use:	Sanitary	Material:	VCP
Drain Area:	NA	Lining:	
Category:	NA		
Comment:

Location Details:		Direction of Survey:	Downstream
US MH:	M-507-013	DS MH:	M-507-023
		Total Length Surveyed (ft):	60.7

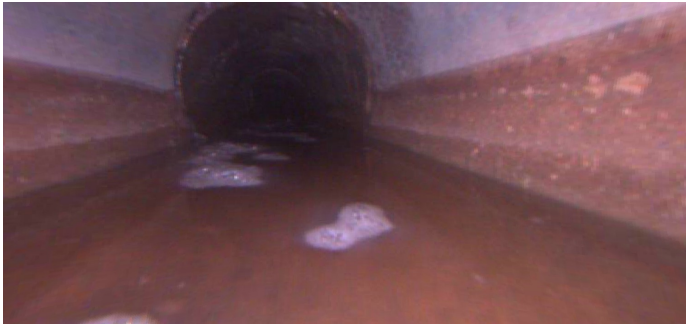
Code: **AMH**
Description: **Manhole**

Distance (ft): **.0**
Structural Grade: **0**
O&M Grade: **0**
Clock Start/From:
Clock To:
1st Value:
2nd Value:
Value Percent:
Continuous Index:
Within 8" of Joint: **NO**
Remarks: **M-507-013**

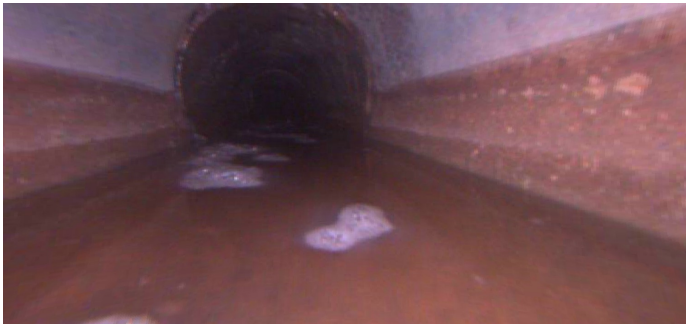
Code: **MWL**
Description: **Water Level**

Distance (ft): **.0**
Structural Grade: **0**
O&M Grade: **0**
Clock Start/From:
Clock To:
1st Value:
2nd Value:
Value Percent: **5.000**
Continuous Index:
Within 8" of Joint: **NO**
Remarks:

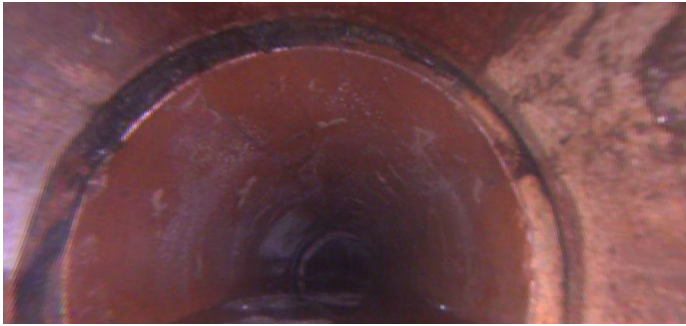
Code: **FL**
Description: **Fracture Longitudinal**

Distance (ft): **14.4**
Structural Grade: **3**
O&M Grade: **0**
Clock Start/From: **11**
Clock To:
1st Value:
2nd Value:
Value Percent:
Continuous Index:
Within 8" of Joint: **YES**
Remarks:

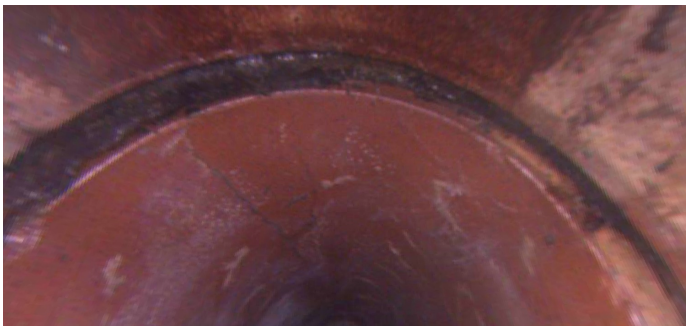
Code: **FL**
Description: **Fracture Longitudinal**

Distance (ft): **14.6**
Structural Grade: **3**
O&M Grade: **0**
Clock Start/From: **12**
Clock To:
1st Value:
2nd Value:
Value Percent:
Continuous Index:
Within 8" of Joint:
Remarks:

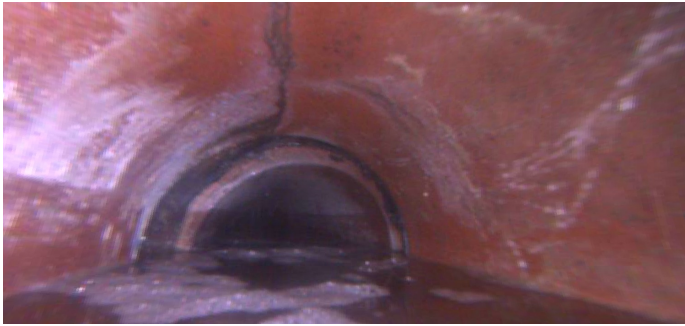
Code: **FL**
Description: **Fracture Longitudinal**

Distance (ft): **16.8**
Structural Grade: **3**
O&M Grade: **0**
Clock Start/From: **12**
Clock To:
1st Value:
2nd Value:
Value Percent:
Continuous Index:
Within 8" of Joint:
Remarks:

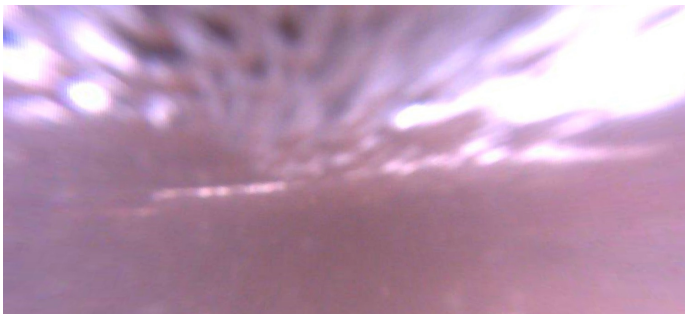
Code: **MWLS**
Description: **Water Level Sag**

Distance (ft): **20.0**
Structural Grade: **2**
O&M Grade: **3**
Clock Start/From:
Clock To:
1st Value:
2nd Value:
Value Percent: **15.000**
Continuous Index:
Within 8" of Joint: **NO**
Remarks:

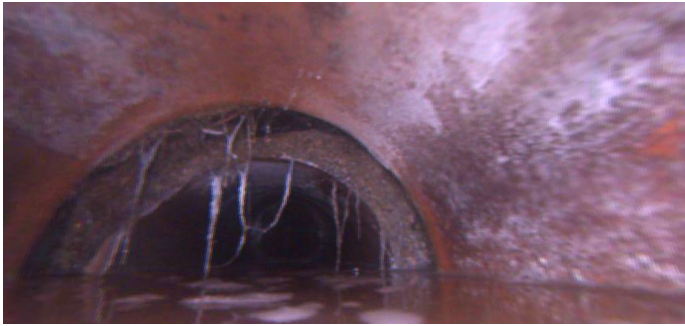
Code: **JOM**
Description: **Joint Offset Medium**

Distance (ft): **20.4**
Structural Grade: **1**
O&M Grade: **0**
Clock Start/From:
Clock To:
1st Value:
2nd Value:
Value Percent:
Continuous Index:
Within 8" of Joint: **NO**
Remarks:

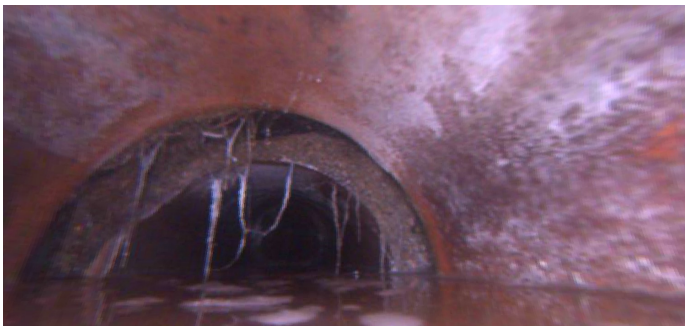
Code: **RFJ**
Description: **Roots Fine Joint**

Distance (ft): **20.4**
Structural Grade: **0**
O&M Grade: **1**
Clock Start/From: **9**
Clock To: **3**
1st Value:
2nd Value:
Value Percent:
Continuous Index:
Within 8" of Joint: **YES**
Remarks:

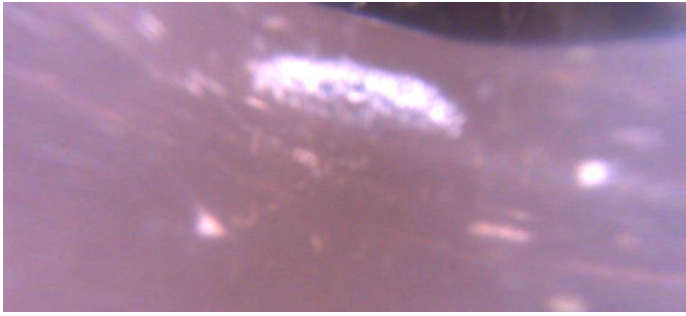
Code: **MWLS**
Description: **Water Level Sag**

Distance (ft): **20.9**
Structural Grade: **2**
O&M Grade: **3**
Clock Start/From:
Clock To:
1st Value:
2nd Value:
Value Percent: **15.000**
Continuous Index:
Within 8" of Joint: **NO**
Remarks:

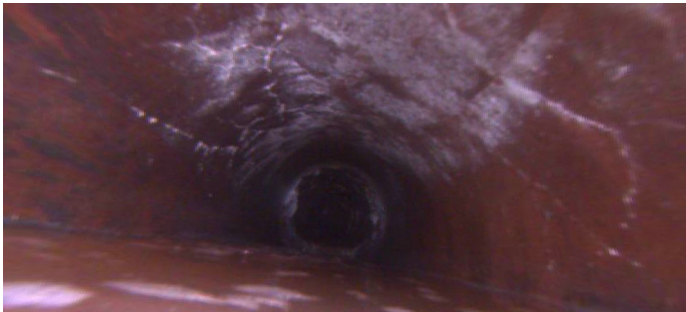
Code: **CM**
Description: **Crack Multiple**

Distance (ft): **21.7**
Structural Grade: **3**
O&M Grade: **0**
Clock Start/From: **9**
Clock To: **4**
1st Value:
2nd Value:
Value Percent:
Continuous Index:
Within 8" of Joint:
Remarks:

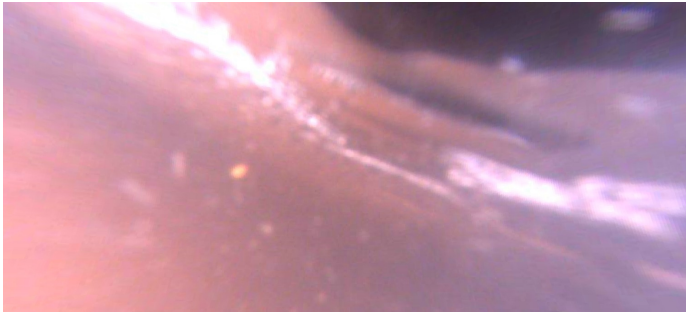
Code: **MWLS**
Description: **Water Level Sag**

Distance (ft): **22.1**
Structural Grade: **2**
O&M Grade: **3**
Clock Start/From:
Clock To:
1st Value:
2nd Value:
Value Percent: **15.000**
Continuous Index:
Within 8" of Joint: **NO**
Remarks:

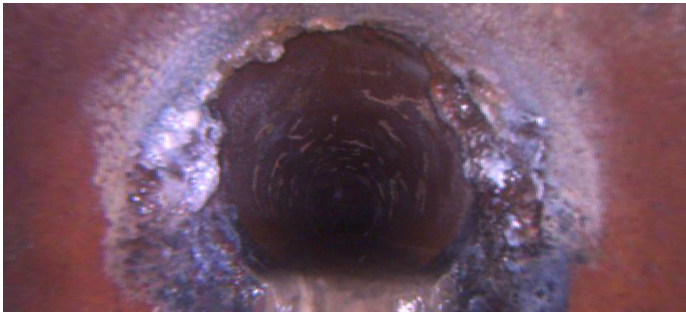
Code: **DAE**
Description: **Deposits Attached Encrustation**

Distance (ft): **23.7**
Structural Grade: **0**
O&M Grade: **4**
Clock Start/From: **6**
Clock To: **6**
1st Value:
2nd Value:
Value Percent: **30.000**
Continuous Index:
Within 8" of Joint: **YES**
Remarks:

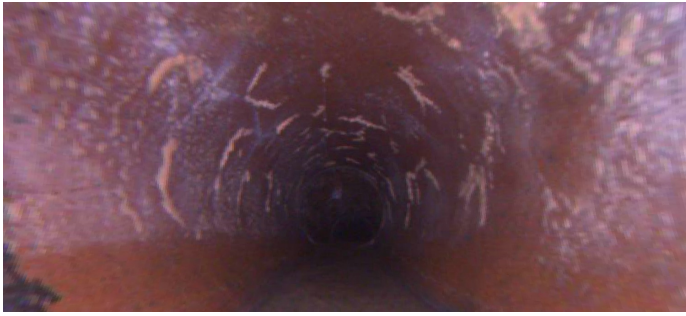
Code: **FM**
Description: **Fracture Multiple**

Distance (ft): **24.5**
Structural Grade: **4**
O&M Grade: **0**
Clock Start/From: **8**
Clock To: **4**
1st Value:
2nd Value:
Value Percent:
Continuous Index:
Within 8" of Joint:
Remarks:

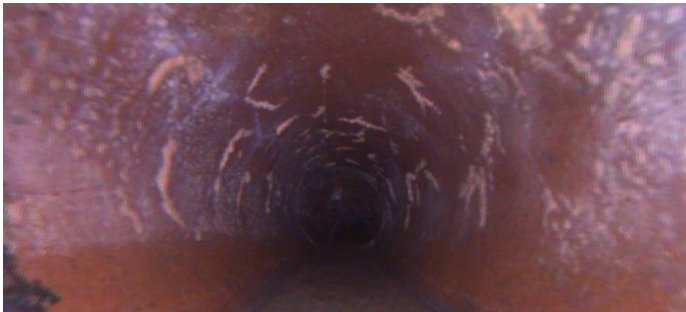
Code: **RFJ**
Description: **Roots Fine Joint**

Distance (ft): **24.5**
Structural Grade: **0**
O&M Grade: **1**
Clock Start/From: **8**
Clock To: **4**
1st Value:
2nd Value:
Value Percent:
Continuous Index:
Within 8" of Joint: **YES**
Remarks:

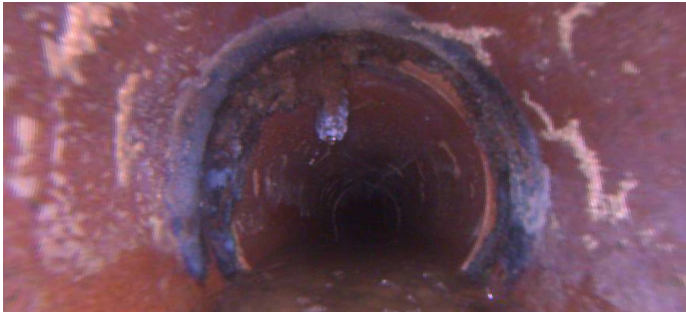
Code: **DAE**
Description: **Deposits Attached Encrustation**

Distance (ft): **26.6**
Structural Grade: **0**
O&M Grade: **3**
Clock Start/From: **8**
Clock To: **4**
1st Value:
2nd Value:
Value Percent: **15.000**
Continuous Index:
Within 8" of Joint: **YES**
Remarks:

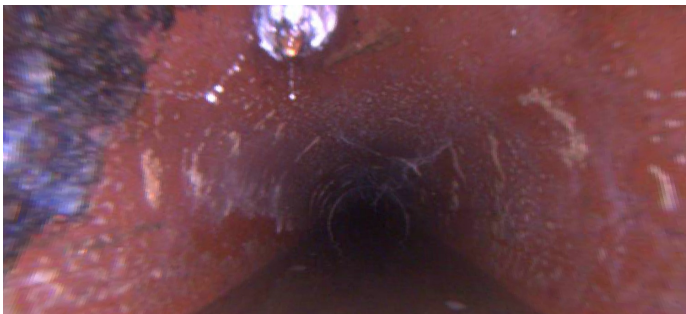
Code: **FM**
Description: **Fracture Multiple**

Distance (ft): **27.2**
Structural Grade: **4**
O&M Grade: **0**
Clock Start/From: **8**
Clock To: **4**
1st Value:
2nd Value:
Value Percent:
Continuous Index:
Within 8" of Joint:
Remarks:

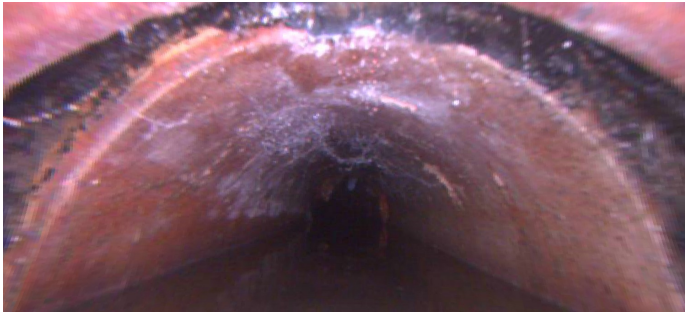
Code: **FM**
Description: **Fracture Multiple**

Distance (ft): **30.3**
Structural Grade: **4**
O&M Grade: **0**
Clock Start/From: **9**
Clock To: **3**
1st Value:
2nd Value:
Value Percent:
Continuous Index:
Within 8" of Joint:
Remarks:

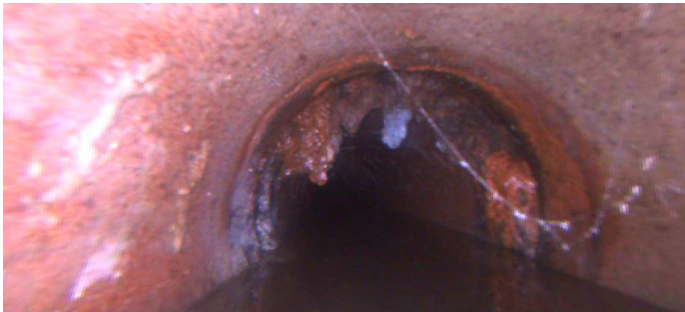
Code: **DAE**
Description: **Deposits Attached Encrustation**

Distance (ft): **32.7**
Structural Grade: **0**
O&M Grade: **3**
Clock Start/From: **8**
Clock To: **4**
1st Value:
2nd Value:
Value Percent: **20.000**
Continuous Index:
Within 8" of Joint: **YES**
Remarks:

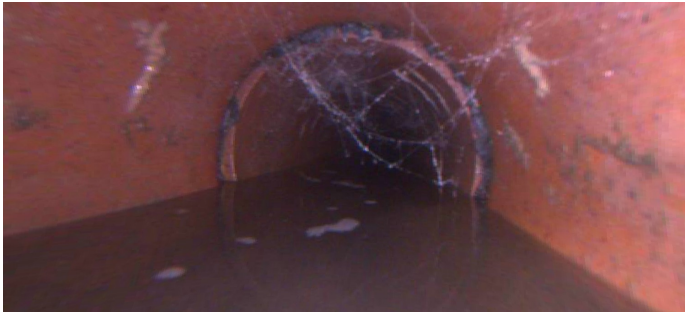
Code: **RFJ**
Description: **Roots Fine Joint**

Distance (ft): **35.8**
Structural Grade: **0**
O&M Grade: **1**
Clock Start/From: **8**
Clock To: **4**
1st Value:
2nd Value:
Value Percent:
Continuous Index:
Within 8" of Joint: **YES**
Remarks:

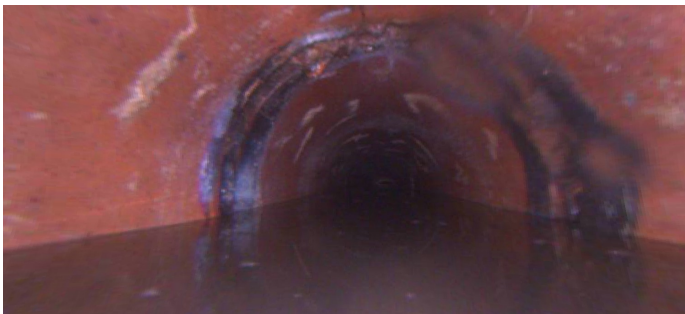
Code: **DAE**
Description: **Deposits Attached Encrustation**

Distance (ft): **39.0**
Structural Grade: **0**
O&M Grade: **3**
Clock Start/From: **8**
Clock To: **4**
1st Value:
2nd Value:
Value Percent: **15.000**
Continuous Index:
Within 8" of Joint: **YES**
Remarks:

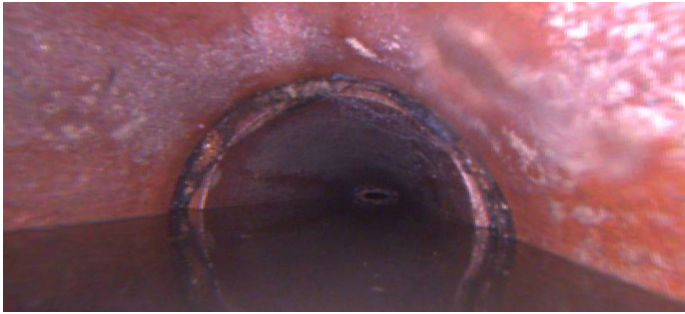
Code: **DAE**
Description: **Deposits Attached Encrustation**

Distance (ft): **42.1**
Structural Grade: **0**
O&M Grade: **3**
Clock Start/From: **9**
Clock To: **3**
1st Value:
2nd Value:
Value Percent: **15.000**
Continuous Index:
Within 8" of Joint: **YES**
Remarks:

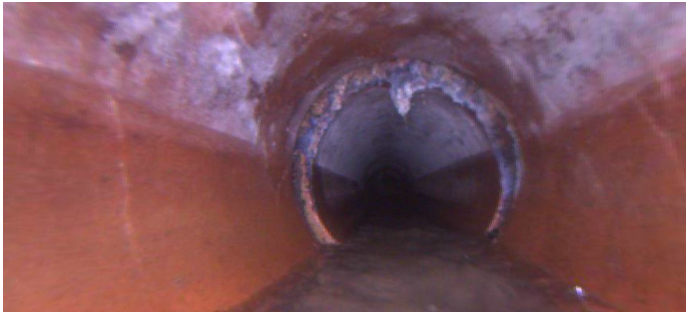
Code: **DAE**
Description: **Deposits Attached Encrustation**

Distance (ft): **51.8**
Structural Grade: **0**
O&M Grade: **3**
Clock Start/From: **9**
Clock To: **3**
1st Value:
2nd Value:
Value Percent: **20.000**
Continuous Index:
Within 8" of Joint: **YES**
Remarks:

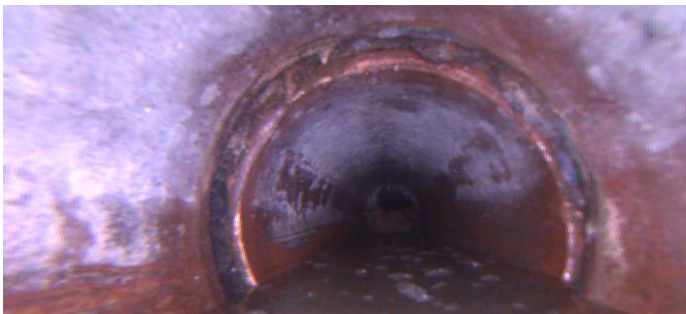
Code: **DAE**
Description: **Deposits Attached Encrustation**

Distance (ft): **56.3**
Structural Grade: **0**
O&M Grade: **3**
Clock Start/From: **8**
Clock To: **4**
1st Value:
2nd Value:
Value Percent: **15.000**
Continuous Index:
Within 8" of Joint: **YES**
Remarks:

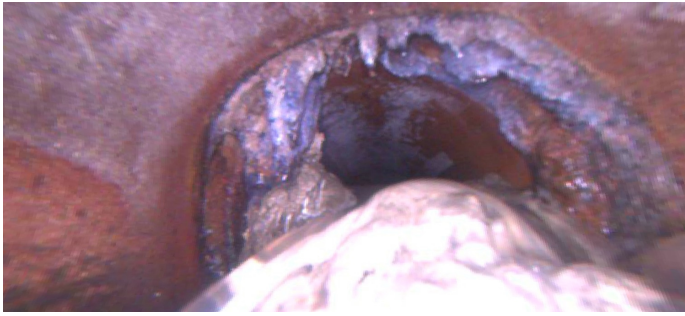
Code: **DSZ**
Description: **Deposits Settled Other**

Distance (ft): **60.7**
Structural Grade: **0**
O&M Grade: **5**
Clock Start/From: **6**
Clock To:
1st Value:
2nd Value:
Value Percent: **40.000**
Continuous Index:
Within 8" of Joint: **YES**
Remarks: **mixed material**

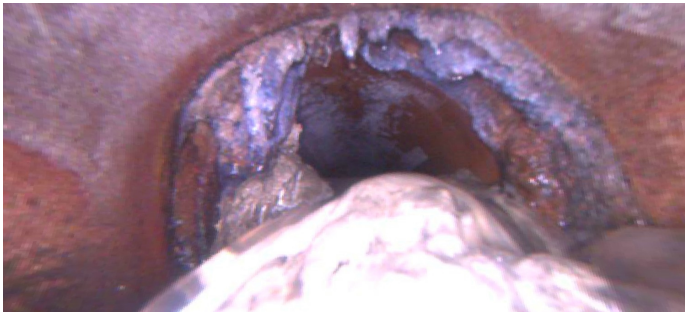
Code: **DAE**
Description: **Deposits Attached Encrustation**

Distance (ft): **60.7**
Structural Grade: **0**
O&M Grade: **4**
Clock Start/From: **8**
Clock To: **4**
1st Value:
2nd Value:
Value Percent: **30.000**
Continuous Index:
Within 8" of Joint: **YES**
Remarks:

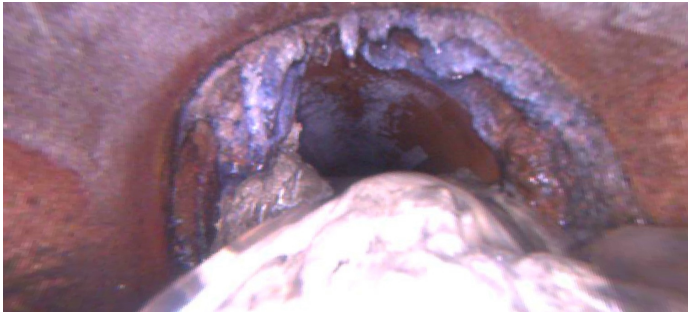
Code:	MSA
Description:	Abandoned Survey
Distance (ft):	60.7
Structural Grade:	0
O&M Grade:	0
Clock Start/From:	
Clock To:	
1st Value:	
2nd Value:	
Value Percent:	
Continuous Index:	
Within 8" of Joint:	NO
Remarks:	mixed material blocking camera passage
