Profile/Photo Observation Report

Date:	03/27/2018	Weather:		Coding:	PACP 6.0
Pipe Length (ft):	145.7	Owner:	NA	Pre Clean:	No Pre-Cleaning
P.O.#:		Surveyor:	Jen Costello	PSR:	P-507-015-014
Customer:		Clean Date:	01/01/1900	Shape:	C

Street:	FOXCROFT STREET	Flow Control:	Not Controlled
City:	Hobart, IN	Year Renewed:	
Location:	Yard	Tape/Media #:	
Purpose:	Routine Assessment	Dia/Height:	10"
Use:	Sanitary	Material:	VCP
Drain Area:	NA	Lining:	
Category:	NA		
Comment:	Flow direction wrong

Location Details:		Direction of Survey:	Downstream
US MH:	M-507-014	DS MH:	M-507-015
		Total Length Surveyed (ft):	142.7

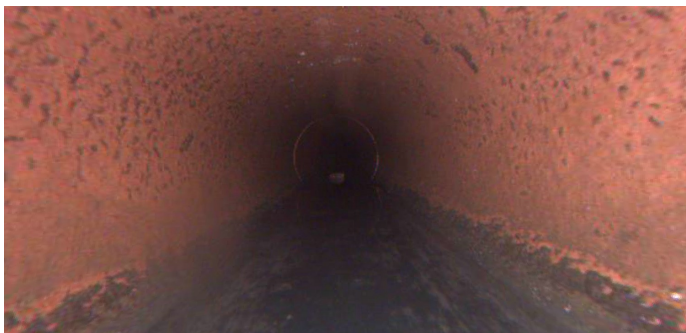
Code: **AMH**
Description: **Manhole**

Distance (ft): **.0**
Structural Grade: **0**
O&M Grade: **0**
Clock Start/From:
Clock To:
1st Value:
2nd Value:
Value Percent:
Continuous Index:
Within 8" of Joint: **NO**
Remarks: **M-507-014**

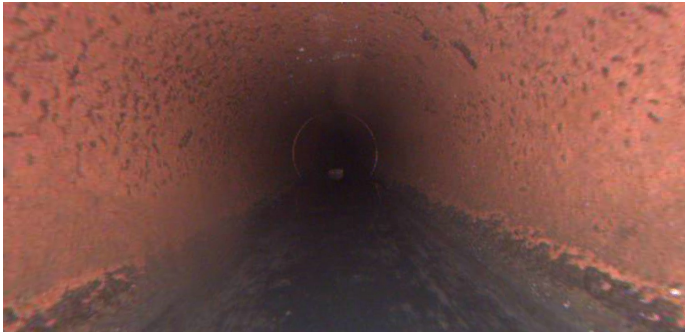
Code:	MWL
Description:	Water Level

Distance (ft):	.0
Structural Grade:	0
O&M Grade:	0
Clock Start/From:	
Clock To:	
1st Value:	
2nd Value:	
Value Percent:	10.000
Continuous Index:	
Within 8" of Joint:	NO
Remarks:

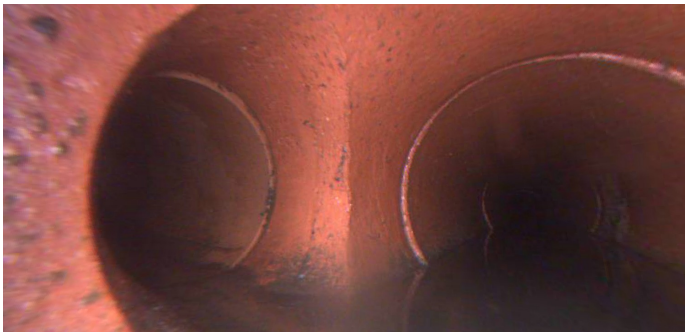
Code:	TFA
Description:	Tap Factory Active

Distance (ft):	24.8
Structural Grade:	0
O&M Grade:	0
Clock Start/From:	9
Clock To:	
1st Value:	4.000
2nd Value:	
Value Percent:	
Continuous Index:	
Within 8" of Joint:	
Remarks:

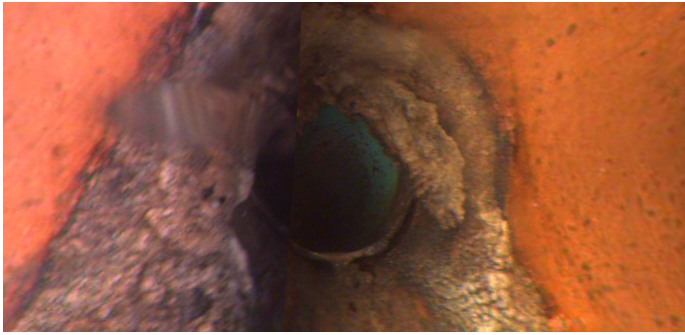
Code: **TBD**
Description: **Tap Break-in Defective**

Distance (ft): **27.3**
Structural Grade: **0**
O&M Grade: **3**
Clock Start/From: **3**
Clock To:
1st Value: **4.000**
2nd Value:
Value Percent:
Continuous Index:
Within 8" of Joint:
Remarks: **dae**

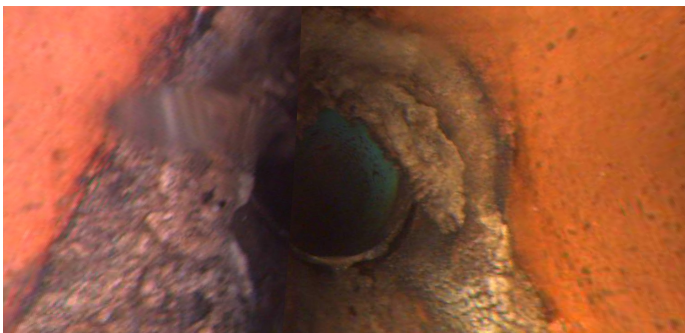
Code: **DAE**
Description: **Deposits Attached Encrustation**

Distance (ft): **27.3**
Structural Grade: **0**
O&M Grade: **2**
Clock Start/From: **1**
Clock To: **4**
1st Value:
2nd Value:
Value Percent: **5.000**
Continuous Index:
Within 8" of Joint: **NO**
Remarks:

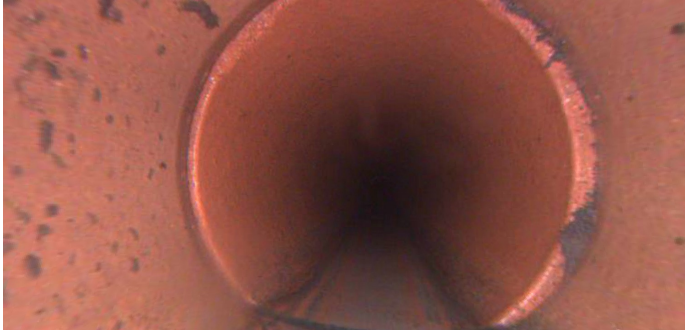
Code: **MWL**
Description: **Water Level**

Distance (ft): **56.9**
Structural Grade: **0**
O&M Grade: **0**
Clock Start/From:
Clock To:
1st Value:
2nd Value:
Value Percent: **5.000**
Continuous Index:
Within 8" of Joint: **NO**
Remarks:

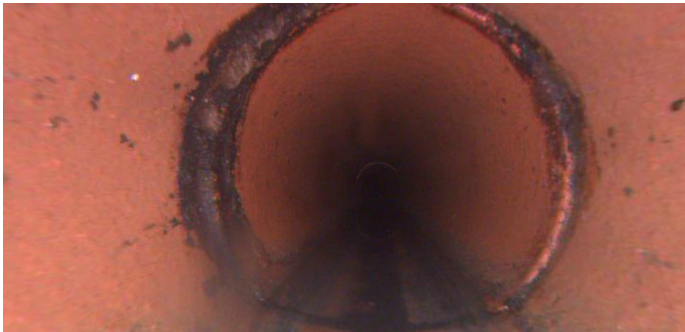
Code: **IW**
Description: **Infil Weeper**

Distance (ft): **61.8**
Structural Grade: **0**
O&M Grade: **2**
Clock Start/From: **8**
Clock To: **4**
1st Value:
2nd Value:
Value Percent:
Continuous Index:
Within 8" of Joint: **YES**
Remarks:

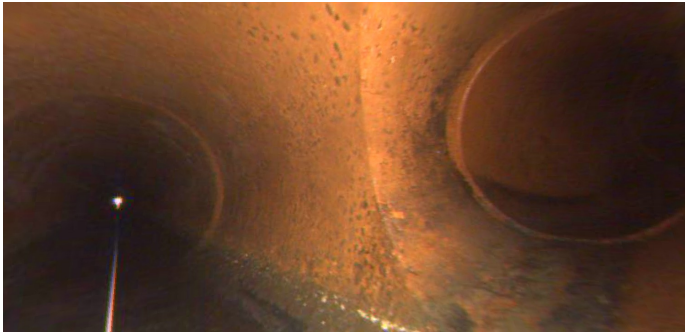
Code: **TF**
Description: **Tap Factory**

Distance (ft): **93.7**
Structural Grade: **0**
O&M Grade: **0**
Clock Start/From: **9**
Clock To:
1st Value: **4.000**
2nd Value:
Value Percent:
Continuous Index:
Within 8" of Joint:
Remarks:

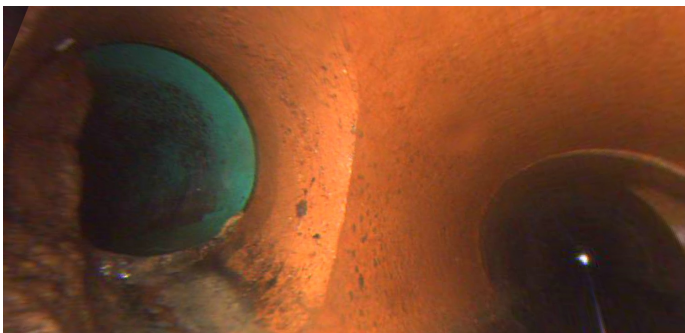
Code: **TFA**
Description: **Tap Factory Active**

Distance (ft): **95.7**
Structural Grade: **0**
O&M Grade: **0**
Clock Start/From: **3**
Clock To:
1st Value: **4.000**
2nd Value:
Value Percent:
Continuous Index:
Within 8" of Joint:
Remarks:

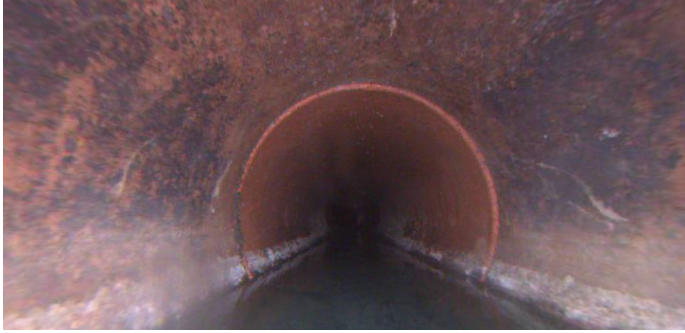
Code: **CM**
Description: **Crack Multiple**

Distance (ft): **134.7**
Structural Grade: **3**
O&M Grade: **0**
Clock Start/From: **8**
Clock To: **4**
1st Value:
2nd Value:
Value Percent:
Continuous Index:
Within 8" of Joint: **YES**
Remarks:

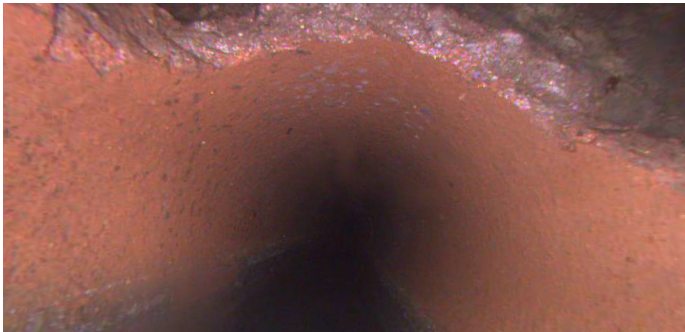
Code: **AMH**
Description: **Manhole**

Distance (ft): **142.7**
Structural Grade: **0**
O&M Grade: **0**
Clock Start/From:
Clock To:
1st Value:
2nd Value:
Value Percent:
Continuous Index:
Within 8" of Joint: **NO**
Remarks: **M-507-015**
