## Profile/Photo Observation Report

Date:	<b>04/05/2018</b>	Weather:		Coding:	<b>PACP 6.0</b>
Pipe Length (ft):	<b>163.3</b>	Owner:	<b>NA</b>	Pre Clean:	<b>No Pre-Cleaning</b>
P.O.#:		Surveyor:	<b>Jen Costello</b>	PSR:	<b>P-507-017-016</b>
Customer:		Clean Date:	<b>01/01/1900</b>	Shape:	<b>C</b>

Street:	<b>ALLEY BETWEEN S DELAWARE ST &amp; S</b>	Flow Control:	<b>Not Controlled</b>
City:	<b>Hobart, IN</b>	Year Renewed:	
Location:	<b>Yard</b>	Tape/Media #:	
Purpose:	<b>Routine Assessment</b>	Dia/Height:	<b>10"</b>
Use:	<b>Sanitary</b>	Material:	<b>PVC</b>
Drain Area:	<b>NA</b>	Lining:	
Category:	<b>NA</b>		
Comment:	<b>Flow direction is marked wrong.</b>		
Location Details:		Direction of Survey:	<b>Downstream</b>
US MH:	<b>M-507-016</b>	DS MH:	<b>M-507-017</b>
		Total Length Surveyed (ft):	<b>170.3</b>

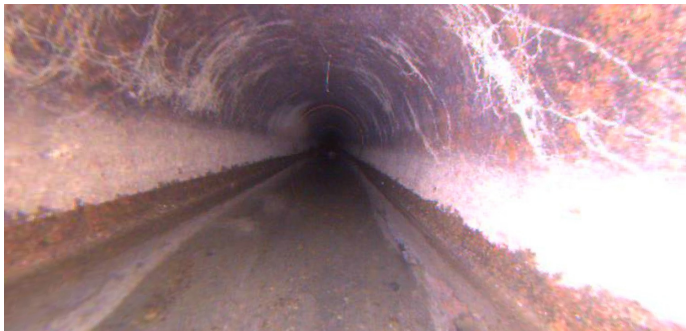
Code: **AMH**  
Description: **Manhole**

Distance (ft): **.0**  
Structural Grade: **0**  
O&M Grade: **0**  
Clock Start/From:  
Clock To:  
1st Value:  
2nd Value:  
Value Percent:  
Continuous Index:  
Within 8" of Joint: **NO**  
Remarks: **M-507-016**

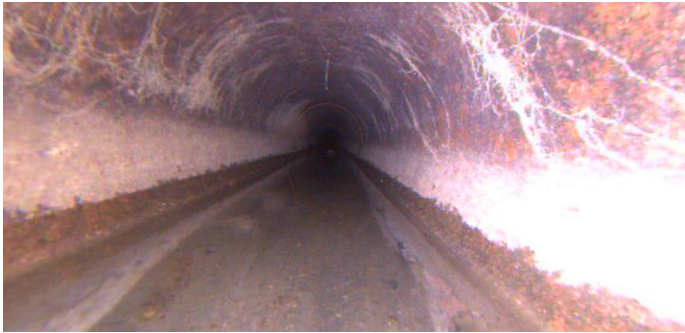
Code:	<b>MWL</b>
Description:	<b>Water Level</b>

Distance (ft):	<b>.0</b>
Structural Grade:	<b>0</b>
O&M Grade:	<b>0</b>
Clock Start/From:	
Clock To:	
1st Value:	
2nd Value:	
Value Percent:	<b>5.000</b>
Continuous Index:	
Within 8" of Joint:	<b>NO</b>
Remarks:

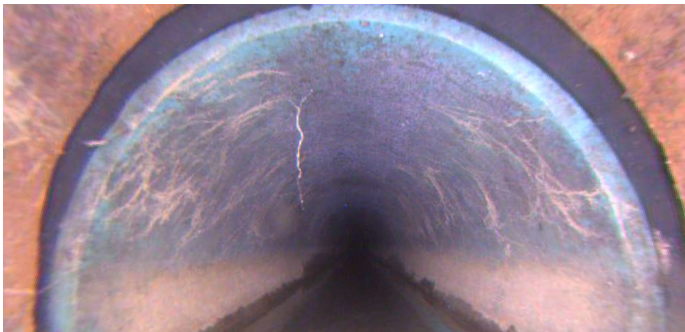
Code:	<b>JOM</b>
Description:	<b>Joint Offset Medium</b>

Distance (ft):	<b>8.8</b>
Structural Grade:	<b>1</b>
O&M Grade:	<b>0</b>
Clock Start/From:	
Clock To:	
1st Value:	
2nd Value:	
Value Percent:	
Continuous Index:	
Within 8" of Joint:	<b>NO</b>
Remarks:

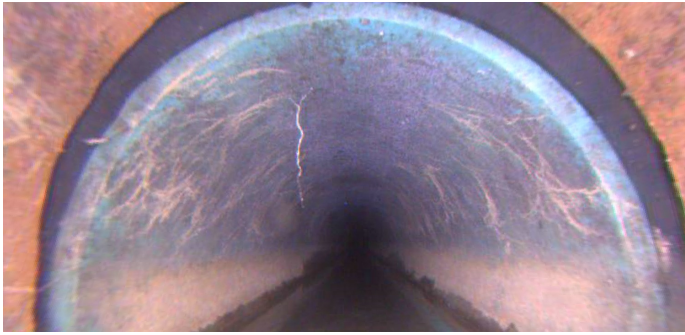
Code: **MMC**  
Description: **Material Change**

Distance (ft): **8.8**  
Structural Grade: **0**  
O&M Grade: **0**  
Clock Start/From:  
Clock To:  
1st Value:  
2nd Value:  
Value Percent:  
Continuous Index:  
Within 8" of Joint: **NO**  
Remarks: **pvc**

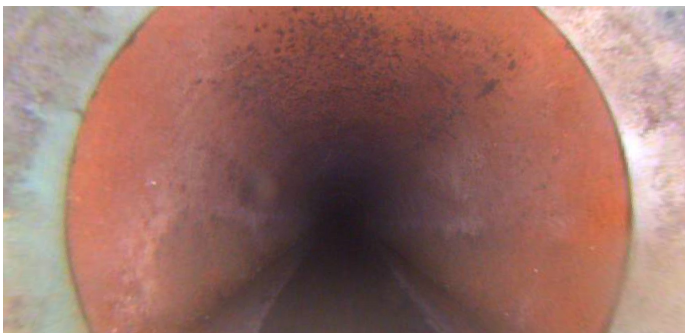
Code: **MMC**  
Description: **Material Change**

Distance (ft): **19.8**  
Structural Grade: **0**  
O&M Grade: **0**  
Clock Start/From:  
Clock To:  
1st Value:  
2nd Value:  
Value Percent:  
Continuous Index:  
Within 8" of Joint: **NO**  
Remarks: **VCP**

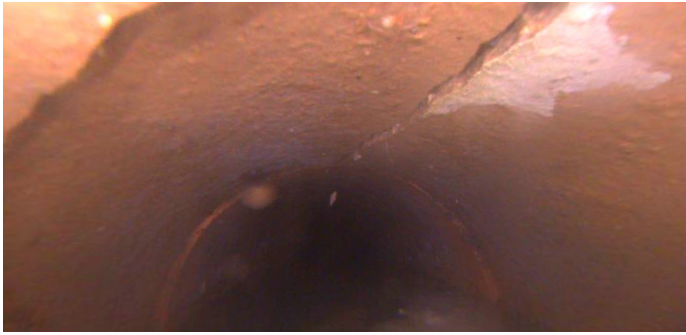
Code: **FM**  
Description: **Fracture Multiple**

Distance (ft): **29.1**  
Structural Grade: **4**  
O&M Grade: **0**  
Clock Start/From: **8**  
Clock To: **4**  
1st Value:  
2nd Value:  
Value Percent:  
Continuous Index:  
Within 8" of Joint: **YES**  
Remarks:

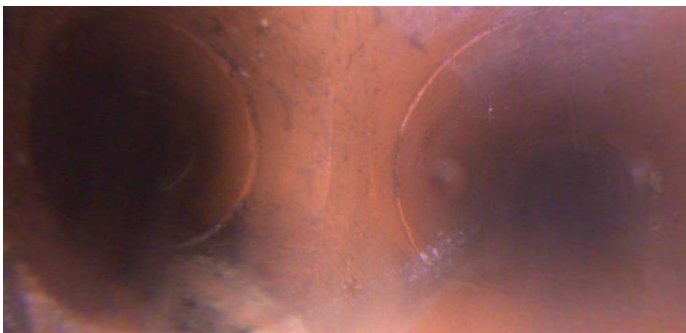
Code: **TFA**  
Description: **Tap Factory Active**

Distance (ft): **51.2**  
Structural Grade: **0**  
O&M Grade: **0**  
Clock Start/From: **9**  
Clock To:  
1st Value: **4.000**  
2nd Value:  
Value Percent:  
Continuous Index:  
Within 8" of Joint:  
Remarks:

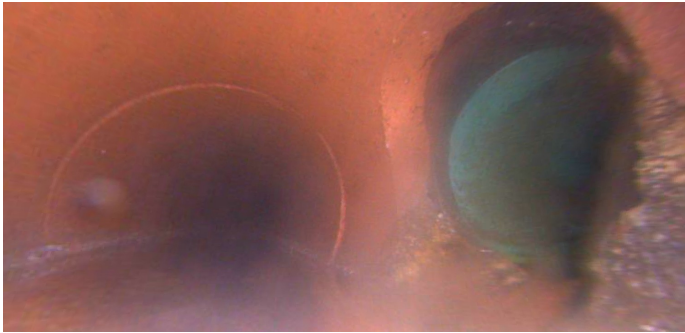
Code: **TFA**  
Description: **Tap Factory Active**

Distance (ft): **53.0**  
Structural Grade: **0**  
O&M Grade: **0**  
Clock Start/From: **3**  
Clock To:  
1st Value: **4.000**  
2nd Value:  
Value Percent:  
Continuous Index:  
Within 8" of Joint:  
Remarks:

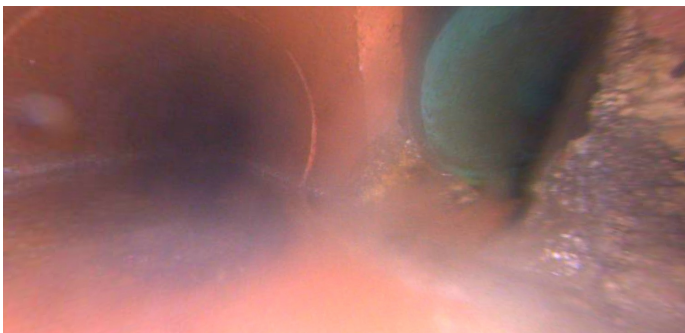
Code: **DAE**  
Description: **Deposits Attached Encrustation**

Distance (ft): **53.0**  
Structural Grade: **0**  
O&M Grade: **2**  
Clock Start/From: **3**  
Clock To: **4**  
1st Value:  
2nd Value:  
Value Percent: **5.000**  
Continuous Index:  
Within 8" of Joint: **NO**  
Remarks:

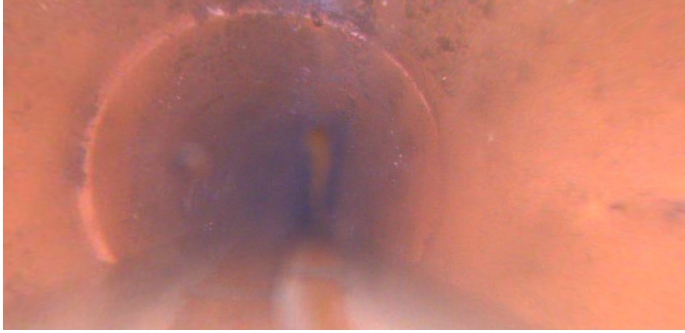
Code: **MWL**  
Description: **Water Level**

Distance (ft): **103.8**  
Structural Grade: **0**  
O&M Grade: **0**  
Clock Start/From:  
Clock To:  
1st Value:  
2nd Value:  
Value Percent: **30.000**  
Continuous Index:  
Within 8" of Joint: **NO**  
Remarks:

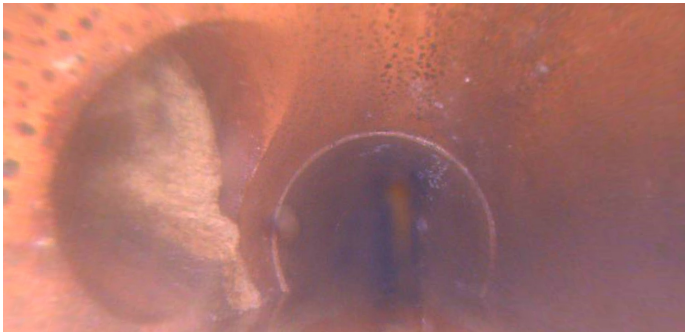
Code: **TFD**  
Description: **Tap Factory Defective**

Distance (ft): **130.8**  
Structural Grade: **0**  
O&M Grade: **2**  
Clock Start/From: **9**  
Clock To:  
1st Value: **4.000**  
2nd Value:  
Value Percent:  
Continuous Index:  
Within 8" of Joint:  
Remarks: **DAE**

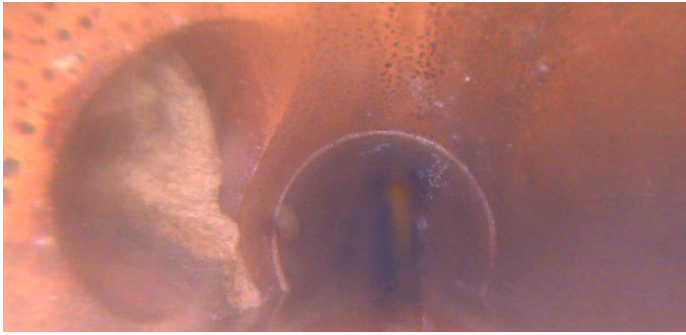
Code: **DAE**  
Description: **Deposits Attached Encrustation**

Distance (ft): **130.8**  
Structural Grade: **0**  
O&M Grade: **2**  
Clock Start/From: **8**  
Clock To: **9**  
1st Value:  
2nd Value:  
Value Percent: **5.000**  
Continuous Index:  
Within 8" of Joint: **NO**  
Remarks:

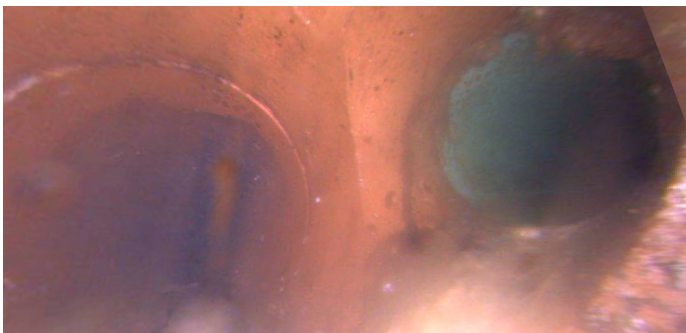
Code: **TFA**  
Description: **Tap Factory Active**

Distance (ft): **133.0**  
Structural Grade: **0**  
O&M Grade: **0**  
Clock Start/From: **3**  
Clock To:  
1st Value: **4.000**  
2nd Value:  
Value Percent:  
Continuous Index:  
Within 8" of Joint:  
Remarks:

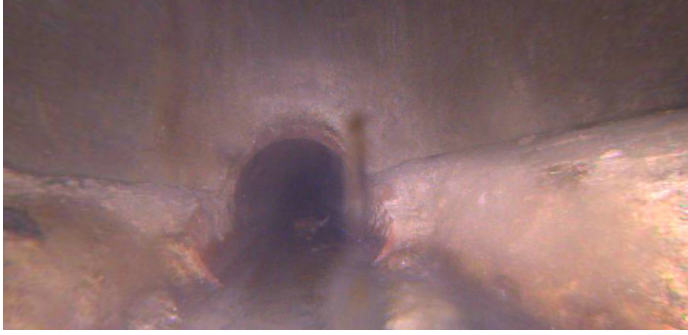
Code:	<b>AMH</b>
Description:	<b>Manhole</b>
Distance (ft):	<b>170.3</b>
Structural Grade:	<b>0</b>
O&M Grade:	<b>0</b>
Clock Start/From:	
Clock To:	
1st Value:	
2nd Value:	
Value Percent:	
Continuous Index:	
Within 8" of Joint:	<b>NO</b>
Remarks:	<b>M-507-017</b>
