## Profile/Photo Observation Report

Date:	<b>04/05/2018</b>	Weather:		Coding:	<b>PACP 6.0</b>
Pipe Length (ft):	<b>163.3</b>	Owner:	<b>NA</b>	Pre Clean:	<b>No Pre-Cleaning</b>
P.O.#:		Surveyor:	<b>Jen Costello</b>	PSR:	<b>P-507-017-016</b>
Customer:		Clean Date:	<b>01/01/1900</b>	Shape:	<b>C</b>

Street:	<b>FOXCROFT STREET</b>	Flow Control:	<b>Not Controlled</b>
City:	<b>Hobart, IN</b>	Year Renewed:	
Location:	<b>Yard</b>	Tape/Media #:	
Purpose:	<b>Routine Assessment</b>	Dia/Height:	<b>10"</b>
Use:	<b>Sanitary</b>	Material:	<b>PVC</b>
Drain Area:	<b>NA</b>	Lining:	
Category:	<b>NA</b>		
Comment:	<b>Flow direction is marked wrong.</b>		
Location Details:		Direction of Survey:	<b>Downstream</b>
US MH:	<b>M-507-016</b>	DS MH:	<b>M-507-017</b>
		Total Length Surveyed (ft):	<b>170.3</b>

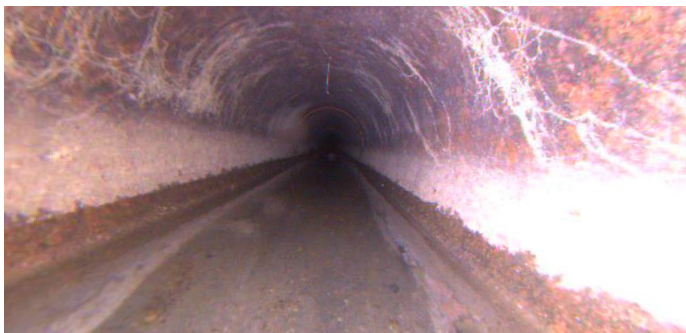
Code: **AMH**  
Description: **Manhole**

Distance (ft): **.0**  
Structural Grade: **0**  
O&M Grade: **0**  
Clock Start/From:  
Clock To:  
1st Value:  
2nd Value:  
Value Percent:  
Continuous Index:  
Within 8" of Joint: **NO**  
Remarks: **M-507-016**

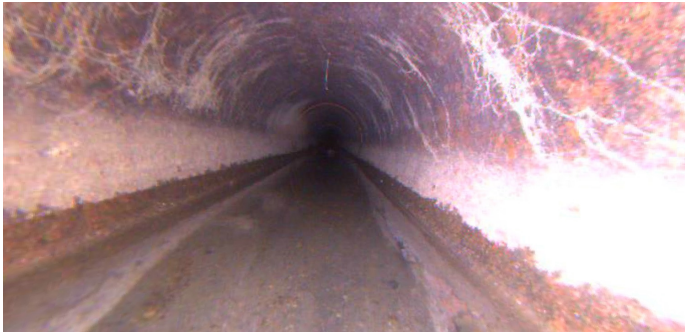
Code:	<b>MWL</b>
Description:	<b>Water Level</b>

Distance (ft):	<b>.0</b>
Structural Grade:	<b>0</b>
O&M Grade:	<b>0</b>
Clock Start/From:	
Clock To:	
1st Value:	
2nd Value:	
Value Percent:	<b>5.000</b>
Continuous Index:	
Within 8" of Joint:	<b>NO</b>
Remarks:

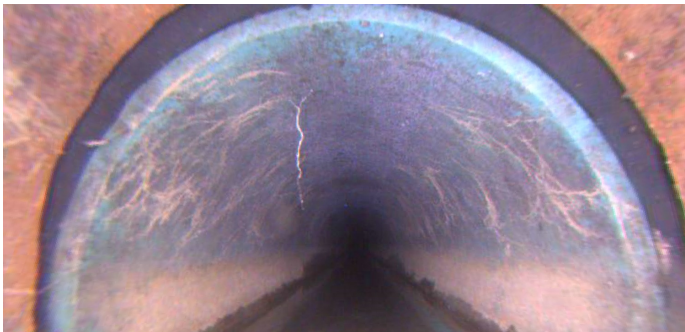
Code:	<b>JOM</b>
Description:	<b>Joint Offset Medium</b>

Distance (ft):	<b>8.8</b>
Structural Grade:	<b>1</b>
O&M Grade:	<b>0</b>
Clock Start/From:	
Clock To:	
1st Value:	
2nd Value:	
Value Percent:	
Continuous Index:	
Within 8" of Joint:	<b>NO</b>
Remarks:

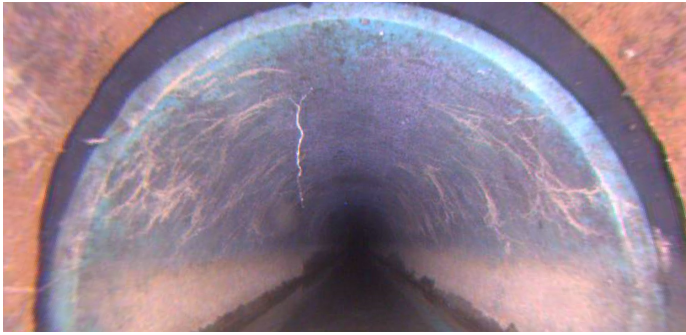
Code: **MMC**  
Description: **Material Change**

Distance (ft): **8.8**  
Structural Grade: **0**  
O&M Grade: **0**  
Clock Start/From:  
Clock To:  
1st Value:  
2nd Value:  
Value Percent:  
Continuous Index:  
Within 8" of Joint: **NO**  
Remarks: **pvc**

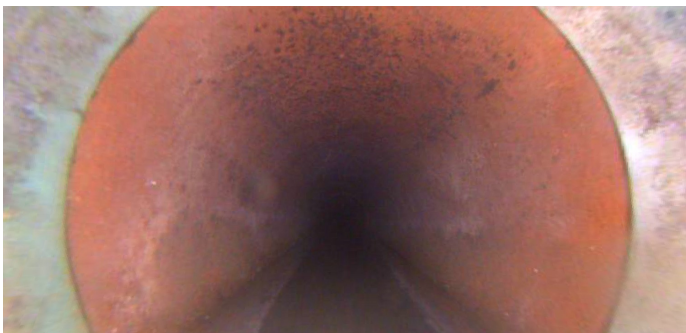
Code: **MMC**  
Description: **Material Change**

Distance (ft): **19.8**  
Structural Grade: **0**  
O&M Grade: **0**  
Clock Start/From:  
Clock To:  
1st Value:  
2nd Value:  
Value Percent:  
Continuous Index:  
Within 8" of Joint: **NO**  
Remarks: **VCP**

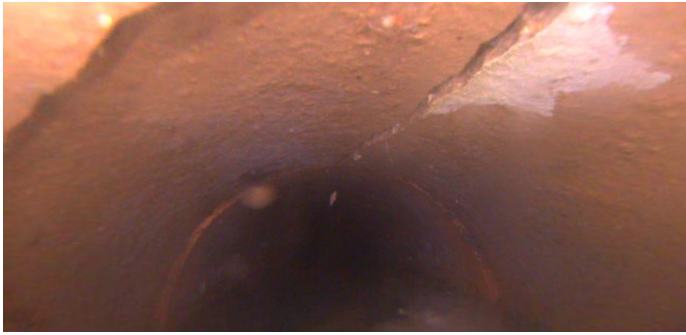
Code: **FM**  
Description: **Fracture Multiple**

Distance (ft): **29.1**  
Structural Grade: **4**  
O&M Grade: **0**  
Clock Start/From: **8**  
Clock To: **4**  
1st Value:  
2nd Value:  
Value Percent:  
Continuous Index:  
Within 8" of Joint: **YES**  
Remarks:

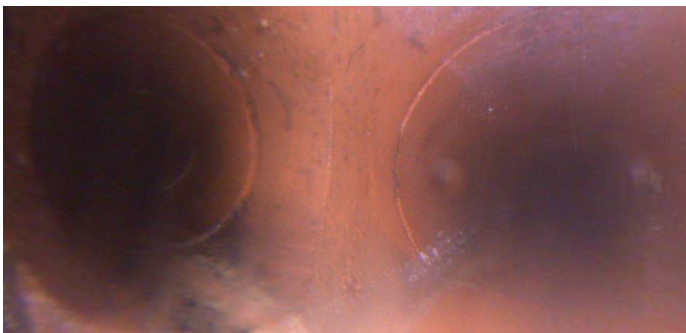
Code: **TFA**  
Description: **Tap Factory Active**

Distance (ft): **51.2**  
Structural Grade: **0**  
O&M Grade: **0**  
Clock Start/From: **9**  
Clock To:  
1st Value: **4.000**  
2nd Value:  
Value Percent:  
Continuous Index:  
Within 8" of Joint:  
Remarks:

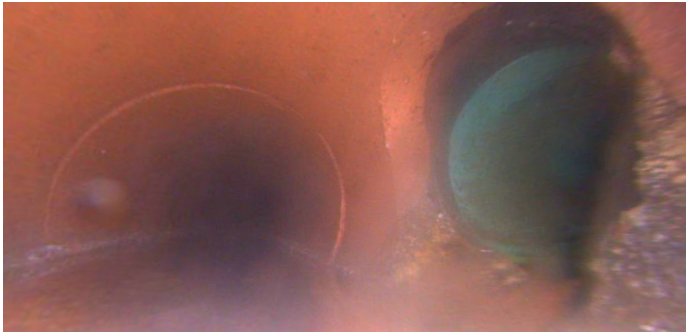
Code: **TFA**  
Description: **Tap Factory Active**

Distance (ft): **53.0**  
Structural Grade: **0**  
O&M Grade: **0**  
Clock Start/From: **3**  
Clock To:  
1st Value: **4.000**  
2nd Value:  
Value Percent:  
Continuous Index:  
Within 8" of Joint:  
Remarks:

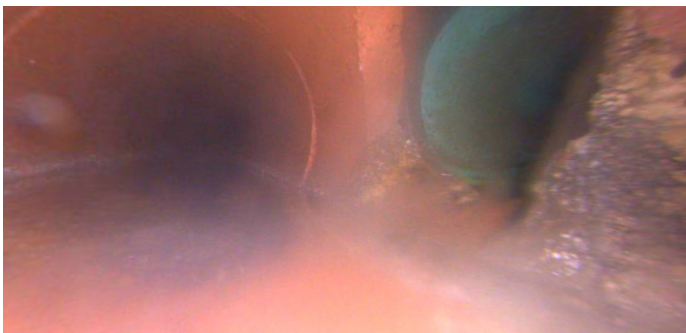
Code: **DAE**  
Description: **Deposits Attached Encrustation**

Distance (ft): **53.0**  
Structural Grade: **0**  
O&M Grade: **2**  
Clock Start/From: **3**  
Clock To: **4**  
1st Value:  
2nd Value:  
Value Percent: **5.000**  
Continuous Index:  
Within 8" of Joint: **NO**  
Remarks:

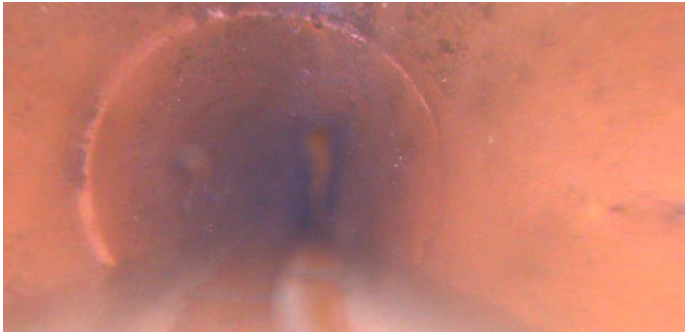
Code: **MWL**  
Description: **Water Level**

Distance (ft): **103.8**  
Structural Grade: **0**  
O&M Grade: **0**  
Clock Start/From:  
Clock To:  
1st Value:  
2nd Value:  
Value Percent: **30.000**  
Continuous Index:  
Within 8" of Joint: **NO**  
Remarks:

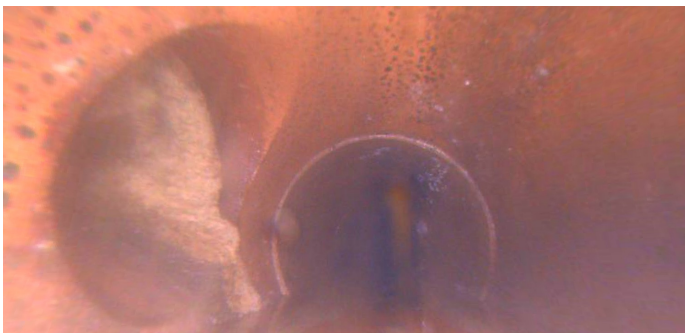
Code: **TFD**  
Description: **Tap Factory Defective**

Distance (ft): **130.8**  
Structural Grade: **0**  
O&M Grade: **2**  
Clock Start/From: **9**  
Clock To:  
1st Value: **4.000**  
2nd Value:  
Value Percent:  
Continuous Index:  
Within 8" of Joint:  
Remarks: **DAE**

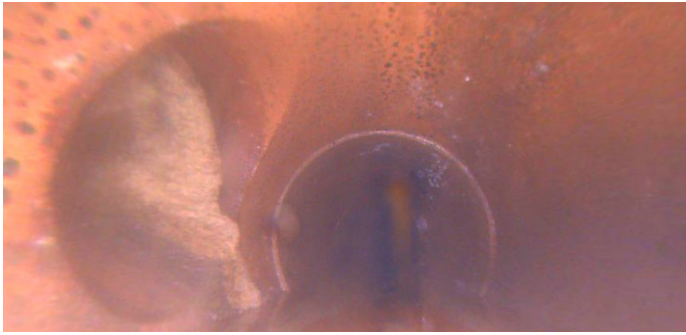
Code: **DAE**  
Description: **Deposits Attached Encrustation**

Distance (ft): **130.8**  
Structural Grade: **0**  
O&M Grade: **2**  
Clock Start/From: **8**  
Clock To: **9**  
1st Value:  
2nd Value:  
Value Percent: **5.000**  
Continuous Index:  
Within 8" of Joint: **NO**  
Remarks:

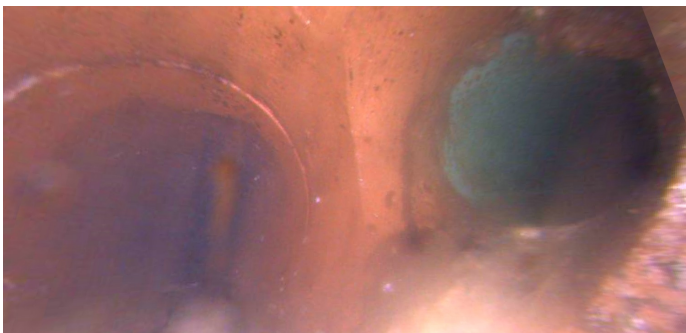
Code: **TFA**  
Description: **Tap Factory Active**

Distance (ft): **133.0**  
Structural Grade: **0**  
O&M Grade: **0**  
Clock Start/From: **3**  
Clock To:  
1st Value: **4.000**  
2nd Value:  
Value Percent:  
Continuous Index:  
Within 8" of Joint:  
Remarks:

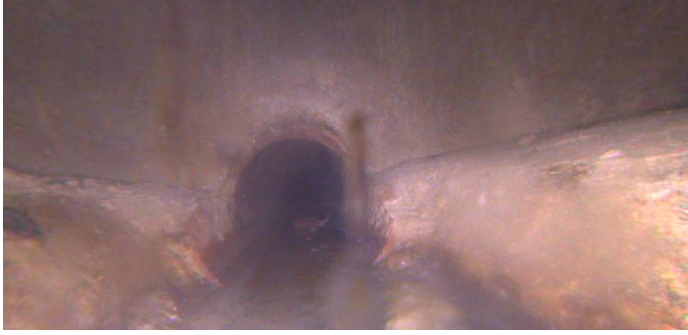
Code:	<b>AMH</b>
Description:	<b>Manhole</b>
Distance (ft):	<b>170.3</b>
Structural Grade:	<b>0</b>
O&M Grade:	<b>0</b>
Clock Start/From:	
Clock To:	
1st Value:	
2nd Value:	
Value Percent:	
Continuous Index:	
Within 8" of Joint:	<b>NO</b>
Remarks:	<b>M-507-017</b>
