Profile/Photo Observation Report

Date:	04/05/2018	Weather:		Coding:	PACP 6.0
Pipe Length (ft):	92.2	Owner:	NA	Pre Clean:	No Pre-Cleaning
P.O.#:		Surveyor:	Jen Costello	PSR:	P-507-018-017
Customer:		Clean Date:	01/01/1900	Shape:	C

Street:	ALLEY BETWEEN S DELAWARE ST & S	Flow Control:	Not Controlled
City:	Hobart, IN	Year Renewed:	
Location:	Yard	Tape/Media #:	
Purpose:	Routine Assessment	Dia/Height:	10"
Use:	Sanitary	Material:	RCP
Drain Area:	NA	Lining:	
Category:	NA		
Comment:	Flow direction is wrong.		
Location Details:		Direction of Survey:	Upstream
US MH:	M-507-017	DS MH:	M-507-018
		Total Length Surveyed (ft):	92.9

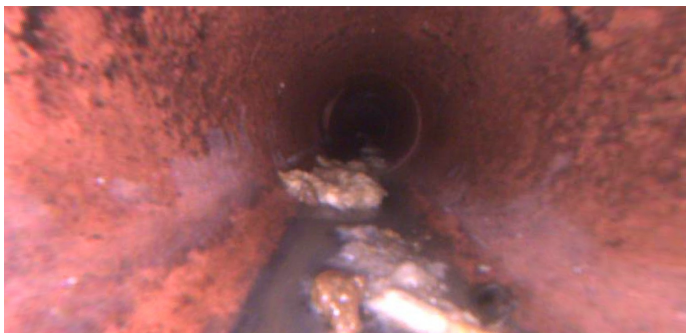
Code: **AMH**
Description: **Manhole**

Distance (ft): **.0**
Structural Grade: **0**
O&M Grade: **0**
Clock Start/From:
Clock To:
1st Value:
2nd Value:
Value Percent:
Continuous Index:
Within 8" of Joint: **NO**
Remarks: **M-507-018**

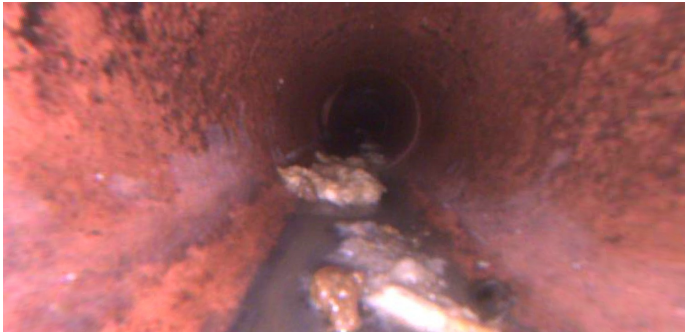
Code:	MWL
Description:	Water Level

Distance (ft):	.0
Structural Grade:	0
O&M Grade:	0
Clock Start/From:	
Clock To:	
1st Value:	
2nd Value:	
Value Percent:	5.000
Continuous Index:	
Within 8" of Joint:	NO
Remarks:

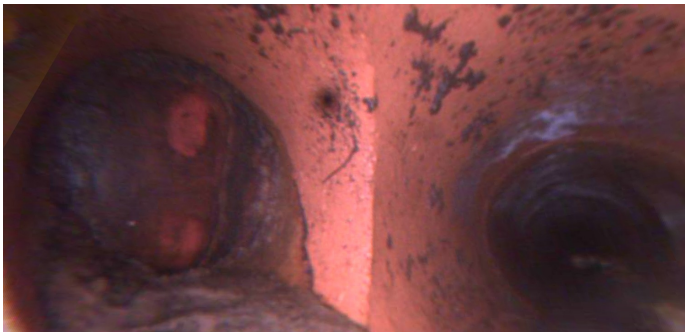
Code:	TF
Description:	Tap Factory

Distance (ft):	3.9
Structural Grade:	0
O&M Grade:	0
Clock Start/From:	9
Clock To:	
1st Value:	4.000
2nd Value:	
Value Percent:	
Continuous Index:	
Within 8" of Joint:	
Remarks:

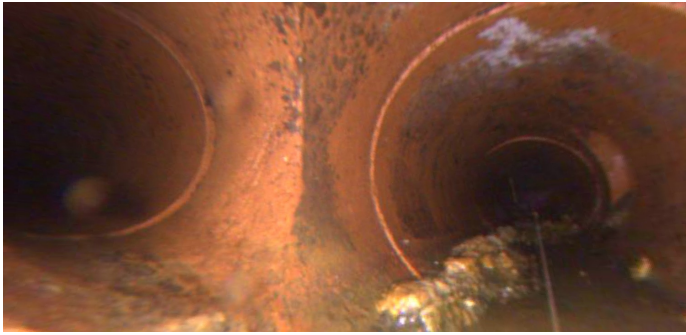
Code: **TF**
Description: **Tap Factory**

Distance (ft): **6.2**
Structural Grade: **0**
O&M Grade: **0**
Clock Start/From: **3**
Clock To:
1st Value: **4.000**
2nd Value:
Value Percent:
Continuous Index:
Within 8" of Joint:
Remarks:

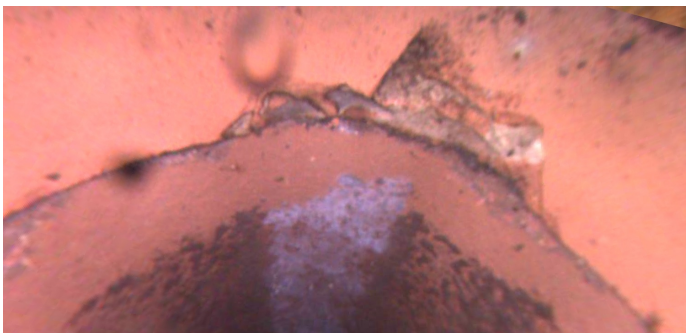
Code: **SSS**
Description: **Surface Spalling**

Distance (ft): **18.3**
Structural Grade: **2**
O&M Grade: **0**
Clock Start/From: **11**
Clock To: **1**
1st Value:
2nd Value:
Value Percent:
Continuous Index:
Within 8" of Joint: **YES**
Remarks:

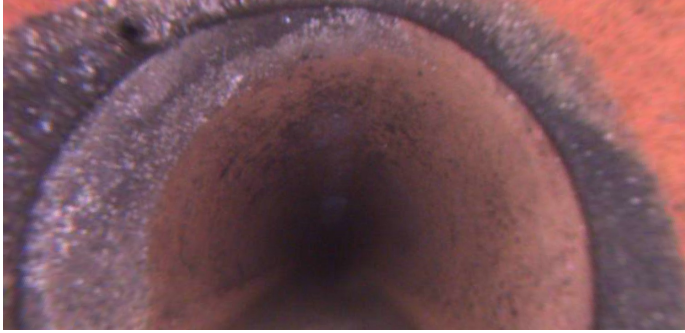
Code: **DAE**
Description: **Deposits Attached Encrustation**

Distance (ft): **27.0**
Structural Grade: **0**
O&M Grade: **2**
Clock Start/From: **8**
Clock To: **4**
1st Value:
2nd Value:
Value Percent: **5.000**
Continuous Index:
Within 8" of Joint: **YES**
Remarks:

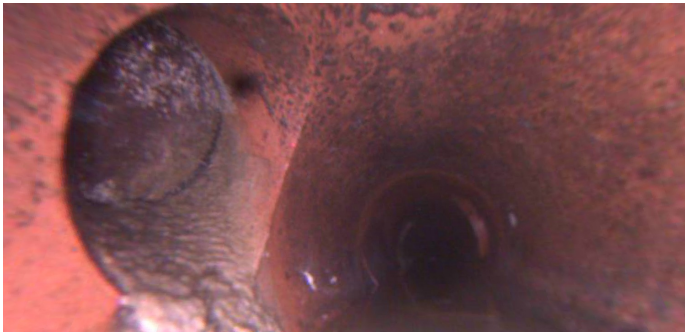
Code: **TFC**
Description: **Tap Factory Capped**

Distance (ft): **57.5**
Structural Grade: **0**
O&M Grade: **0**
Clock Start/From: **9**
Clock To:
1st Value: **4.000**
2nd Value:
Value Percent:
Continuous Index:
Within 8" of Joint:
Remarks:

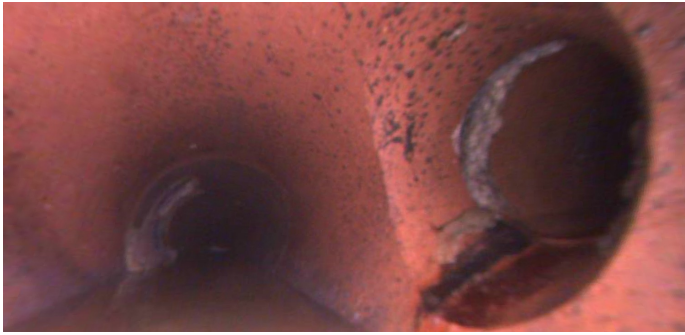
Code: **TF**
Description: **Tap Factory**

Distance (ft): **59.6**
Structural Grade: **0**
O&M Grade: **0**
Clock Start/From: **3**
Clock To:
1st Value: **4.000**
2nd Value:
Value Percent:
Continuous Index:
Within 8" of Joint:
Remarks:

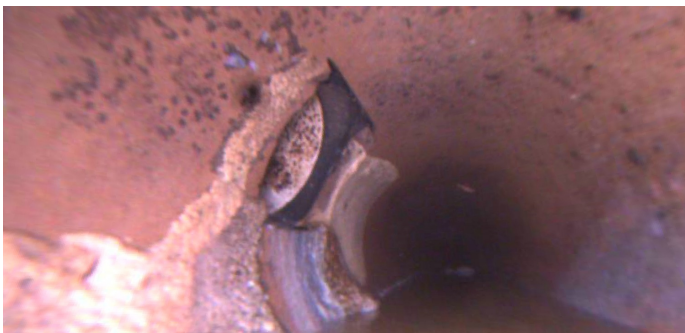
Code: **DAE**
Description: **Deposits Attached Encrustation**

Distance (ft): **61.4**
Structural Grade: **0**
O&M Grade: **2**
Clock Start/From: **8**
Clock To: **9**
1st Value:
2nd Value:
Value Percent: **5.000**
Continuous Index:
Within 8" of Joint: **NO**
Remarks:

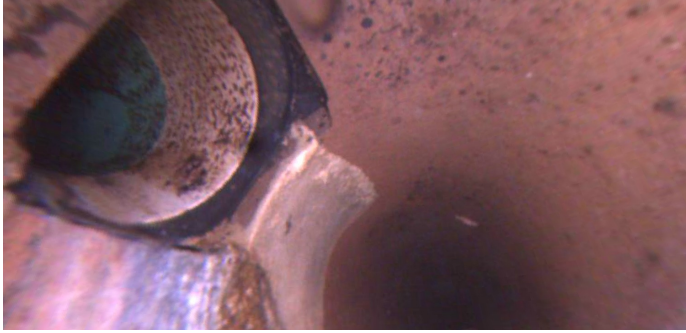
Code: **TS**
Description: **Tap Saddle**

Distance (ft): **61.8**
Structural Grade: **0**
O&M Grade: **0**
Clock Start/From: **10**
Clock To:
1st Value: **4.000**
2nd Value:
Value Percent:
Continuous Index:
Within 8" of Joint:
Remarks:

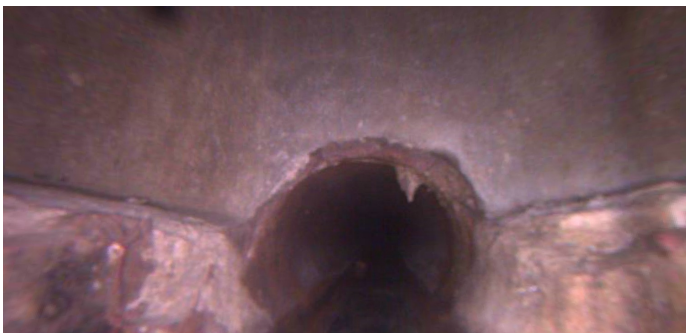
Code: **AMH**
Description: **Manhole**

Distance (ft): **92.9**
Structural Grade: **0**
O&M Grade: **0**
Clock Start/From:
Clock To:
1st Value:
2nd Value:
Value Percent:
Continuous Index:
Within 8" of Joint: **NO**
Remarks: **M-507-017**
