Profile/Photo Observation Report

Date:	04/05/2018	Weather:		Coding:	PACP 6.0
Pipe Length (ft):	92.2	Owner:	NA	Pre Clean:	No Pre-Cleaning
P.O.#:		Surveyor:	Jen Costello	PSR:	P-507-018-017
Customer:		Clean Date:	01/01/1900	Shape:	C

Street:	FOXCROFT STREET	Flow Control:	Not Controlled
City:	Hobart, IN	Year Renewed:	
Location:	Yard	Tape/Media #:	
Purpose:	Routine Assessment	Dia/Height:	10"
Use:	Sanitary	Material:	RCP
Drain Area:	NA	Lining:	
Category:	NA		
Comment:	Flow direction is wrong.		
Location Details:		Direction of Survey:	Upstream
US MH:	M-507-017	DS MH:	M-507-018
		Total Length Surveyed (ft):	92.9

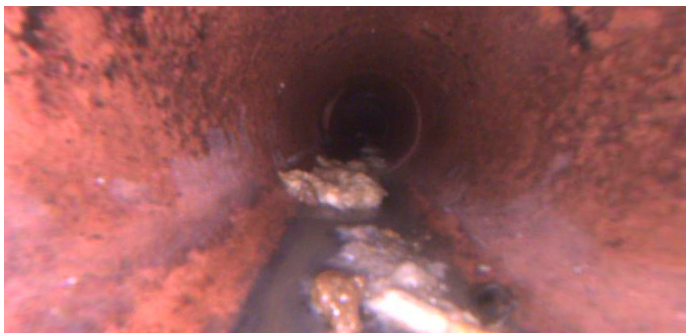
Code: **AMH**
Description: **Manhole**

Distance (ft): **.0**
Structural Grade: **0**
O&M Grade: **0**
Clock Start/From:
Clock To:
1st Value:
2nd Value:
Value Percent:
Continuous Index:
Within 8" of Joint: **NO**
Remarks: **M-507-018**

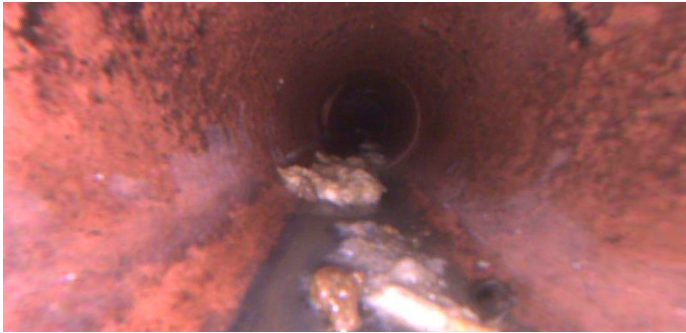
Code:	MWL
Description:	Water Level

Distance (ft):	.0
Structural Grade:	0
O&M Grade:	0
Clock Start/From:	
Clock To:	
1st Value:	
2nd Value:	
Value Percent:	5.000
Continuous Index:	
Within 8" of Joint:	NO
Remarks:

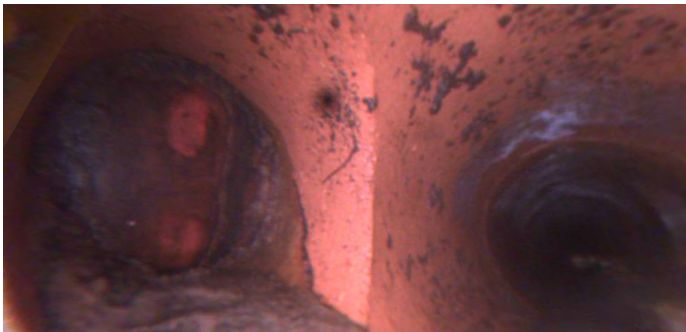
Code:	TF
Description:	Tap Factory

Distance (ft):	3.9
Structural Grade:	0
O&M Grade:	0
Clock Start/From:	9
Clock To:	
1st Value:	4.000
2nd Value:	
Value Percent:	
Continuous Index:	
Within 8" of Joint:	
Remarks:

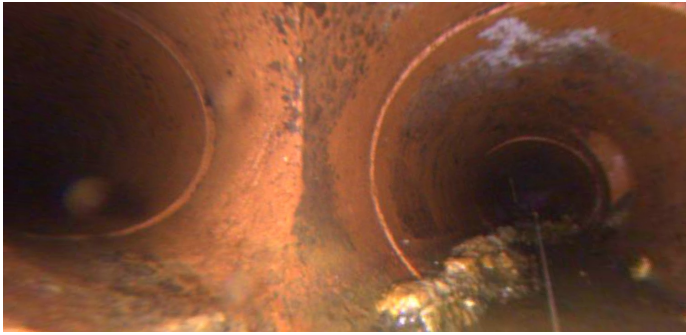
Code: **TF**
Description: **Tap Factory**

Distance (ft): **6.2**
Structural Grade: **0**
O&M Grade: **0**
Clock Start/From: **3**
Clock To:
1st Value: **4.000**
2nd Value:
Value Percent:
Continuous Index:
Within 8" of Joint:
Remarks:

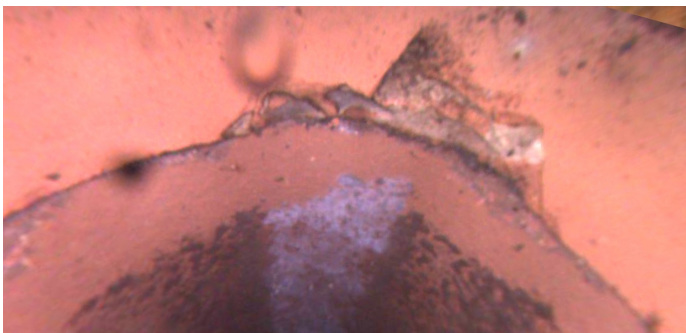
Code: **SSS**
Description: **Surface Spalling**

Distance (ft): **18.3**
Structural Grade: **2**
O&M Grade: **0**
Clock Start/From: **11**
Clock To: **1**
1st Value:
2nd Value:
Value Percent:
Continuous Index:
Within 8" of Joint: **YES**
Remarks:

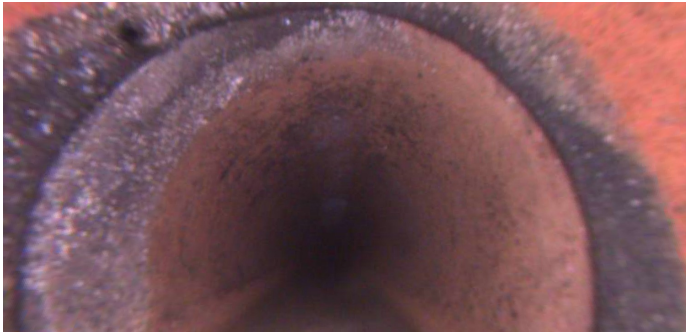
Code: **DAE**
Description: **Deposits Attached Encrustation**

Distance (ft): **27.0**
Structural Grade: **0**
O&M Grade: **2**
Clock Start/From: **8**
Clock To: **4**
1st Value:
2nd Value:
Value Percent: **5.000**
Continuous Index:
Within 8" of Joint: **YES**
Remarks:

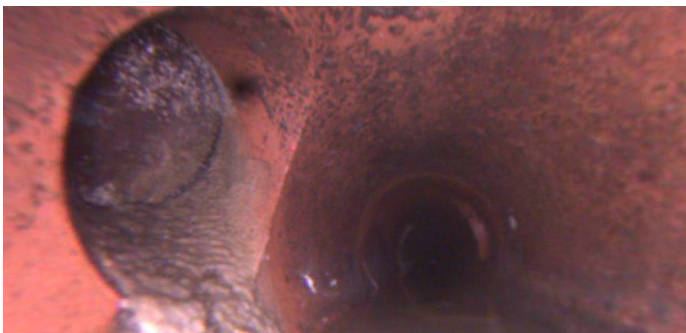
Code: **TFC**
Description: **Tap Factory Capped**

Distance (ft): **57.5**
Structural Grade: **0**
O&M Grade: **0**
Clock Start/From: **9**
Clock To:
1st Value: **4.000**
2nd Value:
Value Percent:
Continuous Index:
Within 8" of Joint:
Remarks:

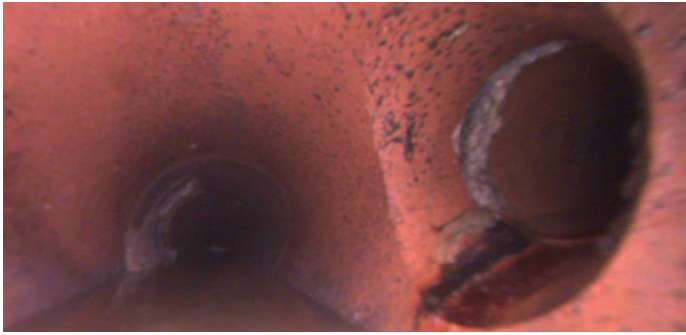
Code: **TF**
Description: **Tap Factory**

Distance (ft): **59.6**
Structural Grade: **0**
O&M Grade: **0**
Clock Start/From: **3**
Clock To:
1st Value: **4.000**
2nd Value:
Value Percent:
Continuous Index:
Within 8" of Joint:
Remarks:

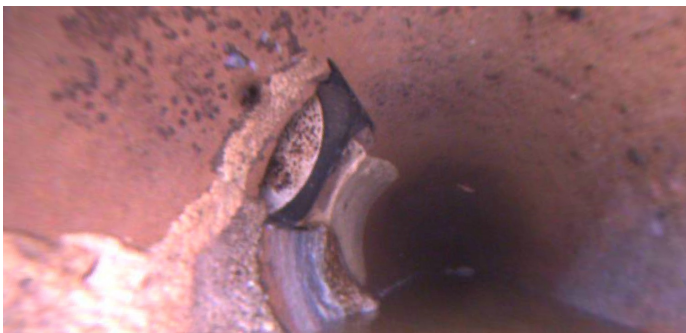
Code: **DAE**
Description: **Deposits Attached Encrustation**

Distance (ft): **61.4**
Structural Grade: **0**
O&M Grade: **2**
Clock Start/From: **8**
Clock To: **9**
1st Value:
2nd Value:
Value Percent: **5.000**
Continuous Index:
Within 8" of Joint: **NO**
Remarks:

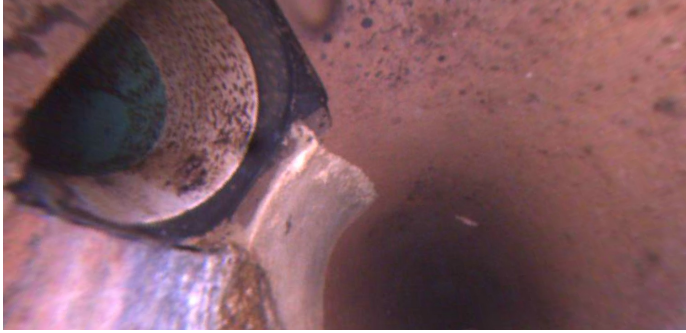
Code: **TS**
Description: **Tap Saddle**

Distance (ft): **61.8**
Structural Grade: **0**
O&M Grade: **0**
Clock Start/From: **10**
Clock To:
1st Value: **4.000**
2nd Value:
Value Percent:
Continuous Index:
Within 8" of Joint:
Remarks:

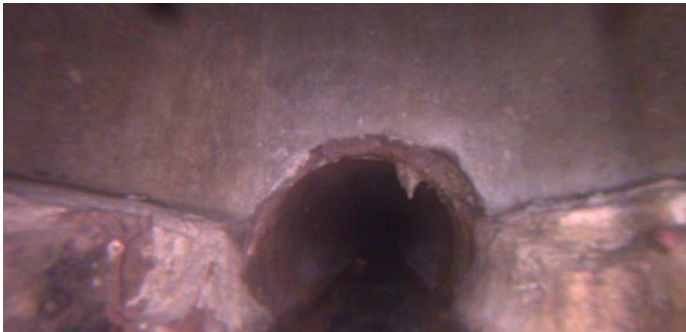
Code: **AMH**
Description: **Manhole**

Distance (ft): **92.9**
Structural Grade: **0**
O&M Grade: **0**
Clock Start/From:
Clock To:
1st Value:
2nd Value:
Value Percent:
Continuous Index:
Within 8" of Joint: **NO**
Remarks: **M-507-017**
