Profile/Ph	oto Observatio	n Report			RedZone
Date: Pipe Length (ft) P.O.#: Customer:	03/28/2018): 218.0	Weather: Owner: Surveyor: Clean Date:	NA Selasie Honu 01/01/1900	Coding: Pre Clean: PSR: Shape:	PACP 6.0 No Pre-Cleaning P-507-020-019 C
Street:	FOXCROFT STREE	т	Flow Control:	Not Controlle	d
City:	Hobart, IN		Year Renewed:		
Location:	Woods		Tape/Media #:		
Purpose:	Routine Assessme	ent	Dia/Height:	12"	
Use:	Sanitary		Material:	VCP	
Drain Area:	NA		Lining:		
Category:	NA				
Comment:	P_C at 151 ft deb	ris . Flow directio	n wrong		
Location Detail	S:		Direction of Surv	vey: Upstream	
US MH:	M-507-019	DS MH:	M-507-020	Total Length Surveyed (f	t): 152.8
D&M Index:	0.00	O&M Quick:	000	00 O&M Rating:	0.00
Structural Index:	0.00	Structural Q	uick: 000	00 Structural Rating	.000
Overall Index:	0.00	Overall Quic	k: 000	00 Overall Rating:	0.00

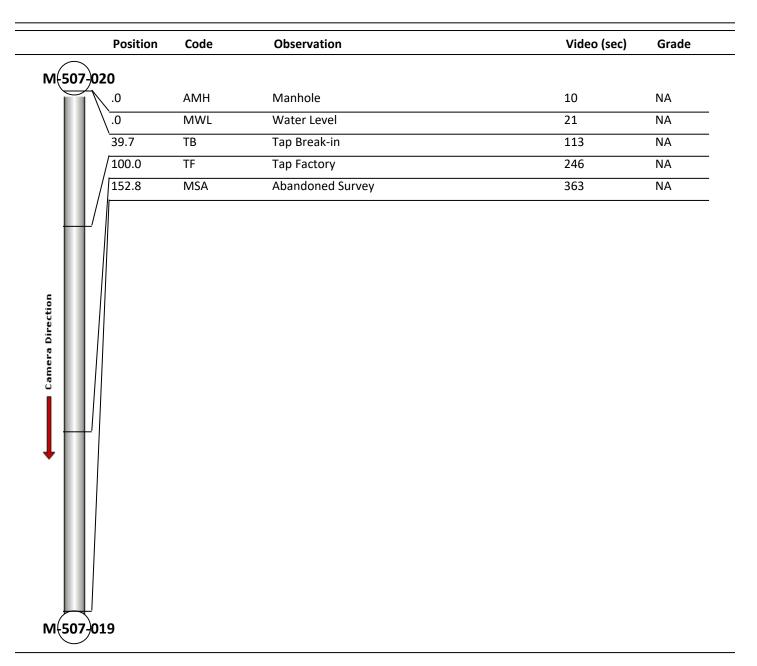
Code: Description:	AMH Manhole
Distance (ft):	.0
Structural Grade:	0
O&M Grade:	0
Clock Start/From:	
Clock To:	
1st Value:	
2nd Value:	
Value Percent:	
Continuous Index:	
Within 8" of Joint:	NO
Remarks:	M-507-020
