Profile/Photo Observation Report

Date:	03/28/2018	Weather:		Coding:	PACP 6.0
Pipe Length (ft):	218.0	Owner:	NA	Pre Clean:	No Pre-Cleaning
P.O.#:		Surveyor:	Selasie Honu	PSR:	P-507-020-019
Customer:		Clean Date:	01/01/1900	Shape:	C

Street:	OFF COLORADO CT	Flow Control:	Not Controlled
City:	Hobart, IN	Year Renewed:	
Location:	Woods	Tape/Media #:	
Purpose:	Routine Assessment	Dia/Height:	12"
Use:	Sanitary	Material:	VCP
Drain Area:	NA	Lining:	
Category:	NA		
Comment:	F_S_P_C at 5 ft debris . Flow direction wrong		
Location Details:		Direction of Survey:	Downstream
US MH:	M-507-019	DS MH:	M-507-020
		Total Length Surveyed (ft):	6.2

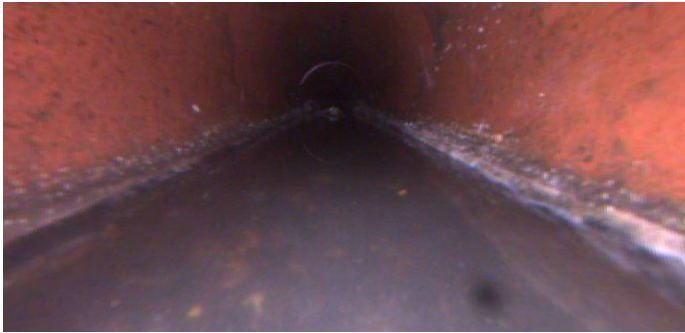
Code:	MWL
Description:	Water Level

Distance (ft):	.0
Structural Grade:	0
O&M Grade:	0
Clock Start/From:	
Clock To:	
1st Value:	
2nd Value:	
Value Percent:	5.000
Continuous Index:	
Within 8" of Joint:	NO
Remarks:

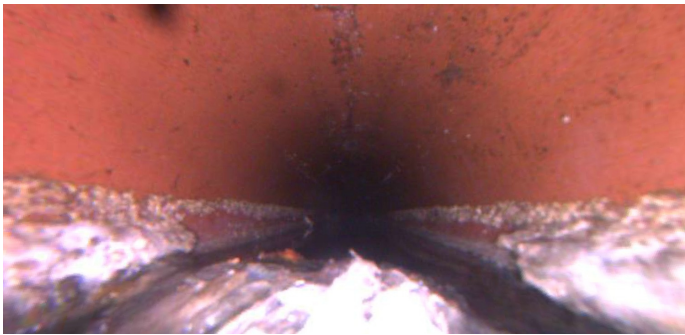
Code:	DAGS
Description:	Deposits Attached Grease

Distance (ft):	6.2
Structural Grade:	0
O&M Grade:	2
Clock Start/From:	8
Clock To:	4
1st Value:	
2nd Value:	
Value Percent:	5.000
Continuous Index:	
Within 8" of Joint:	NO
Remarks:

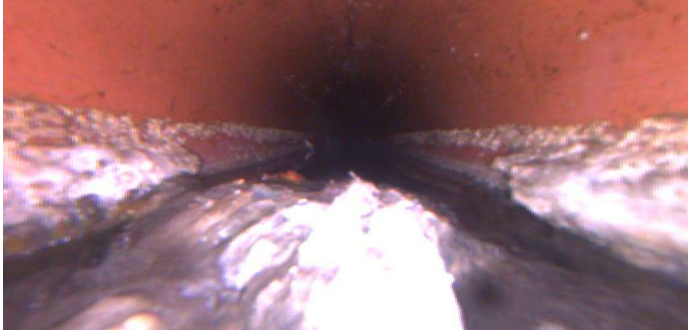
Code: **MSA**
Description: **Abandoned Survey**

Distance (ft): **6.2**

Remarks: **camera stopped due to mixed material found in pipe**
