Profile/Photo Observation Report

Street:	FOXCROFT STREET	Flow Control:	Not Controlled
City:	Hobart, IN	Year Renewed:	
Location:	Woods	Tape/Media #:	
Purpose:	Routine Assessment	Dia/Height:	12"
Use:	Sanitary	Material:	VCP
Drain Area:	NA	Lining:	
Category:	NA		
Comment:	F_S_P_C at 5 ft debris . Flow direction wrong		
Location Details:		Direction of Survey:	Downstream
US MH:	M-507-019	DS MH:	M-507-020
		Total Length Surveyed (ft):	6.2

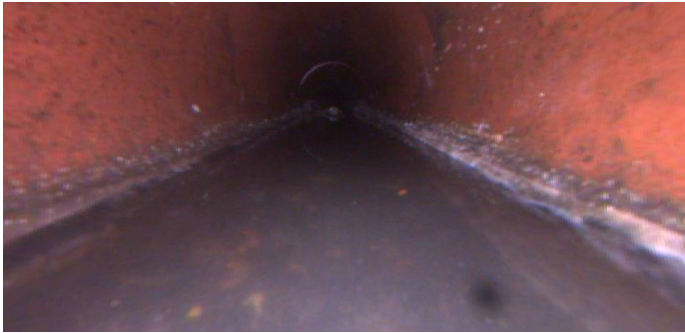
Code:	MWL
Description:	Water Level

Distance (ft):	.0
Structural Grade:	0
O&M Grade:	0
Clock Start/From:	
Clock To:	
1st Value:	
2nd Value:	
Value Percent:	5.000
Continuous Index:	
Within 8" of Joint:	NO
Remarks:

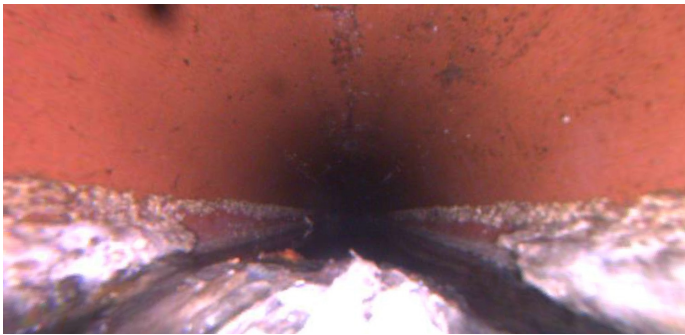
Code:	DAGS
Description:	Deposits Attached Grease

Distance (ft):	6.2
Structural Grade:	0
O&M Grade:	2
Clock Start/From:	8
Clock To:	4
1st Value:	
2nd Value:	
Value Percent:	5.000
Continuous Index:	
Within 8" of Joint:	NO
Remarks:

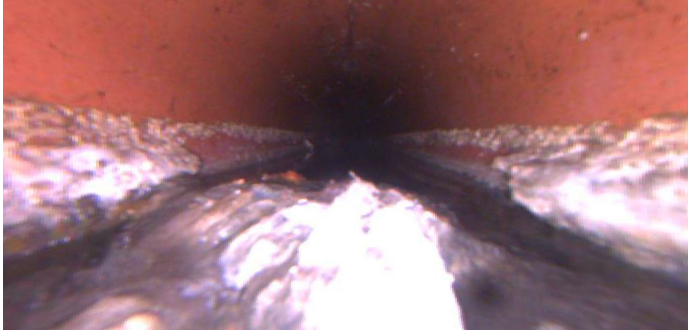
Code: **MSA**
Description: **Abandoned Survey**

Distance (ft): **6.2**

Remarks: **camera stopped due to mixed material found in pipe**
