Profile/Photo Observation Report

Date:	10/09/2018	Weather:		Coding:	PACP 6.0
Pipe Length (ft):	218.0	Owner:	NA	Pre Clean:	Not Known
P.O.#:		Surveyor:	Selasie Honu	PSR:	P-507-020-019
Customer:		Clean Date:	01/01/1900	Shape:	C

Street:	OFF COLORADO CT	Flow Control:	Not Controlled
City:	Hobart, IN	Year Renewed:	
Location:	Light Highway	Tape/Media #:	
Purpose:	Routine Assessment	Dia/Height:	12"
Use:	Sanitary	Material:	VCP
Drain Area:	NA	Lining:	
Category:	NA		
Comment:

Location Details:		Direction of Survey:	Upstream
US MH:	M-507-019	DS MH:	M-507-020
		Total Length Surveyed (ft):	205.3

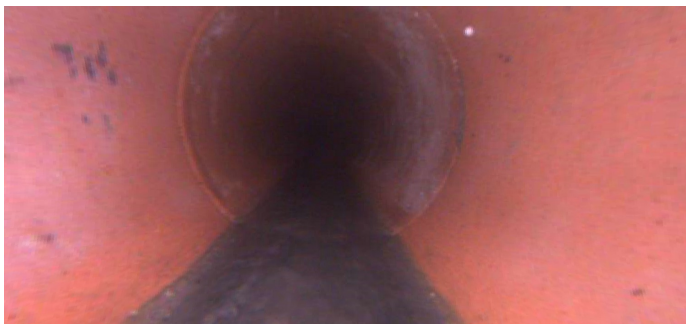
Code: **AMH**
Description: **Manhole**

Distance (ft): **.0**
Structural Grade: **0**
O&M Grade: **0**
Clock Start/From:
Clock To:
1st Value:
2nd Value:
Value Percent:
Continuous Index:
Within 8" of Joint: **NO**
Remarks: **M-507-020**

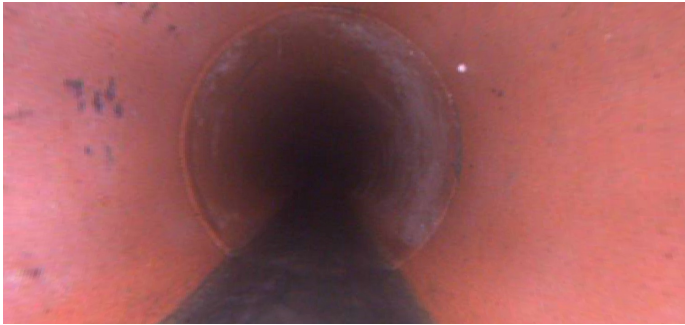
Code:	MWL
Description:	Water Level

Distance (ft):	.0
Structural Grade:	0
O&M Grade:	0
Clock Start/From:	
Clock To:	
1st Value:	
2nd Value:	
Value Percent:	5.000
Continuous Index:	
Within 8" of Joint:	NO
Remarks:

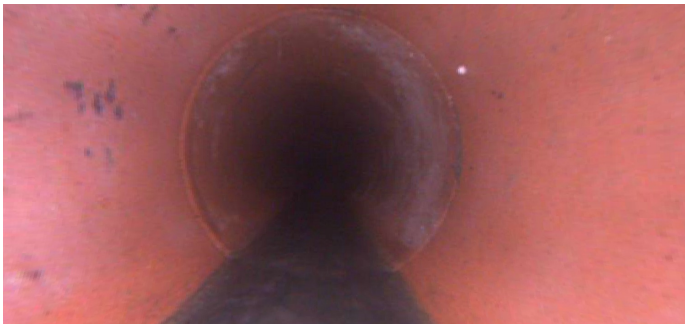
Code:	RFJ
Description:	Roots Fine Joint

Distance (ft):	.0
Structural Grade:	0
O&M Grade:	1
Clock Start/From:	12
Clock To:	3
1st Value:	
2nd Value:	
Value Percent:	
Continuous Index:	
Within 8" of Joint:	YES
Remarks:

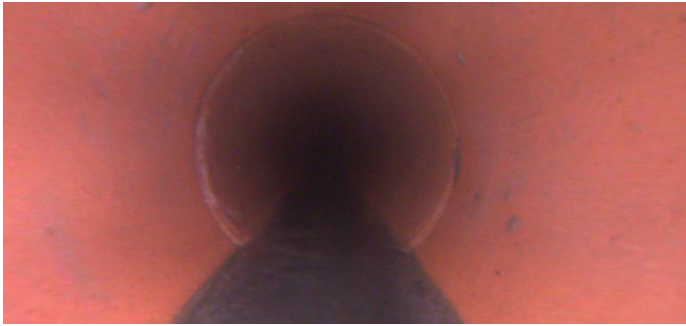
Code: **RFJ**
Description: **Roots Fine Joint**

Distance (ft): **7.1**
Structural Grade: **0**
O&M Grade: **1**
Clock Start/From: **3**
Clock To:
1st Value:
2nd Value:
Value Percent:
Continuous Index:
Within 8" of Joint: **YES**
Remarks:

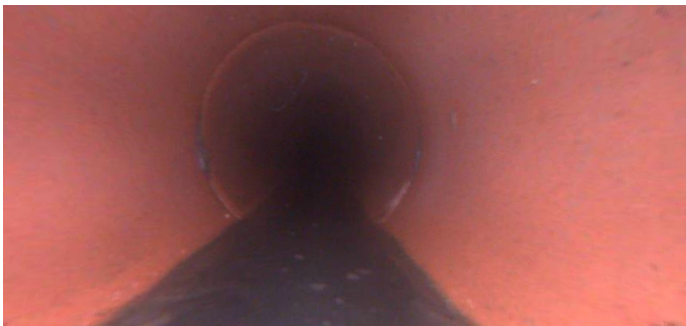
Code: **RFJ**
Description: **Roots Fine Joint**

Distance (ft): **12.8**
Structural Grade: **0**
O&M Grade: **1**
Clock Start/From: **8**
Clock To: **4**
1st Value:
2nd Value:
Value Percent:
Continuous Index: **S01**
Within 8" of Joint: **YES**
Remarks:

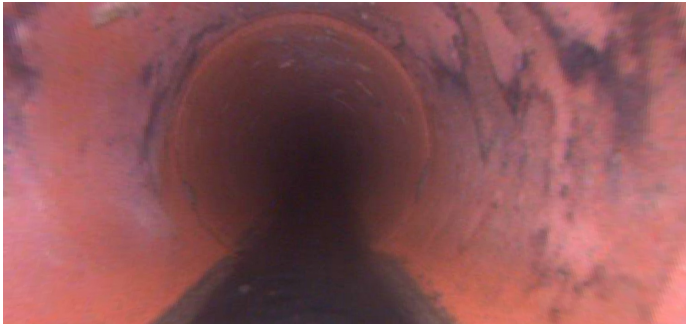
Code: **RFJ**
Description: **Roots Fine Joint**

Distance (ft): **54.0**
Structural Grade: **0**
O&M Grade: **1**
Clock Start/From: **8**
Clock To: **4**
1st Value:
2nd Value:
Value Percent:
Continuous Index: **F01**
Within 8" of Joint: **YES**
Remarks:

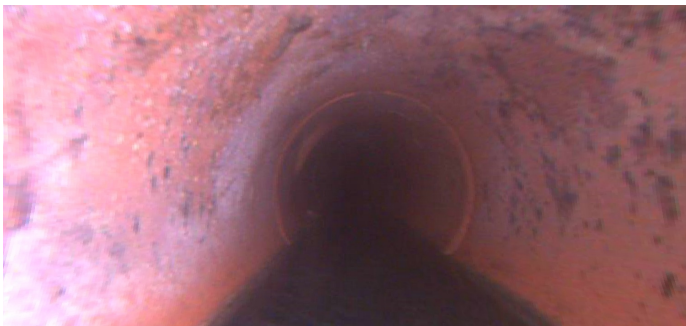
Code: **TF**
Description: **Tap Factory**

Distance (ft): **95.4**
Structural Grade: **0**
O&M Grade: **0**
Clock Start/From: **10**
Clock To:
1st Value: **4.000**
2nd Value:
Value Percent:
Continuous Index:
Within 8" of Joint:
Remarks:

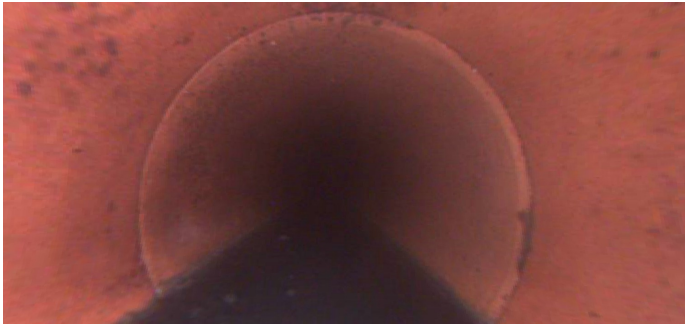
Code: **RFJ**
Description: **Roots Fine Joint**

Distance (ft): **104.1**
Structural Grade: **0**
O&M Grade: **1**
Clock Start/From: **3**
Clock To: **4**
1st Value:
2nd Value:
Value Percent:
Continuous Index:
Within 8" of Joint: **YES**
Remarks:

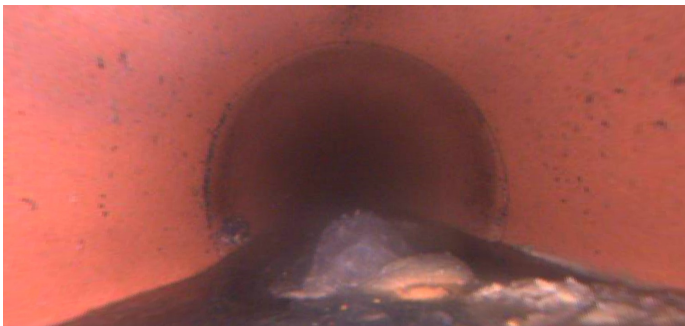
Code: **DSZ**
Description: **Deposits Settled Other**

Distance (ft): **204.7**
Structural Grade: **0**
O&M Grade: **2**
Clock Start/From: **4**
Clock To: **6**
1st Value:
2nd Value:
Value Percent: **10.000**
Continuous Index:
Within 8" of Joint: **YES**
Remarks: **mixed material**

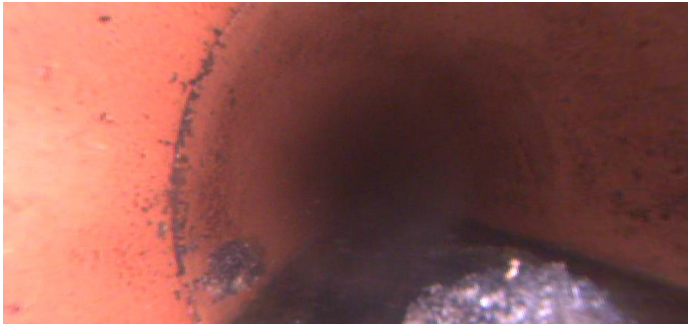
Code:	MSA
Description:	Abandoned Survey
Distance (ft):	205.3
Structural Grade:	0
O&M Grade:	0
Clock Start/From:	
Clock To:	
1st Value:	
2nd Value:	
Value Percent:	
Continuous Index:	
Within 8" of Joint:	NO
Remarks:	camera stopped
