Profile/Photo Observation Report

Date:	10/09/2018	Weather:		Coding:	PACP 6.0
Pipe Length (ft):	218.0	Owner:	NA	Pre Clean:	Not Known
P.O.#:		Surveyor:	Selasie Honu	PSR:	P-507-020-019
Customer:		Clean Date:	01/01/1900	Shape:	C

Street:	Dekalb St.	Flow Control:	Not Controlled
City:	Hobart, IN	Year Renewed:	
Location:	Light Highway	Tape/Media #:	
Purpose:	Routine Assessment	Dia/Height:	12"
Use:	Sanitary	Material:	VCP
Drain Area:	NA	Lining:	
Category:	NA		
Comment:

Location Details:		Direction of Survey:	Upstream
US MH:	M-507-019	DS MH:	M-507-020
		Total Length Surveyed (ft):	205.3

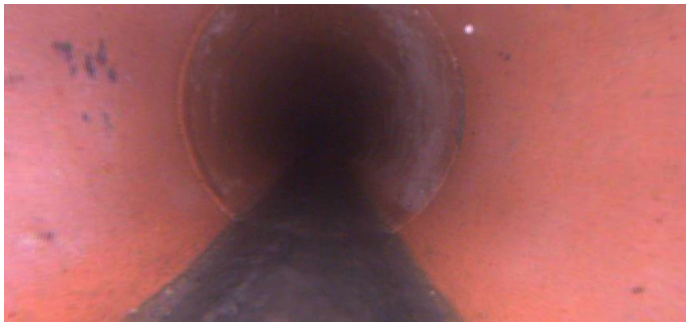
Code: **AMH**
Description: **Manhole**

Distance (ft): **.0**
Structural Grade: **0**
O&M Grade: **0**
Clock Start/From:
Clock To:
1st Value:
2nd Value:
Value Percent:
Continuous Index:
Within 8" of Joint: **NO**
Remarks: **M-507-020**

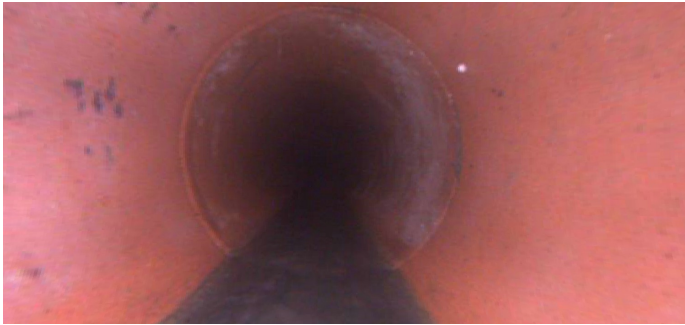
Code:	MWL
Description:	Water Level

Distance (ft):	.0
Structural Grade:	0
O&M Grade:	0
Clock Start/From:	
Clock To:	
1st Value:	
2nd Value:	
Value Percent:	5.000
Continuous Index:	
Within 8" of Joint:	NO
Remarks:

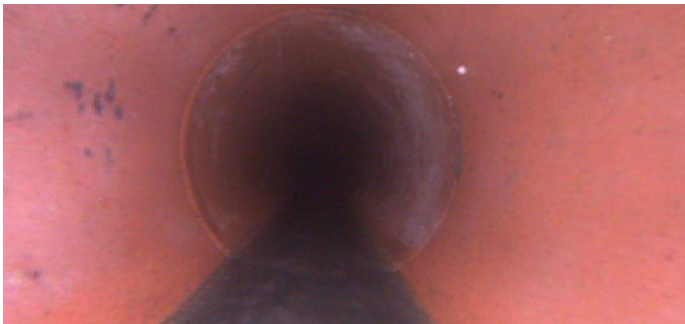
Code:	RFJ
Description:	Roots Fine Joint

Distance (ft):	.0
Structural Grade:	0
O&M Grade:	1
Clock Start/From:	12
Clock To:	3
1st Value:	
2nd Value:	
Value Percent:	
Continuous Index:	
Within 8" of Joint:	YES
Remarks:

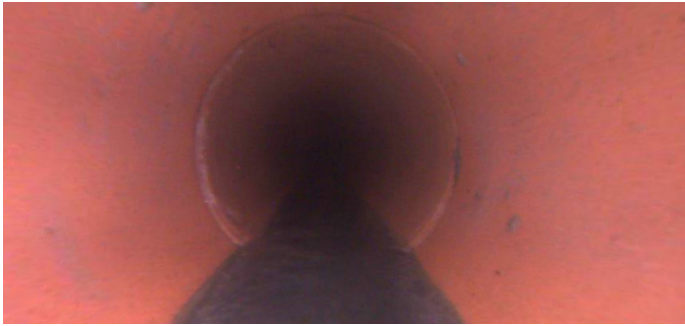
Code: **RFJ**
Description: **Roots Fine Joint**

Distance (ft): **7.1**
Structural Grade: **0**
O&M Grade: **1**
Clock Start/From: **3**
Clock To:
1st Value:
2nd Value:
Value Percent:
Continuous Index:
Within 8" of Joint: **YES**
Remarks:

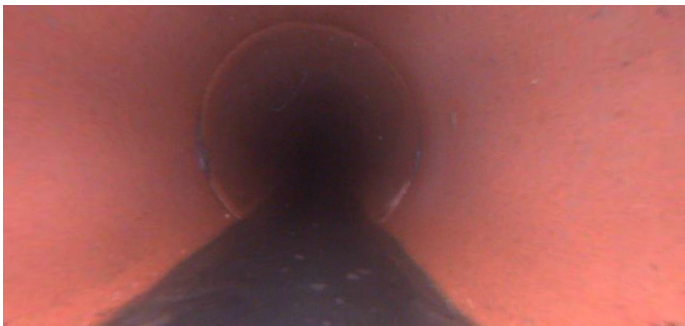
Code: **RFJ**
Description: **Roots Fine Joint**

Distance (ft): **12.8**
Structural Grade: **0**
O&M Grade: **1**
Clock Start/From: **8**
Clock To: **4**
1st Value:
2nd Value:
Value Percent:
Continuous Index: **S01**
Within 8" of Joint: **YES**
Remarks:

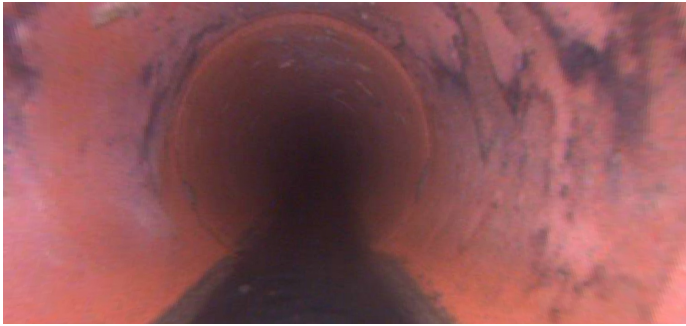
Code: **RFJ**
Description: **Roots Fine Joint**

Distance (ft): **54.0**
Structural Grade: **0**
O&M Grade: **1**
Clock Start/From: **8**
Clock To: **4**
1st Value:
2nd Value:
Value Percent:
Continuous Index: **F01**
Within 8" of Joint: **YES**
Remarks:

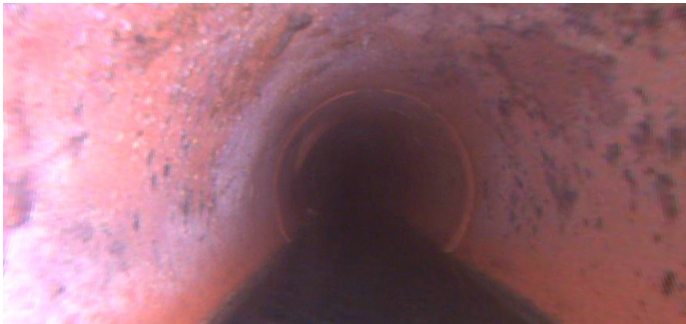
Code: **TF**
Description: **Tap Factory**

Distance (ft): **95.4**
Structural Grade: **0**
O&M Grade: **0**
Clock Start/From: **10**
Clock To:
1st Value: **4.000**
2nd Value:
Value Percent:
Continuous Index:
Within 8" of Joint:
Remarks:

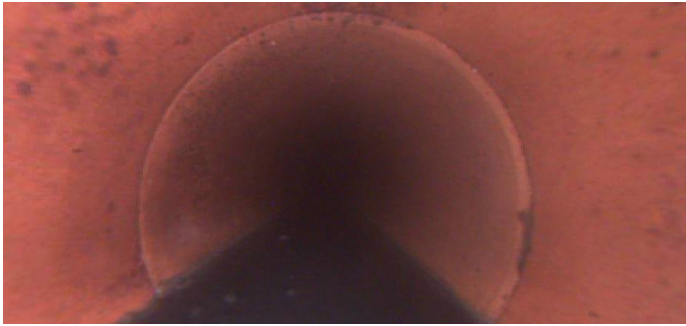
Code: **RFJ**
Description: **Roots Fine Joint**

Distance (ft): **104.1**
Structural Grade: **0**
O&M Grade: **1**
Clock Start/From: **3**
Clock To: **4**
1st Value:
2nd Value:
Value Percent:
Continuous Index:
Within 8" of Joint: **YES**
Remarks:

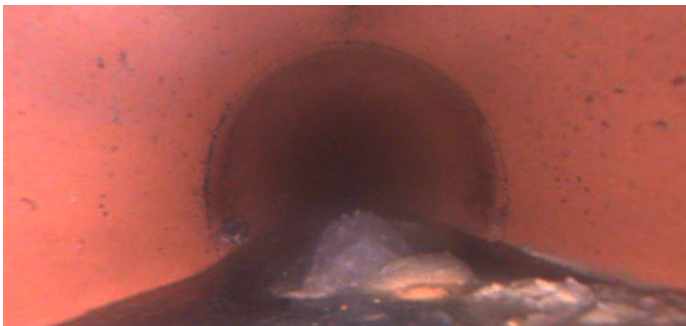
Code: **DSZ**
Description: **Deposits Settled Other**

Distance (ft): **204.7**
Structural Grade: **0**
O&M Grade: **2**
Clock Start/From: **4**
Clock To: **6**
1st Value:
2nd Value:
Value Percent: **10.000**
Continuous Index:
Within 8" of Joint: **YES**
Remarks: **mixed material**

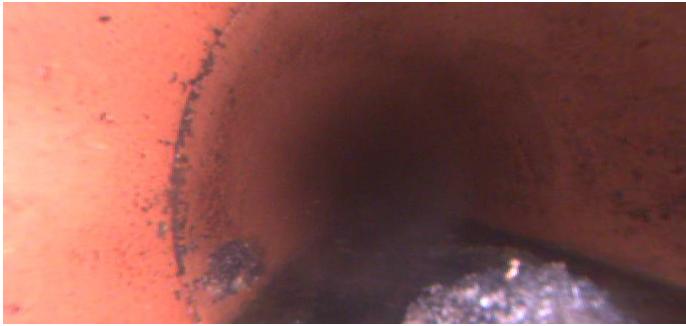
Code:	MSA
Description:	Abandoned Survey
Distance (ft):	205.3
Structural Grade:	0
O&M Grade:	0
Clock Start/From:	
Clock To:	
1st Value:	
2nd Value:	
Value Percent:	
Continuous Index:	
Within 8" of Joint:	NO
Remarks:	camera stopped
