Profile/Photo Observation Report

Street:	FOXCROFT STREET	Flow Control:	Not Controlled
City:	Hobart, IN	Year Renewed:	
Location:	Woods	Tape/Media #:	
Purpose:	Routine Assessment	Dia/Height:	12"
Use:	Sanitary	Material:	VCP
Drain Area:	NA	Lining:	
Category:	NA		
Comment:	R_M at 157 ft debris . Flow direction wrong		
Location Details:		Direction of Survey:	Upstream
US MH:	M-507-020	DS MH:	M-507-029
		Total Length Surveyed (ft):	158.2

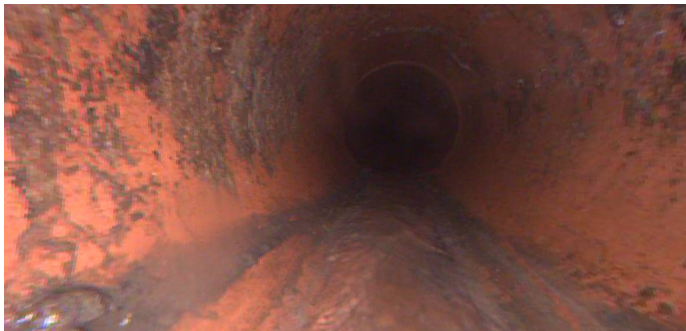
Code: **AMH**
Description: **Manhole**

Distance (ft): **.0**
Structural Grade: **0**
O&M Grade: **0**
Clock Start/From:
Clock To:
1st Value:
2nd Value:
Value Percent:
Continuous Index:
Within 8" of Joint: **NO**
Remarks: **M-507-029**

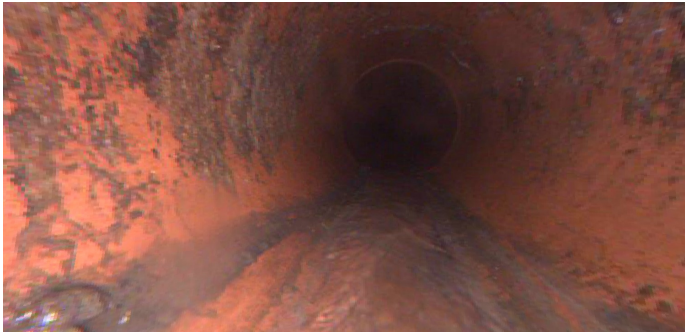
Code:	MWL
Description:	Water Level

Distance (ft):	.0
Structural Grade:	0
O&M Grade:	0
Clock Start/From:	
Clock To:	
1st Value:	
2nd Value:	
Value Percent:	5.000
Continuous Index:	
Within 8" of Joint:	NO
Remarks:

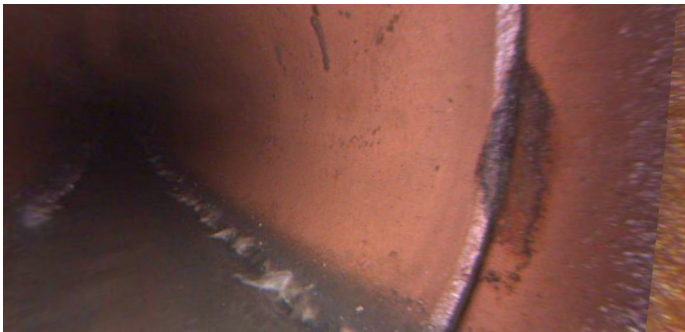
Code:	IW
Description:	Infil Weeper

Distance (ft):	21.2
Structural Grade:	0
O&M Grade:	2
Clock Start/From:	3
Clock To:	
1st Value:	
2nd Value:	
Value Percent:	
Continuous Index:	
Within 8" of Joint:	YES
Remarks:

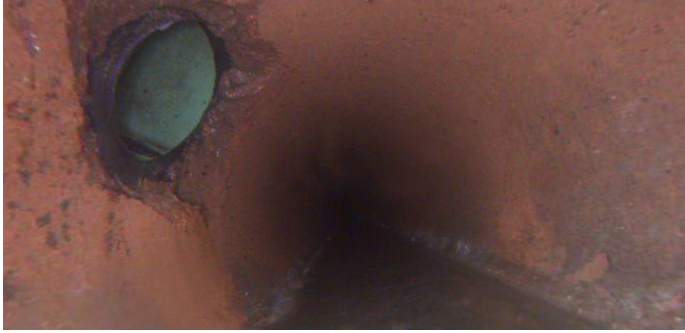
Code: **TB**
Description: **Tap Break-in**

Distance (ft): **63.6**
Structural Grade: **0**
O&M Grade: **0**
Clock Start/From: **10**
Clock To:
1st Value: **4.000**
2nd Value:
Value Percent:
Continuous Index:
Within 8" of Joint:
Remarks:

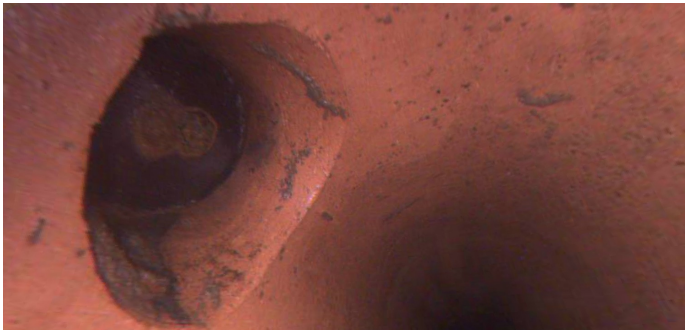
Code: **TFC**
Description: **Tap Factory Capped**

Distance (ft): **71.2**
Structural Grade: **0**
O&M Grade: **0**
Clock Start/From: **10**
Clock To:
1st Value: **4.000**
2nd Value:
Value Percent:
Continuous Index:
Within 8" of Joint:
Remarks:

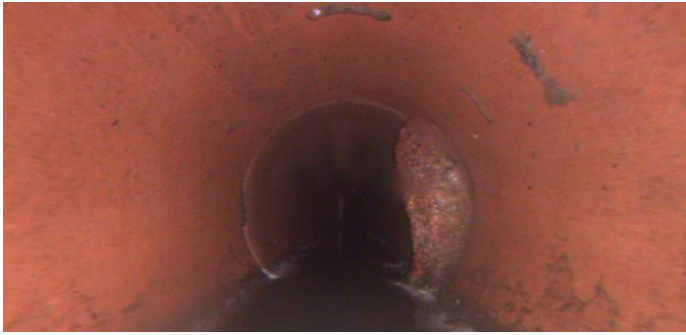
Code: **DAE**
Description: **Deposits Attached Encrustation**

Distance (ft): **113.5**
Structural Grade: **0**
O&M Grade: **2**
Clock Start/From: **7**
Clock To: **5**
1st Value:
2nd Value:
Value Percent: **10.000**
Continuous Index: **S01**
Within 8" of Joint: **YES**
Remarks:

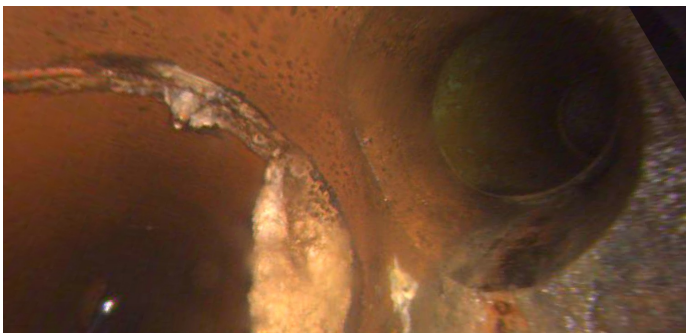
Code: **TF**
Description: **Tap Factory**

Distance (ft): **121.7**
Structural Grade: **0**
O&M Grade: **0**
Clock Start/From: **10**
Clock To:
1st Value: **4.000**
2nd Value:
Value Percent:
Continuous Index:
Within 8" of Joint:
Remarks:

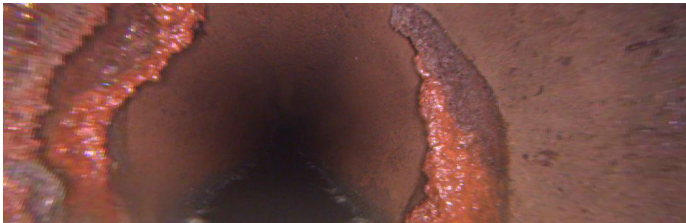
Code: **DAE**
Description: **Deposits Attached Encrustation**

Distance (ft): **122.4**
Structural Grade: **0**
O&M Grade: **2**
Clock Start/From: **7**
Clock To: **5**
1st Value:
2nd Value:
Value Percent: **10.000**
Continuous Index: **F01**
Within 8" of Joint: **YES**
Remarks:

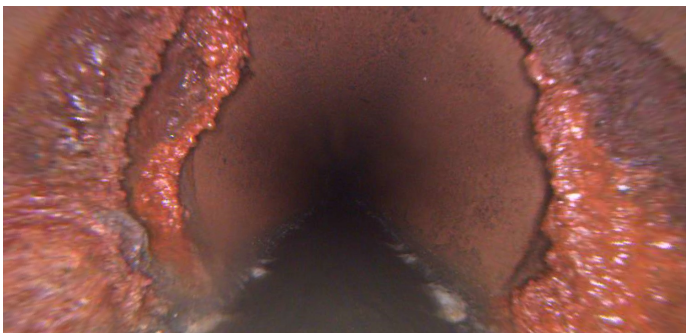
Code: **IW**
Description: **Infil Weeper**

Distance (ft): **122.5**
Structural Grade: **0**
O&M Grade: **2**
Clock Start/From: **8**
Clock To: **4**
1st Value:
2nd Value:
Value Percent:
Continuous Index:
Within 8" of Joint: **YES**
Remarks:

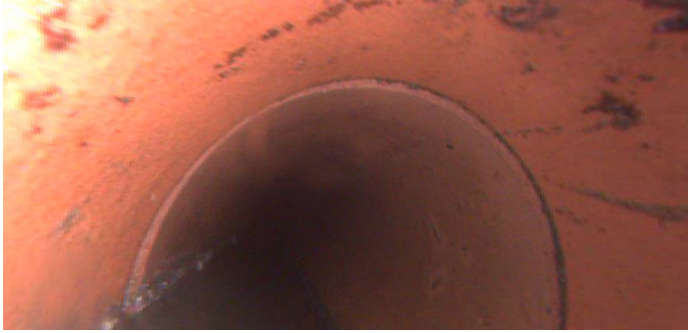
Code:	MSA
Description:	Abandoned Survey
Distance (ft):	158.2
Structural Grade:	0
O&M Grade:	0
Clock Start/From:	
Clock To:	
1st Value:	
2nd Value:	
Value Percent:	
Continuous Index:	
Within 8" of Joint:	NO
Remarks:	camera stopped
